Near-miss, Serious aircraft incident in Turku terminal control area, Finland on 13.8.2001

Investigation report

B 6/2001 L

Serious aircraft incident in Turku terminal control area, Finland on 13.8.2001

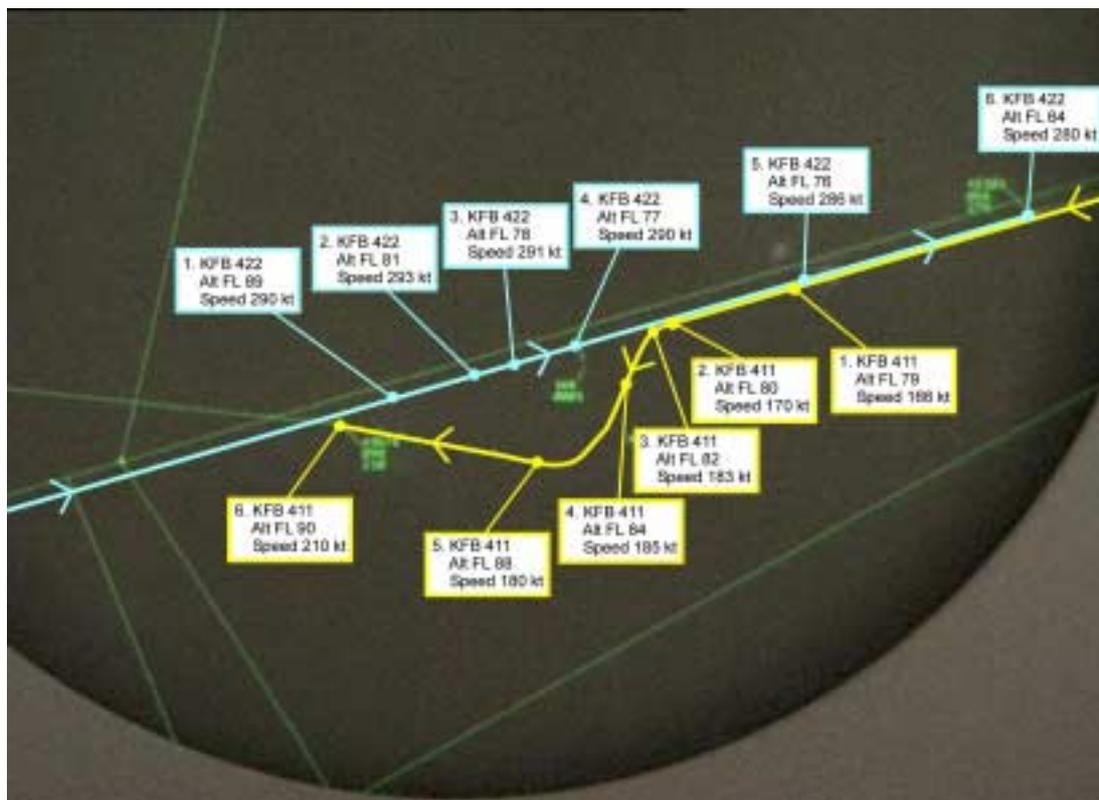
Picture 1. Sequence of events based on the radar record:

When the 1000 feet altitude separation was lost, the distance between KFB 411 and KFB 422 was 6.1 NM. When the two aircraft were at the same altitude, the distance between them was 3.1 NM. When KFB 411 started its avoiding turn, the distance was 2.4 NM, and the shortest distance between the aircraft was 1.1 NM.

1. 16.08.30 1000 feet vertical separation is broken. Distance between aircraft 6.1 NM.
2. 16.09.09 Aircraft on the same level. Distance between aircraft 3.1 NM.
3. 16.09.15 KFB 411 begins avoiding turn left. Distance between aircraft 2.4 NM.
4. 16.09.33 Closest distance between aircraft 1.1 NM.
5. 16.10.10 1000 feet vertical separation re-established
6. 16.11.05 KFB 411 returns on route.
