## Loss of separation south east of Helsinki-Vantaa, Finland on 11.1.2002

C 2/2002 L

# Loss of separation south east of Helsinki-Vantaa, Finland on 11.1.2002

RA11962 Antonov An -12

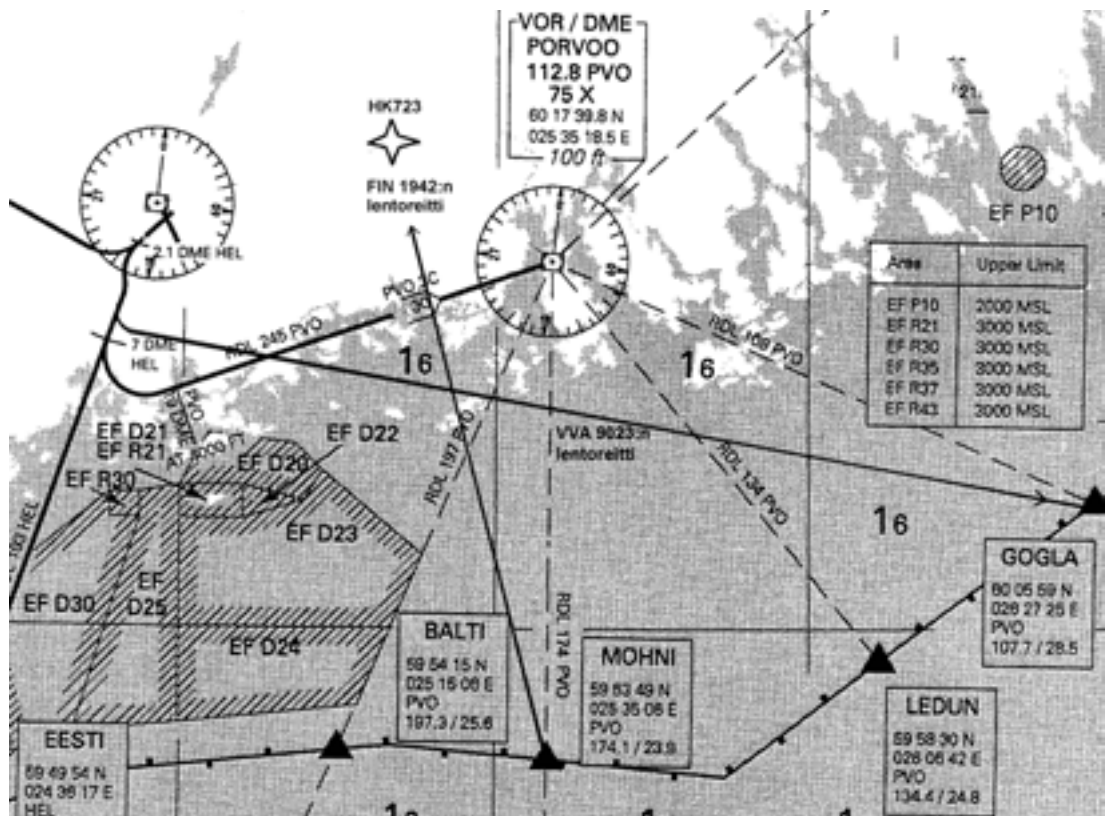
Picture 1. Routes of the aircraft

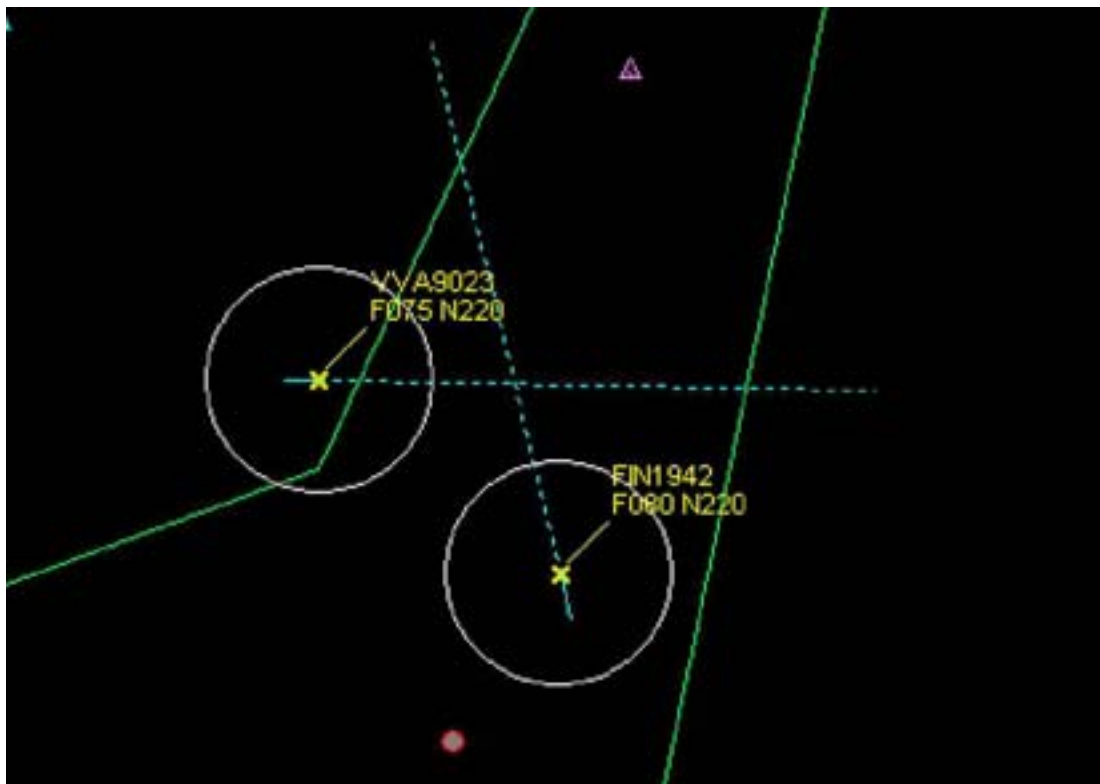
Less than a minute later, at 15.56.05, the cockpit crew of FIN1942 and both controllers noticed that VVA9023 had not maintained flight level 70, but was passing flight level 75 climbing. The distance between the aircraft was about four nautical miles and their flight paths were crossing. In addition to this the commander of FIN1942 had visual contact of VVA9023. According to his statement he found An-12 continuing its climb.

Picture 2. Positions and C-mode altitudes of the aircraft in the beginning of the evasion

Despite that the TCAS-system of FIN1942 had not yet given evasion instruction and the air traffic control had not yet had time to interfere, the cockpit crew decided to take evasive manoeuvre by a gentle climb over VVA9023. The commander informed the APP controller, who gave them clearance to climb to flight level 90 and allowed it to turn at pilots discretion. The horizontal evasion was possible, hence other incoming traffic was far enough in south west although at the same flight level.

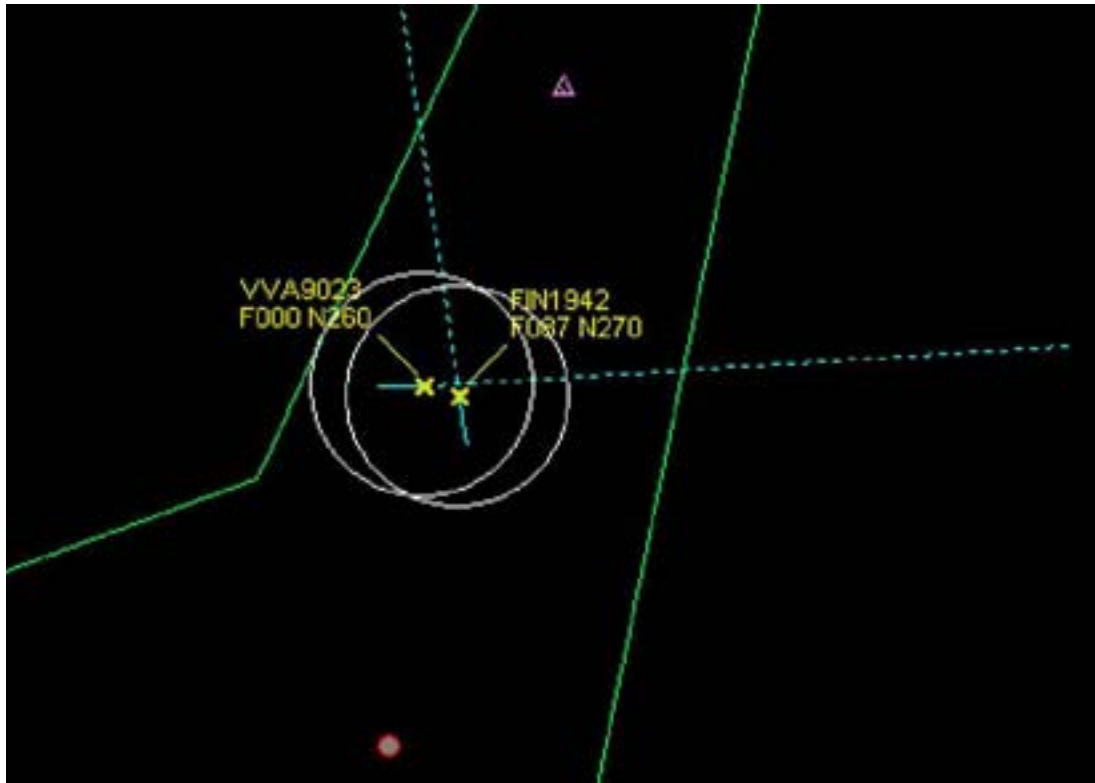
At 15.56.10 when the air traffic controller ordered VVA9023 to descend to flight level 70, the aircraft did not descend immediately. According to the radar recording it maintained flight level 74-73 for approximately 20 seconds, which after C-mode altitude indication of

VVA9023 disappeared for approximately 20 seconds from radar screen. When the altitude indication resumed, the aircraft was at flight level 70. The reason for altitude indication disappearance could not be solved during the investigation. Possible reasons could be either communication interruption between the transponder of VVA9023 and SSR radar or that the transponder of VVA9023 did not send the C-mode information at that time.

Picture 3. The positions and C-mode altitudes of the aircraft at the passing moment
