Investigation report

C 9/2002 L

Loss of separation over BALTI on 6.9.2002

OH-LYV DC-9

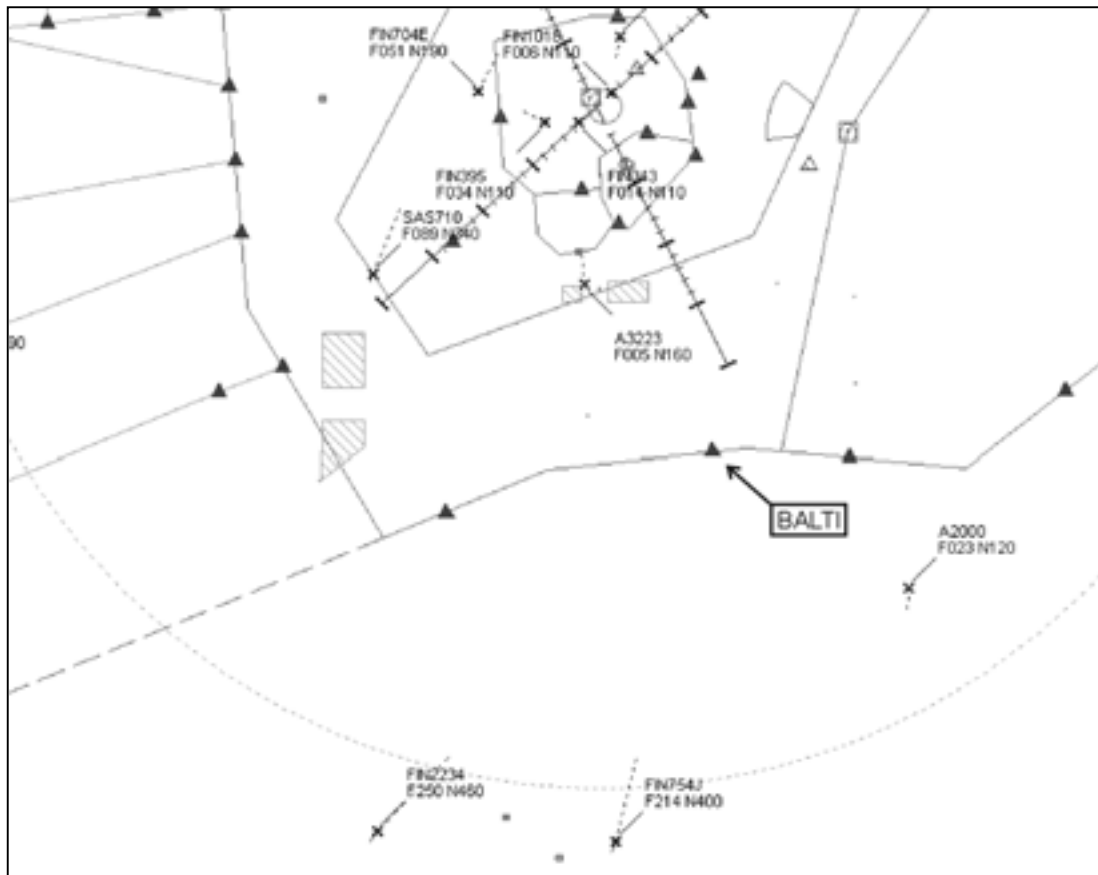
Figure 1. Positions and flight levels of the aircraft when the rate of descent restriction was issued at 09.48.00 UTC

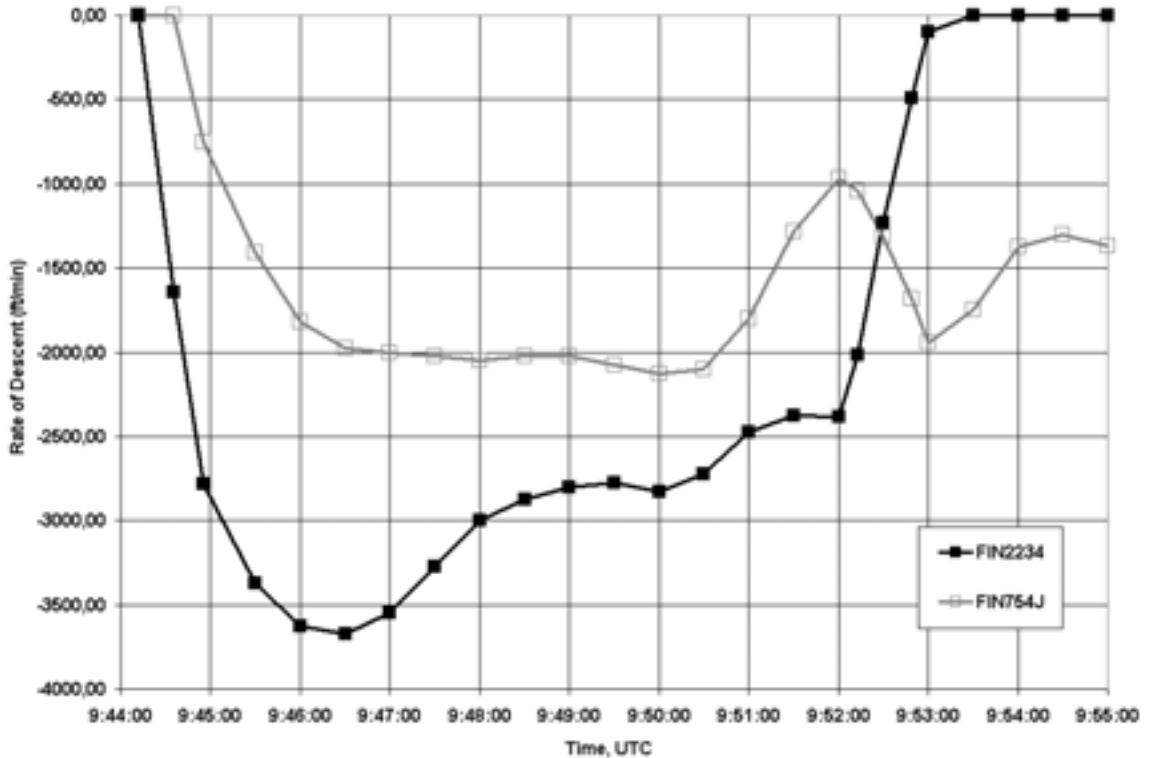
Figure 2. Rate of descent curves of the aircraft

FIN754J descended at a rate of 2000-2200 ft/min, but reduced the rate of descent after passing through FL 150 at 09.50.30, when the Tallinn controller asked it to change over to Helsinki approach frequency. At 09.52.00 the rate of descent was 1000 ft/min, increasing thereafter momentarily to 2000 feet per minute. The vertical speeds of the aircraft are presented as a graph in Figure 2.

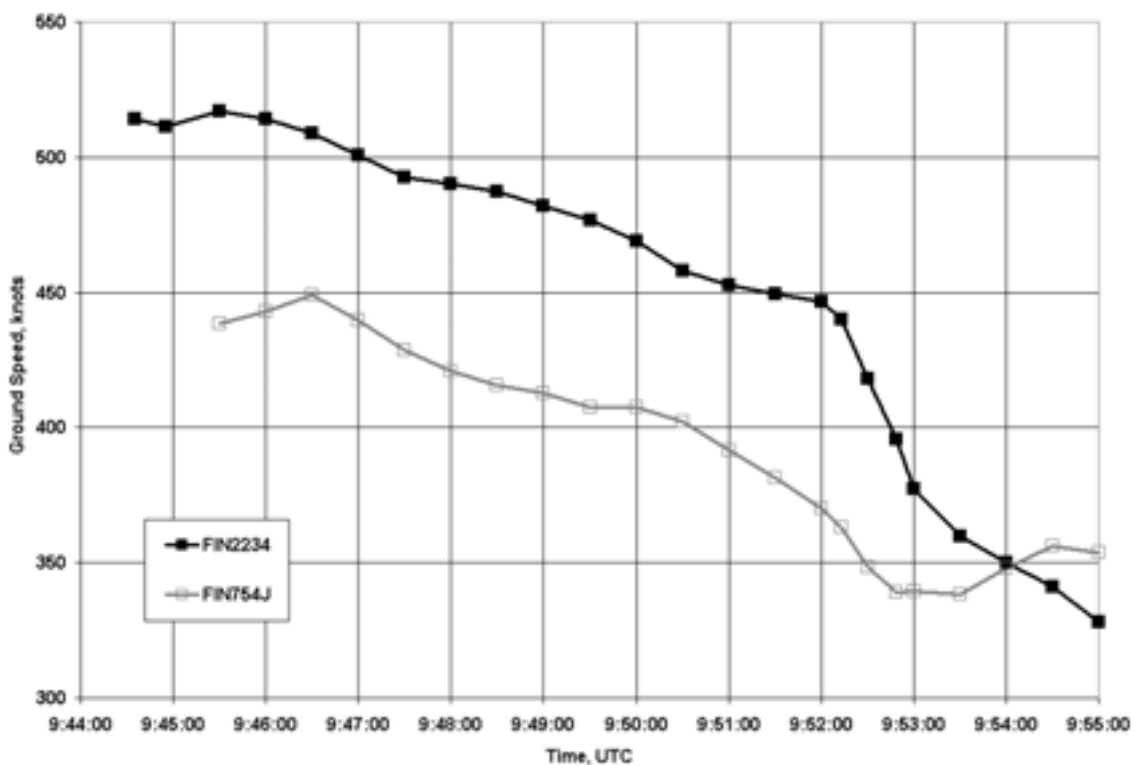
Figure 3. Groundspeed curves of the aircraft

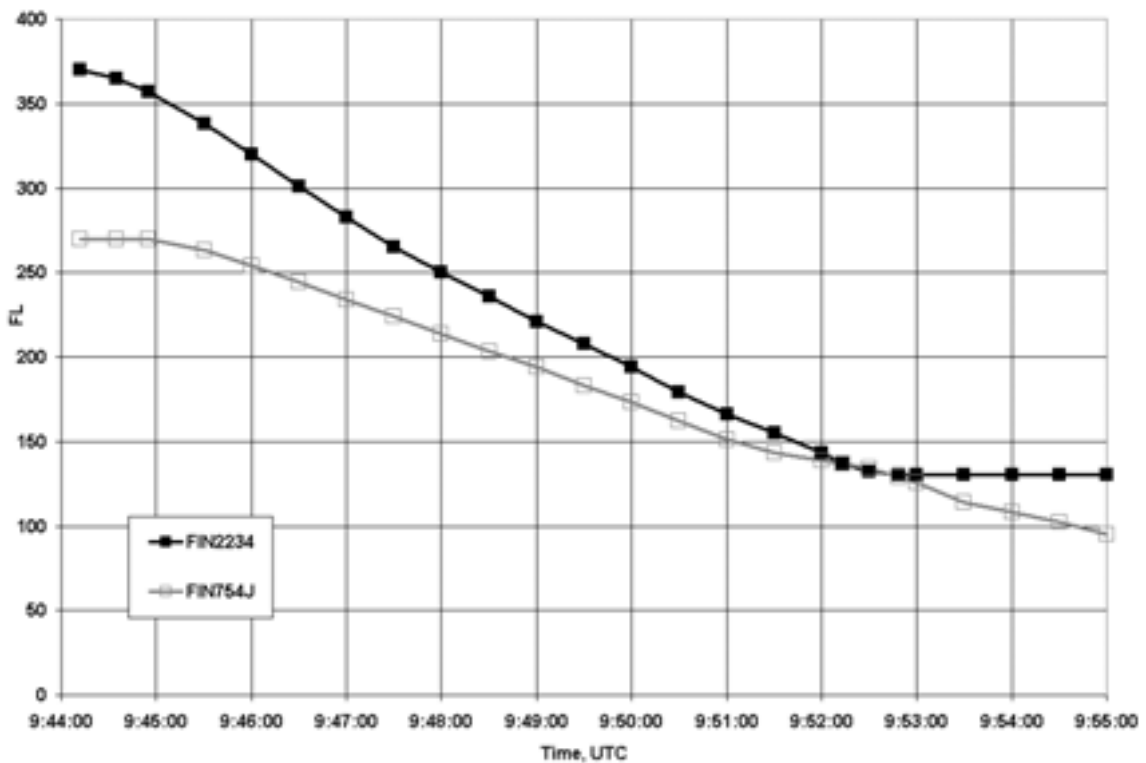
Figure 4. Flight profiles

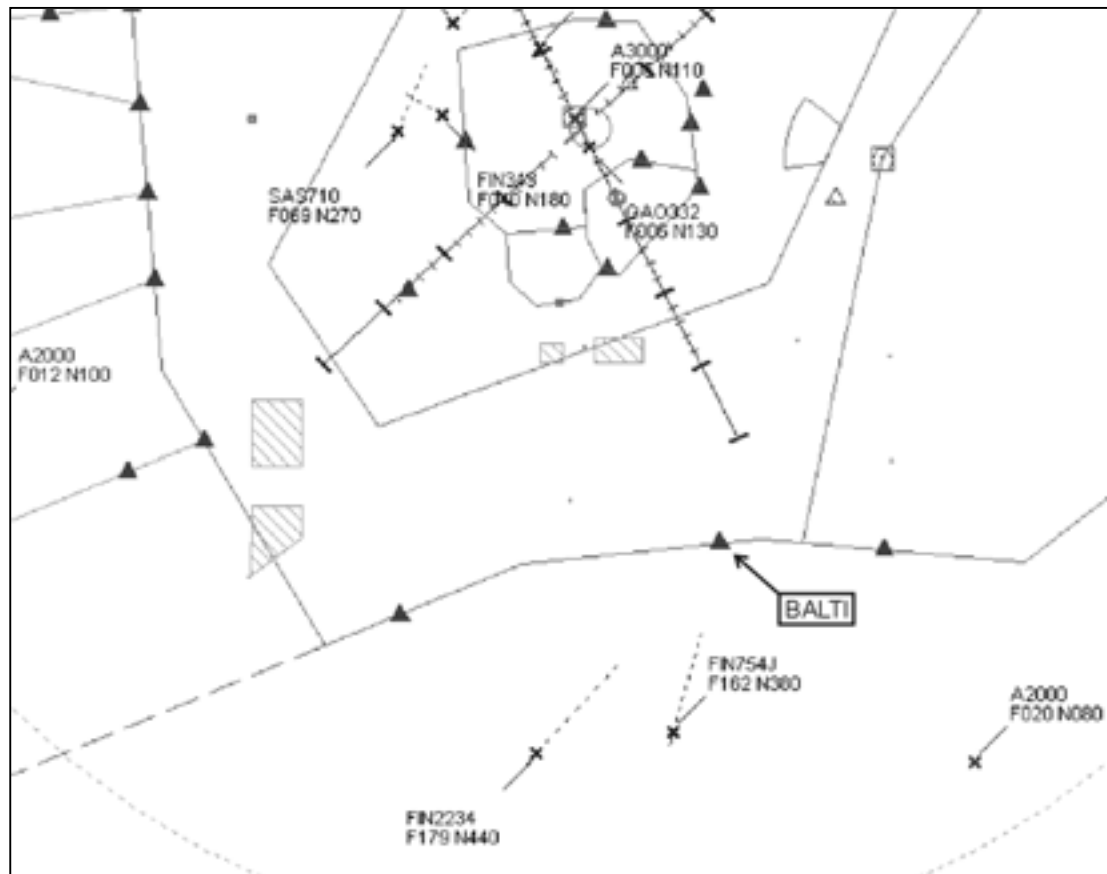
Figure 5. Positions and flight levels of the aircraft at 09.50.30

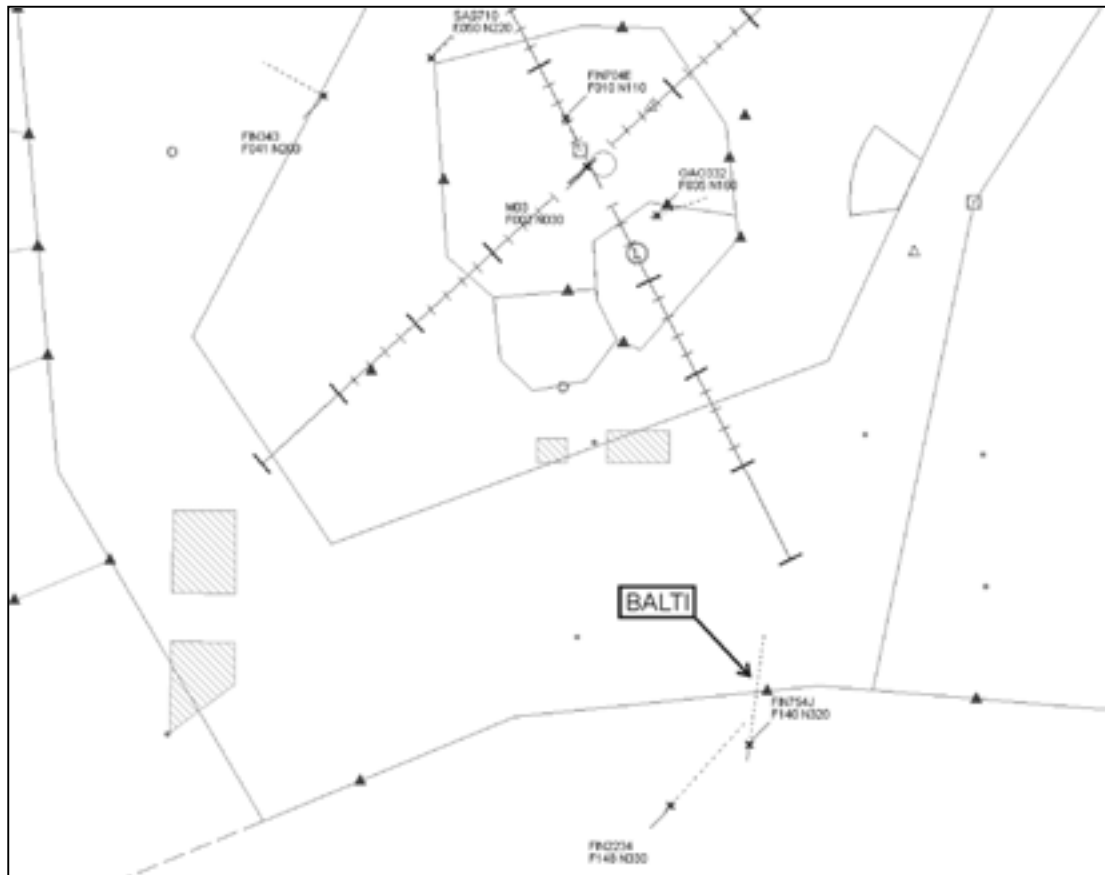
Figure 6. Positions and flight levels of the aircraft at 09.51.50

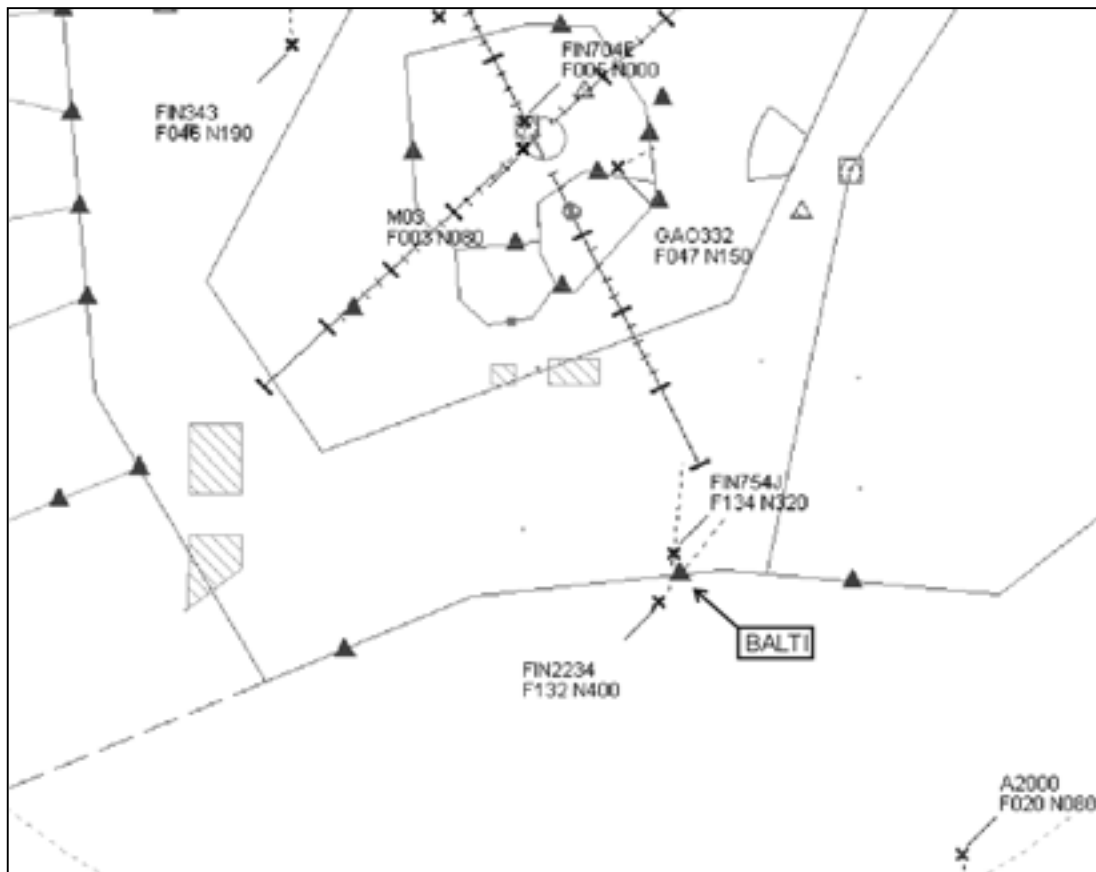
Figure 7. Positions and flight levels of the aircraft at 09.52.30
