Loss of Separation East of Turku Airport on 23.10.2002

C 10a/2002 L

HB-VNF Gulfstream G100

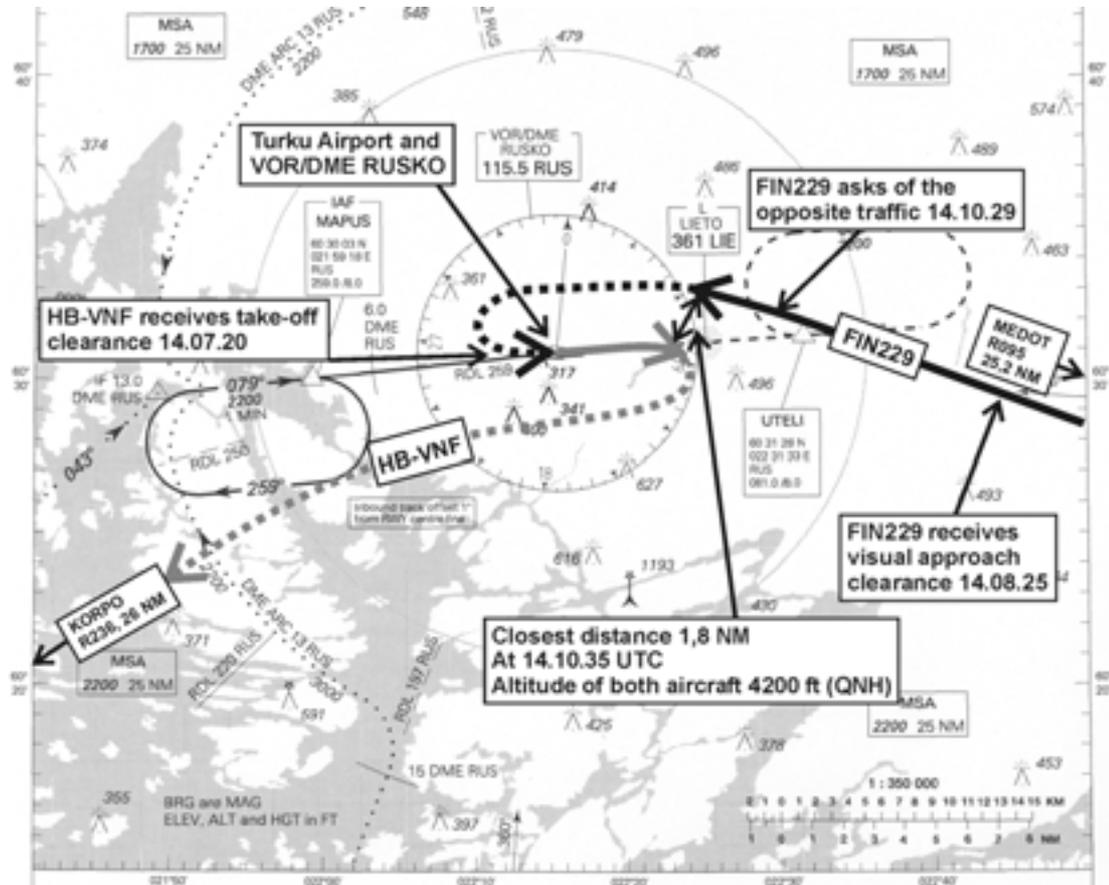
Figure 1. Flight tracks

The radar recording indicates that HB-VNF passed through the initial clearance altitude of 3200 ft at a distance of 3.0 NM from the airport at 14.10.00. The aircraft had climbed following the runway 08 direction. The distance to FIN229 was 5.0 NM at that time.

The radar recording indicates that HB-VNF continued its right-hand climbing turn. FIN229 continued at the altitude of 4500 ft (4200 ft on QNH) towards the left down-wind leg of runway 08. HB-VNF passed through the FIN229 altitude at 14.10.35, at which time the horizontal distance was 1.8 NM according to the radar recording. This was also the minimum distance between the two aircraft. Figure 1 illustrates the aircrafts' flight tracks based on the radar recording.

8. At the time when HB-VNF passed through the FIN229 altitude, the radar recording indicates that the distance between the two aircraft was 1.8 NM which was also the minimum distance between them.

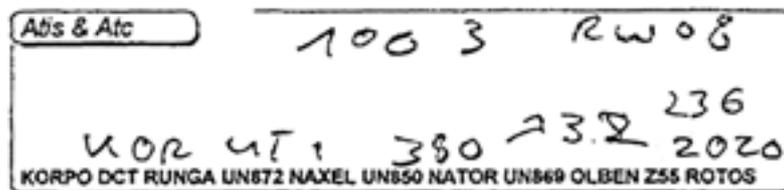
Figure 2. Notes in the upper corner on the HB-VNF operative flight plan

HB-VNF requested start-up clearance from the Turku tower and received it immediately. It requested taxi clearance 2 minutes 46 seconds later and received taxi clearance to holding position runway 08 including information on air pressure QNH 1003. The notes on the flight log about the taxi clearance are visible on the uppermost row in Figure 2.

HB-VNF called the Turku tower one minute after starting to taxi and reported to be ready to copy the route clearance. The pilots requested the clearance because the aircraft was equipped with a flight management system (FMS), into which the departure route data have to be entered manually prior to takeoff when the departure airport does not have any designated standard instrument departure route. The air traffic controller gave the clearance immediately: "HNF, cleared to Bern via KORPO, UT81, RUNGA, flight level 380, after departure maintain 3200 feet until radial 236, squawk 2020". The first officer read back the clearance correctly except for the altitude of 3200 ft which he read as 3500 ft. The air traffic controller corrected the altitude to 3200 ft, after which the first officer read it back correctly. The note on the log about the clearance is visible on the second row in Figure 2. Also the altitude correction can be seen.

Although the first officer read back the clearance correctly, it is possible that the crew in carrying out takeoff briefing and setting the cockpit navigation aids for takeoff, misinterpreted the up arrow in front of the altitude marking 3.2 in the log. The commander stated in his report that they understood the clearance so that they would climb directly to 3200 ft and thereafter home to radial 236. Therefore they also set the aircraft altitude alerter at FL 380. Had they understood the first restrictive altitude to be 3200 ft in the route clearance, they would have set altitude alerter at 3200 ft. In manual controlling the altitude alert function would have informed about the approach of the set altitude and about reaching it, whereas in autopilot mode it would have stopped the climb and levelled the aircraft at this altitude.
