Loss of separation west of Helsinki-Vantaa airport on 22.1.2003

C 1/2003 L

RA-85185 Tu-154M

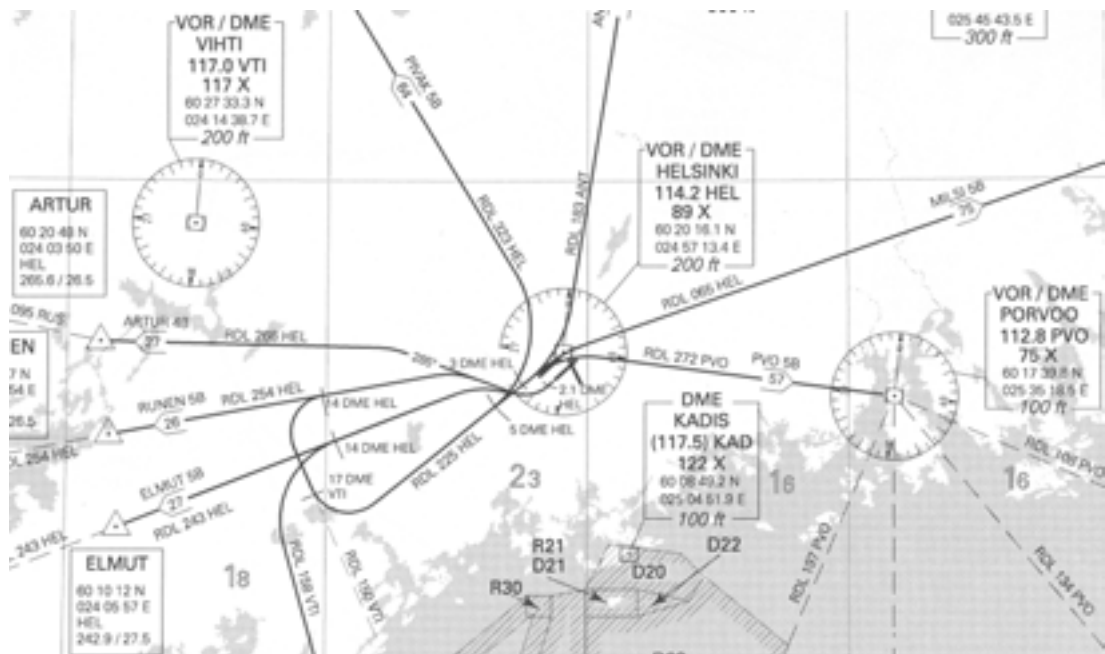
Figure 1. Standard Instrument Departures ARTUR 4B and PORVOO 5B

Finnair Oyj's ATR72, OH-KRC with callsign FIN225, departed from runway 22L to Turku at 18.53 UTC and was cleared to follow the Standard Instrument Departure (SID) ARTUR 4B. Pulkovo Airlines Tu-154M, RA-85185 with callsign PLK230, departed from the same runway to St.Petersburg at 18.55 and was cleared to follow SID PORVOO 5B. The SIDs are presented in figure 1.

The beginning of both SIDs is identical. They turn right to track 285° at a distance of 2.1 NM from HEL VOR/DME. After this the aircraft is supposed to intercept and follow HEL VOR/DME radial 266 with ARTUR 4B and radial 254 with PORVOO 5B. The SIDs include instructions to contact Helsinki Radar when passing 1500 ft (QNH), and to climb initially to 4000 feet. Both the Finnish Aeronautical Information Publication (AIP) and the Jeppesen Airway Manual contain the following instructions:

Climb to 4000 ft or assigned altitude if lower. Climb to higher level only when cleared by ATC. When passing 1500 ft contact Helsinki Radar.

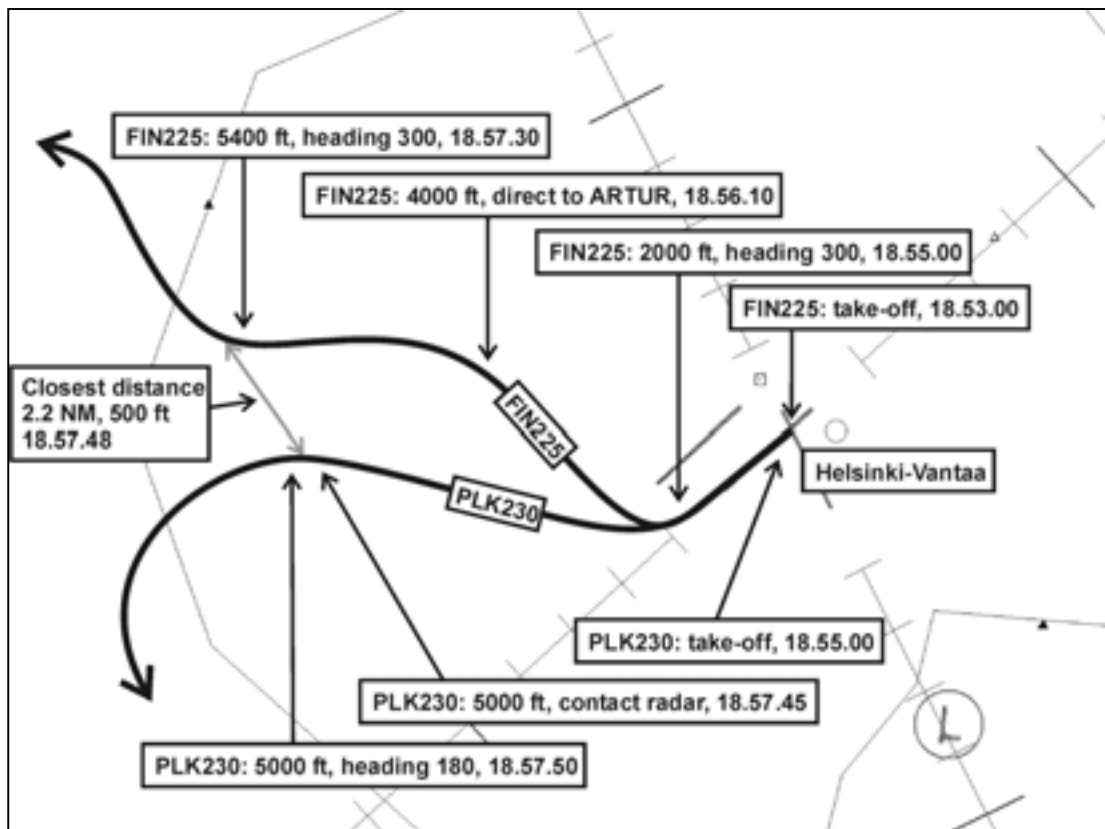
Figure 2. Flight tracks of the aircraft

There was no danger of mid-air collision, but the Accident Investigation Board Finland decided to investigate the incident because the required 3 NM radar separation was lost. The closest horizontal distance between FIN225 and PLK230 was 2.2 NM according to the Helsinki radar recording. The vertical distance between the aircraft was 500 feet at that time. It should have been at least 1000 feet for the required vertical separation to exist. If the vertical separation is less than 1000 feet, horizontal separation must be at least 5 NM. The flight paths of the aircraft were divergent at the closest point of approach. The radar controller had the situation under control at all times even though PLK230 was not able to establish radio contact with him before it had climbed above the initial climb altitude.

8. PLK230 did not level off at 4000 ft as instructed by the SID but climbed instead approximately 1100 feet higher.
9. As the radar controller noted that PLK230 was climbing above 4000 feet he instructed FIN225 to turn again right to heading 300°.

12. The radar controller gave FIN225 traffic information about PLK230.
13. According to the Helsinki-Vantaa radar recording the aircraft passed each other with a horizontal separation of 2.2 NM and a vertical separation of 500 feet.

1. The operator Pulkovo Airlines should develop its crew co-operation so that the complete crew would have a consistent conception of the flight path and its limitations. Then the monitoring crew members could support the flying pilot in completing the flight according to the clearance.

2. The operator Pulkovo Airlines should install in its aircraft the Altitude Alert/Capture -system to remind the crews of approaching and reaching cleared altitudes, and make its use a part of its standard operating procedures.
