## Incident between an airliner and airport maintenance vehicle at Kuusamo airport on 29 January 2003

## Investigation report

C 2/2003 L

F-GFUI, Boeing 737-300

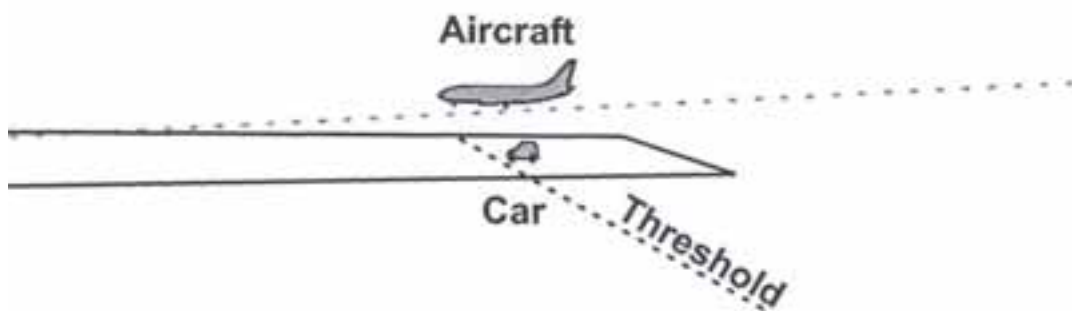
Finnair 3395, which was standing on the apron, asked at 11.52.11 the FISO (in Finnish) to give AXY852's estimate KS inbound. FISO first replied on the ground frequency in Finnish "56, 51 went outbound" and after a while made the same report on the AFIS frequency. At 11.52.48 AXY852 reported "Short final, AXY852". At first FISO replied on the ground frequency "AXY852, say again, what did you say", but immediately after this he changed over to the AFIS frequency and said only "AXY852". AXY852 landed while the RVR measurement vehicle was still in front of runway 12 threshold near the centerline, thus occupying the runway. FISO told having seen the landing aircraft, but not the measurement vehicle. The aircraft was flying at a height of about 15-20 meters over the threshold. After landing, PNF told PF that he had seen something on the right-hand side of the threshold, but was not sure what it was.

Picture 1. Landing aircraft over the threshold
