## Uncontained engine failure, Boeing 737-236 series 1, G-BGJL

# Boeing 737-236 series 1, G-BGJL

Aircraft Incident Report No: 8/88

Report on the accident to Boeing 737-236, G-BGJL at Manchester International Airport on 22 August 1985

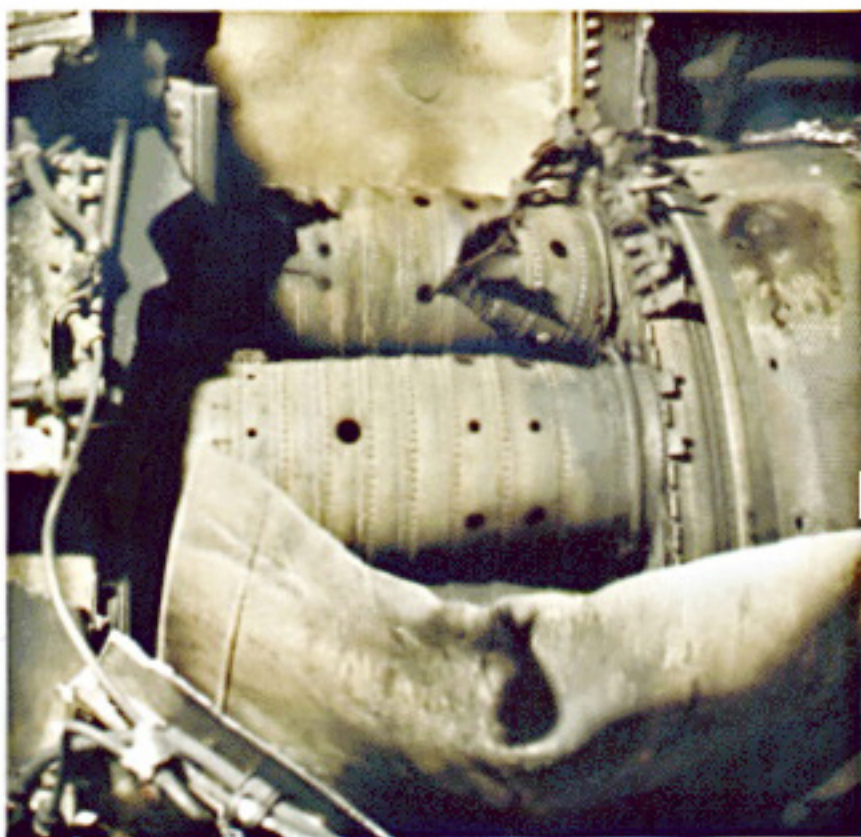
Remains of combustor can No 9 viewed through the CCOC rupture

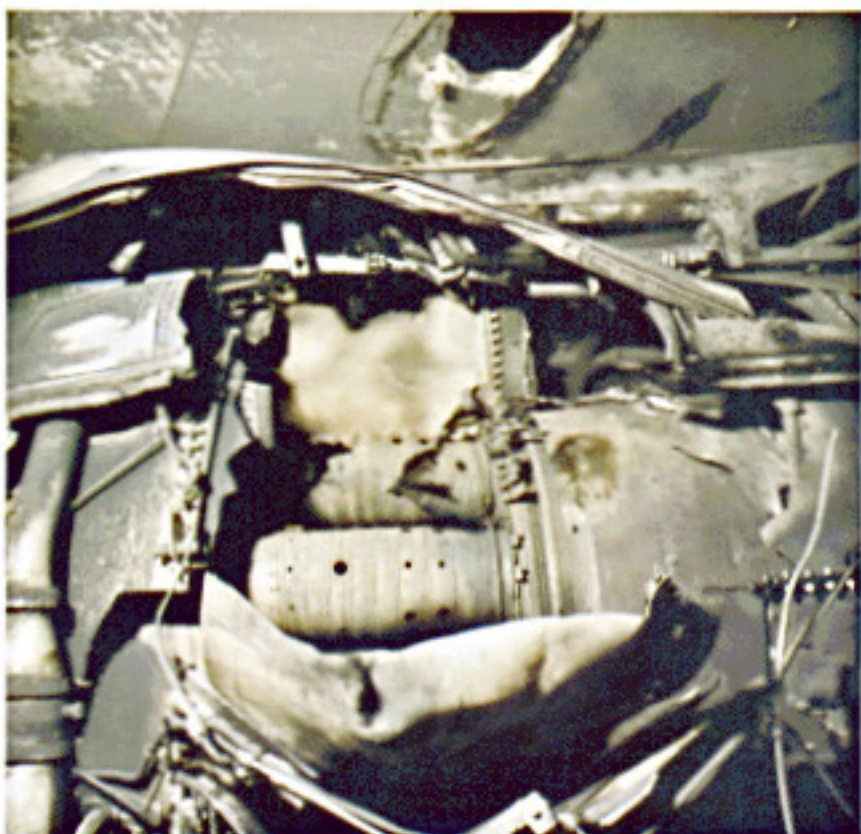
The left hand engine, Serial No P702868, had suffered an explosive rupture of the CCOC. The case had split along an axial line adjacent to No 9 combustor can and had then 'petalled' apart from approximately the 11 o'clock to 5 o'clock position (viewed from the front), failing the attachment bolts on the front flange and the flange itself on the rear face. The upper section of the CCOC had blown upwards onto the underside of the engine pylon, striking the fire/overheat detection system

electrical loom. The lower section had blown downwards and outwards. Witness marks on the exterior surface of the CCOC adjacent to the rupture showed that it had struck the inner surface of the fan case as the rupture occurred. (Appendix 5 Fig e)

Engine rupture and holed fuel tank access panel

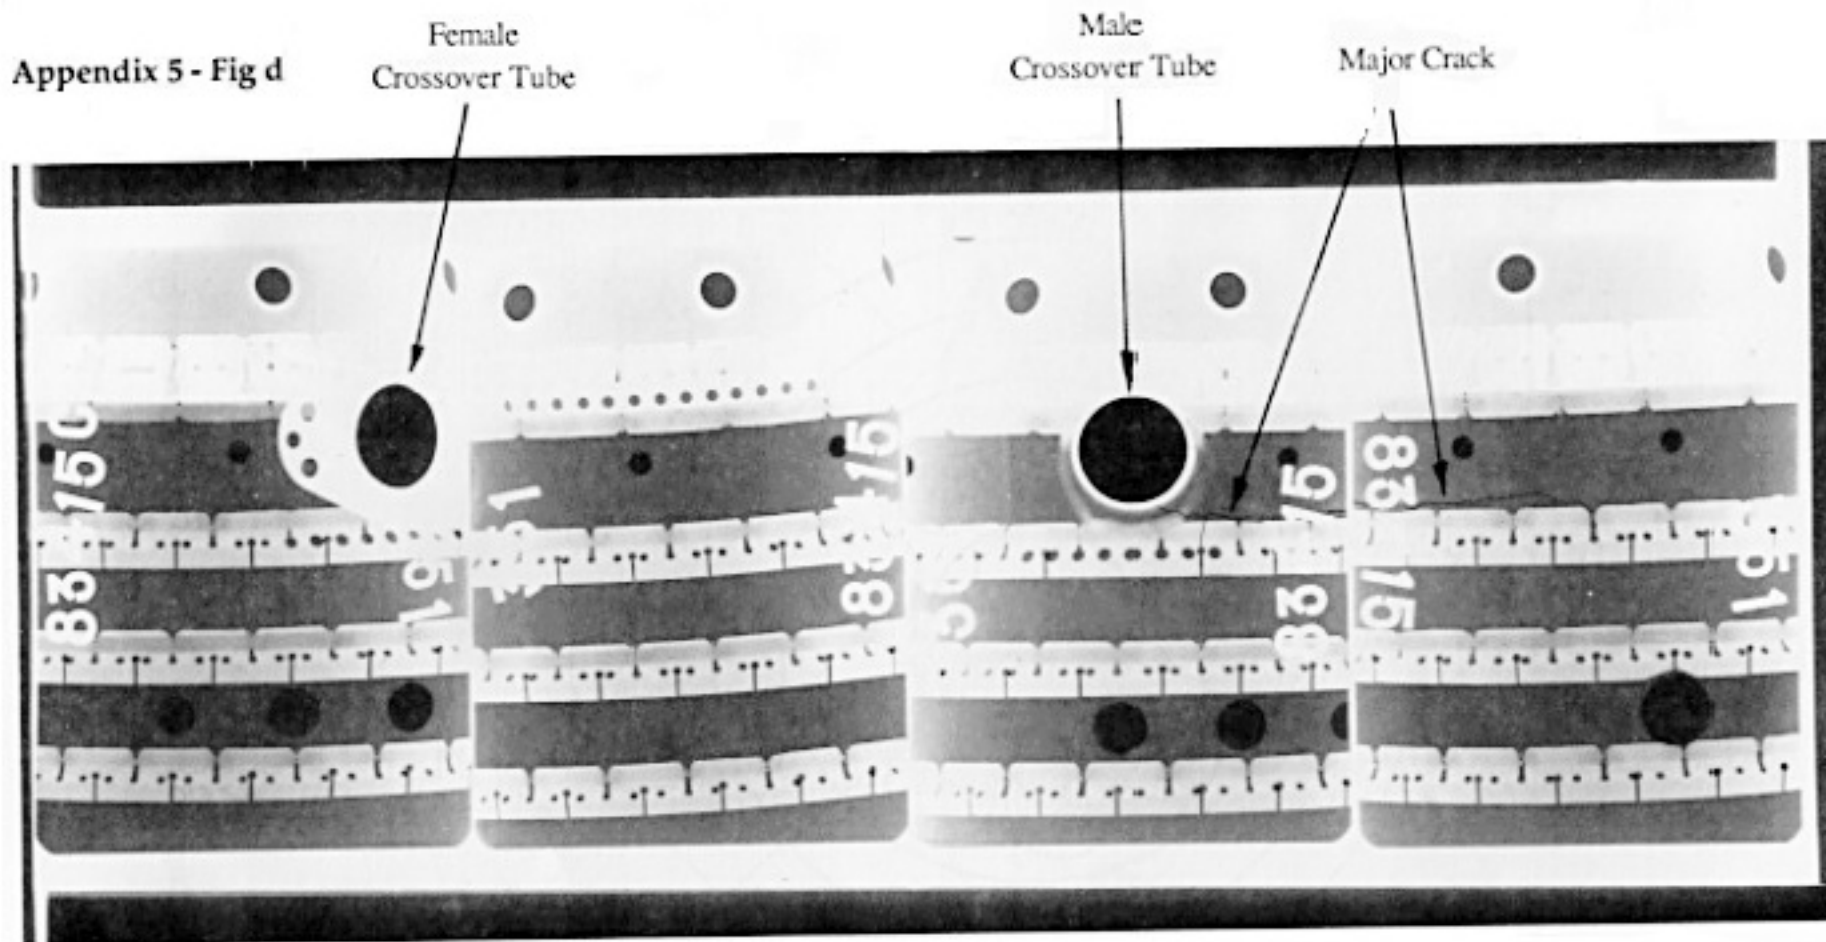
Examination of the radiographs showed that the can exhibiting the most cracking in the 3/4 liner joint was can No 9, serial number TS351 (installation position was the same on both engines). A circumferential crack 160 mm in length extended in the third liner from the male flame transfer tube around the outboard face of the can, in the area of the seam weld to the fourth liner. A second crack 25 mm in length, barely discernible from the radiograph, was seen about 50 mm further round from the main crack (Appendix 5 Fig d).

Positive Prints of X-Radiographs Taken Around the Circumference of Can No 9 After 7,582 Flying Hours

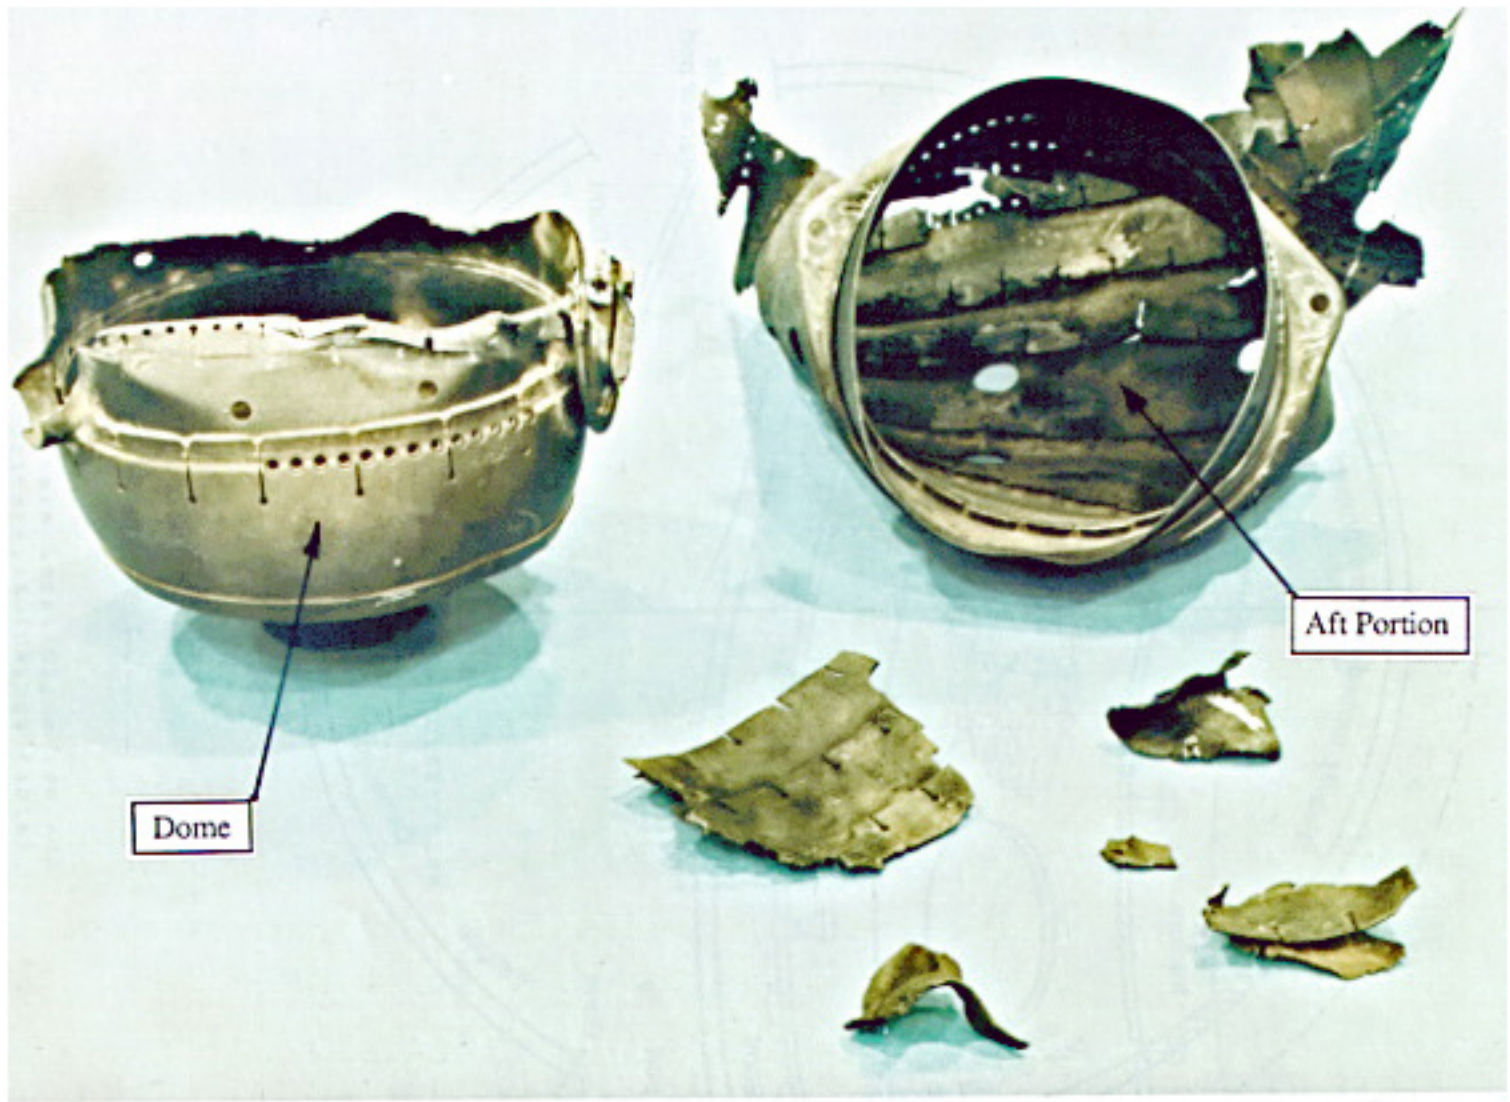
The Recovered Remains of Combustion Can No 9 from the Left Engine Appendix 5 - Fig f

The dome-shaped section of the left engine No 9 combustor can, sections of engine cowl, broken pieces of bypass duct, fragments of left wing tank access panel and other debris from the vicinity of the ruptured left engine combustor case were found on the runway between link 'C' and runway 06 fast turnoff.

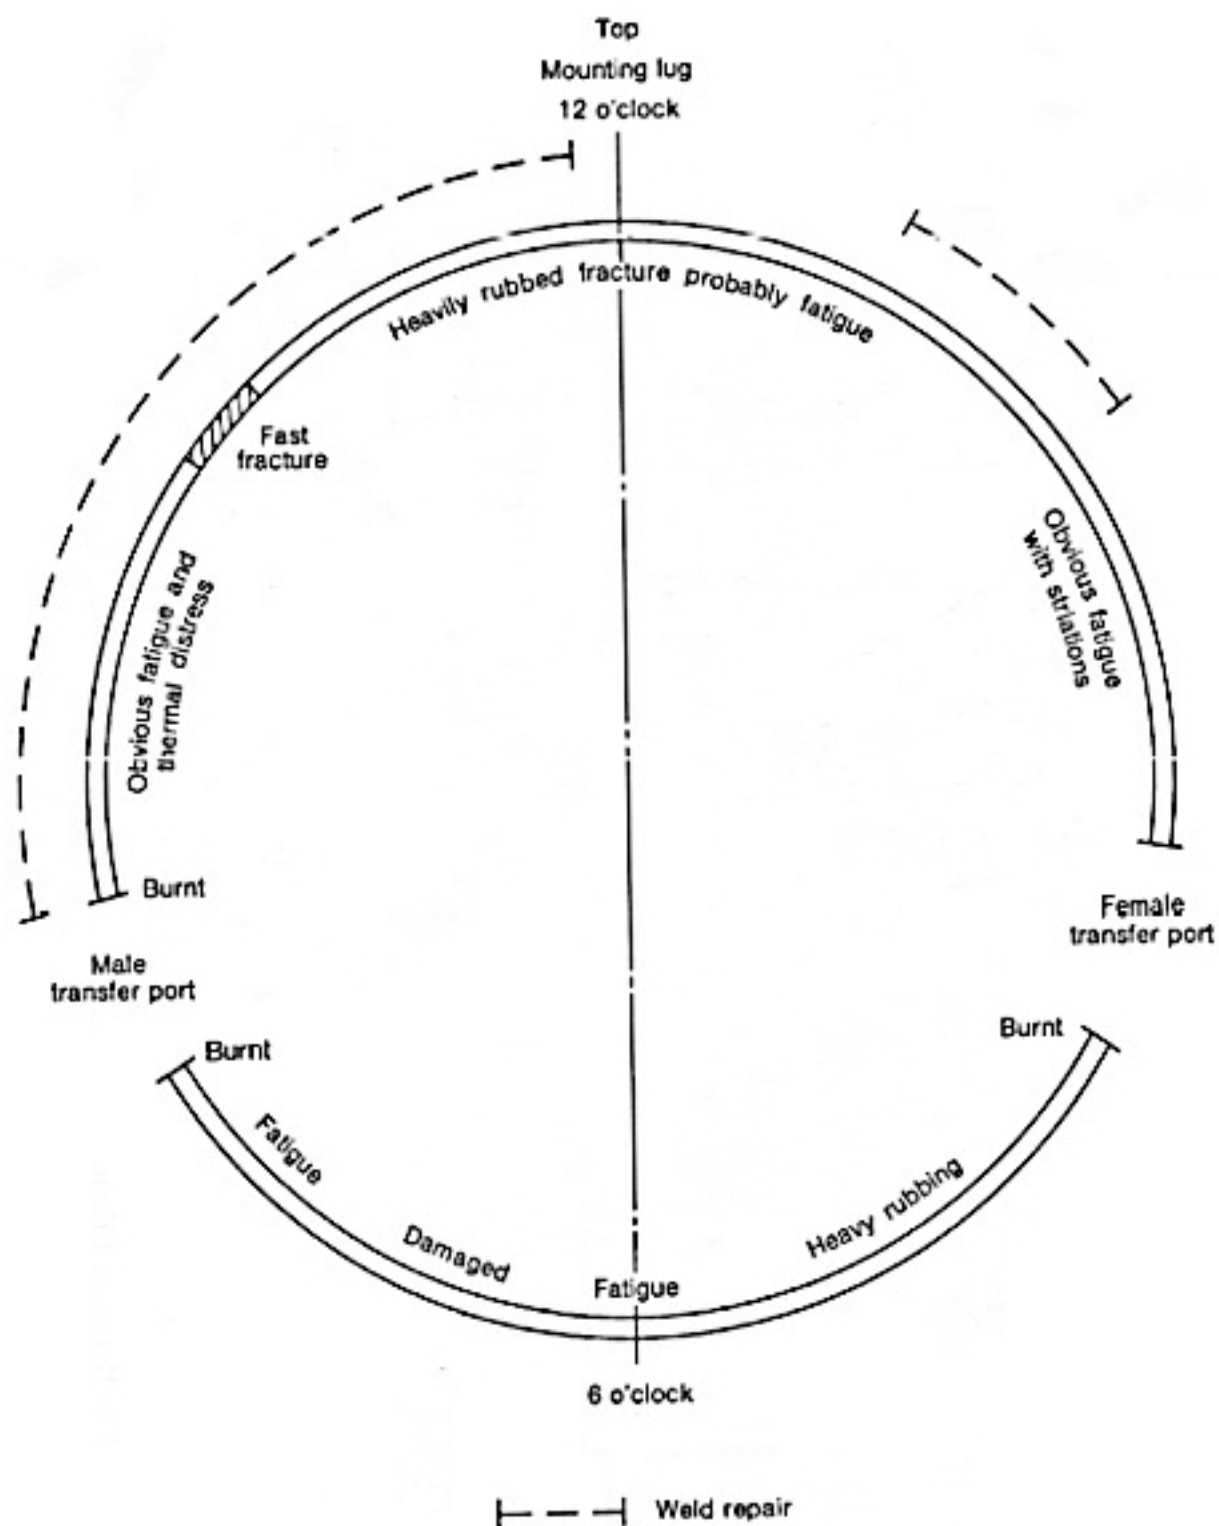
Schematic Summary of the Fractographic Features of the Circumferential Cracking in the 3rd Liner of Can No 9

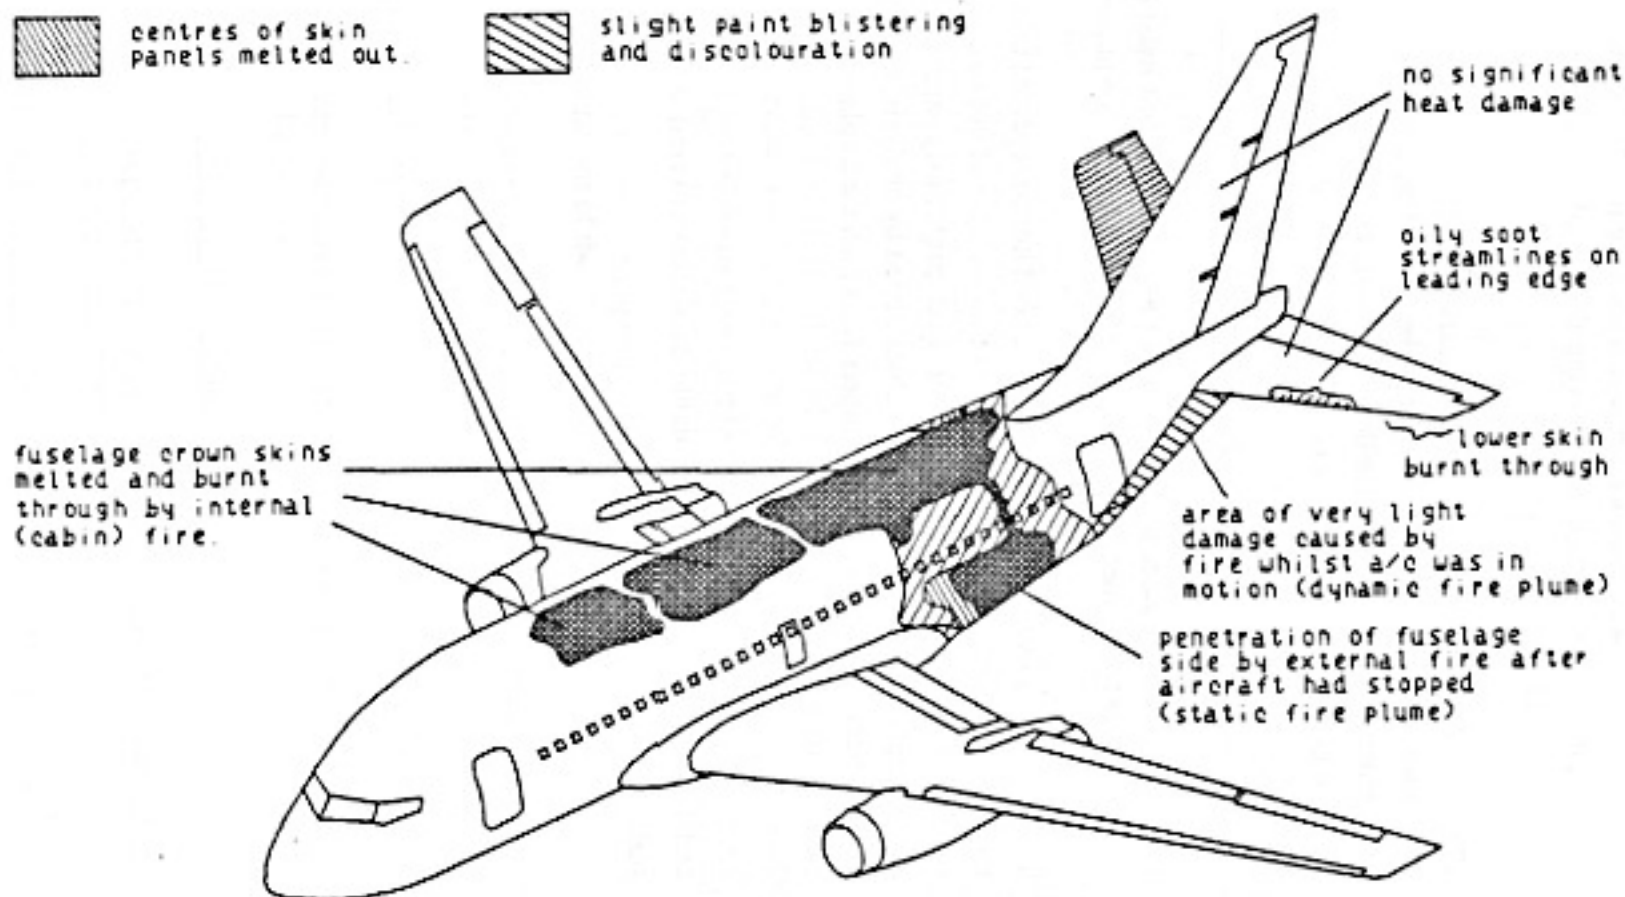
Appendix 8 - Fig a

Parts of the rear fuselage left side wall together with most of the cabin roof were burnt away, and the rear fuselage and tail section had collapsed to the ground. Most of the cabin interior was extensively

PRINCIPAL FIRE DAMAGE - FUSELAGE AND TAIL PORT SIDE

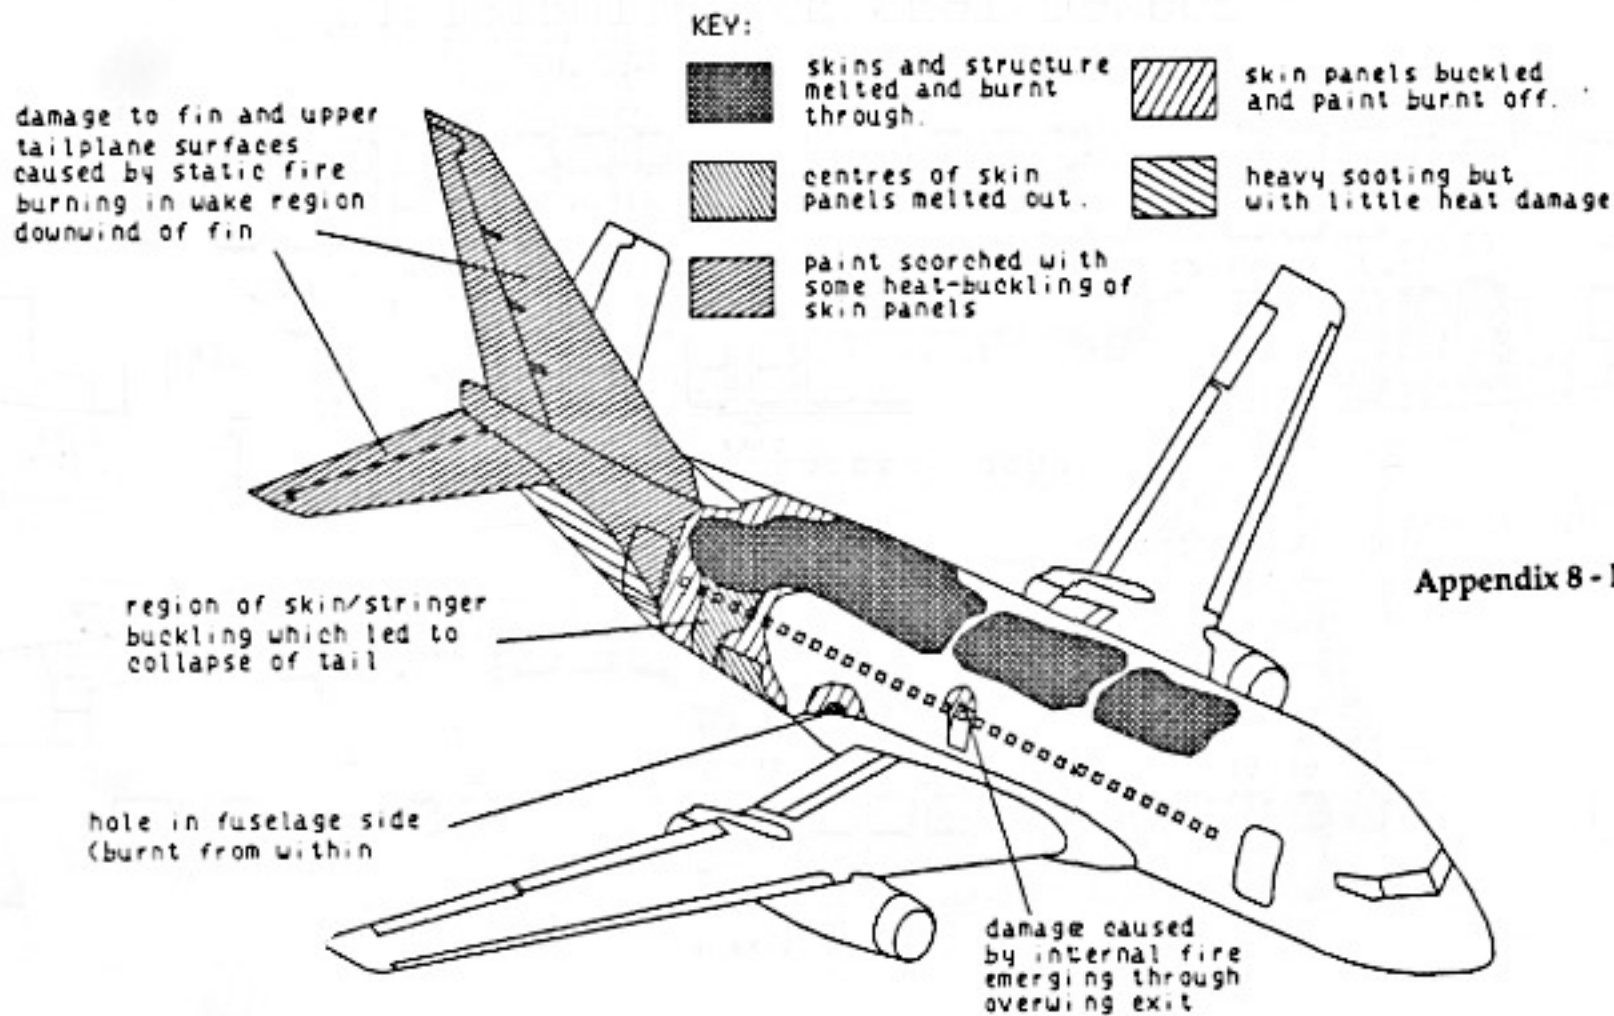
Appendix 8 - Fig b

PRINCIPAL FIRE DAMAGE - FUSELAGE AND TAIL STARBOARD SIDE

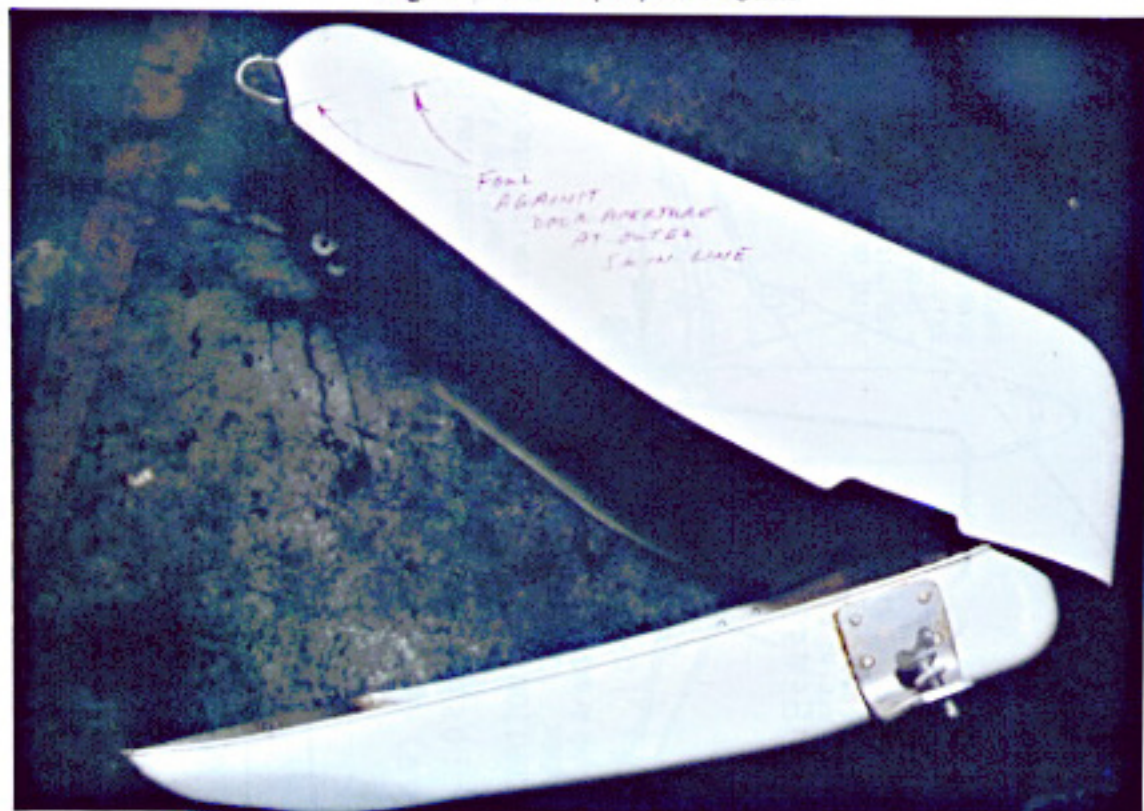
a - Witness Mark on Slide Box Lid

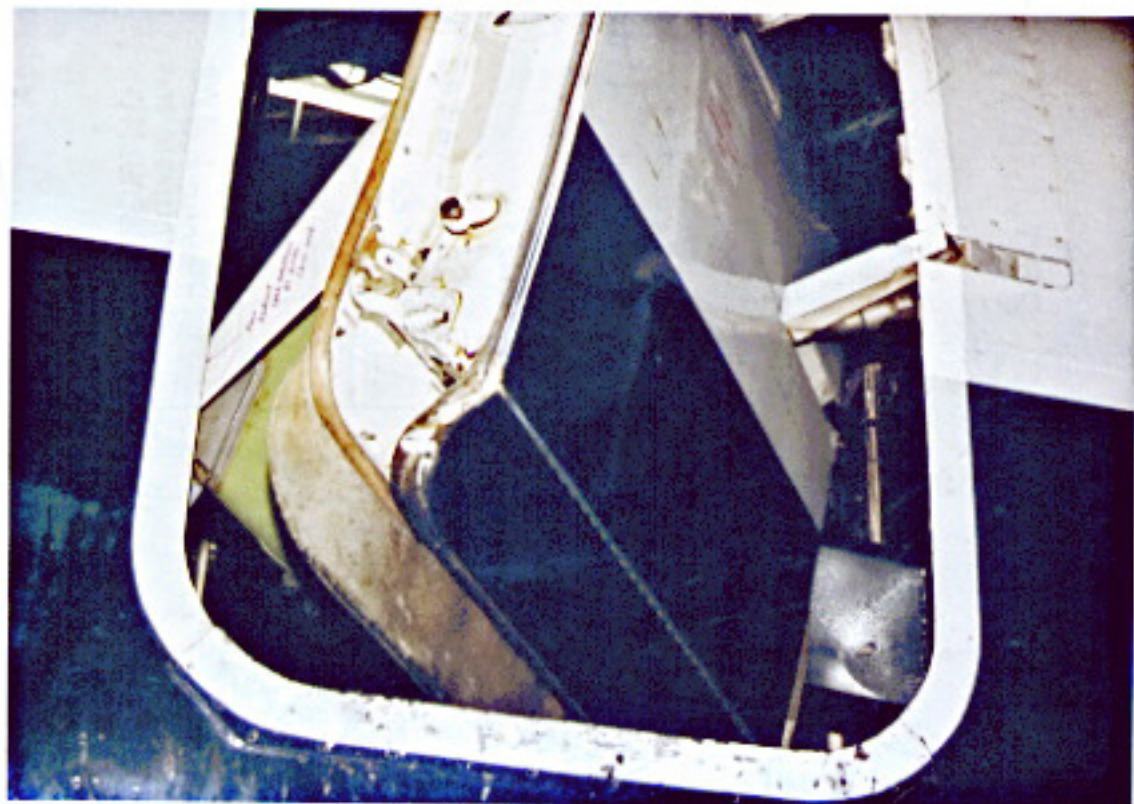
b - Door Position With Witness Marks Aligned-External

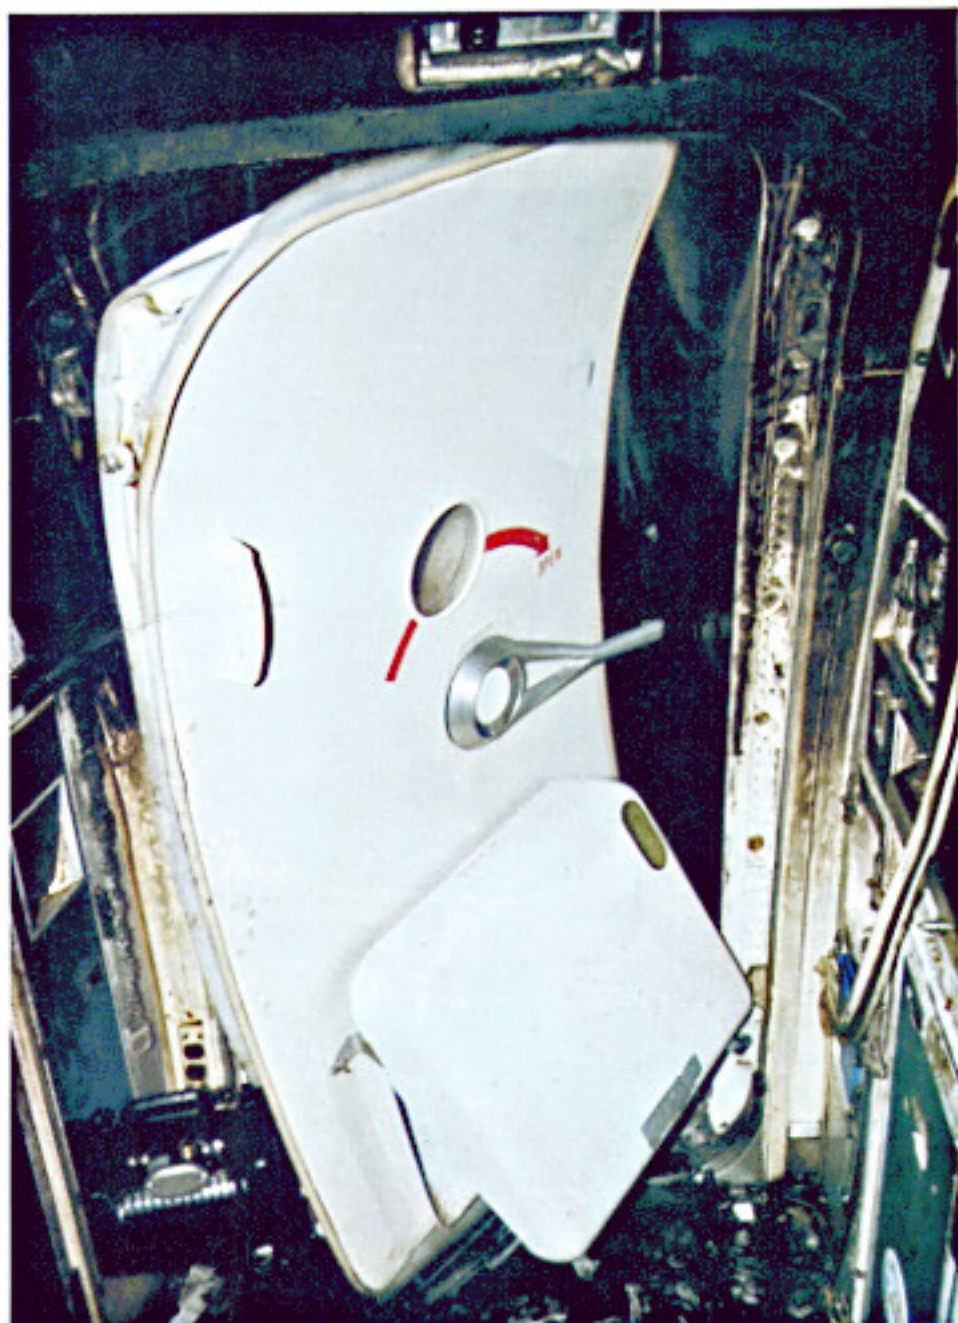
c-Door Position Witness Mark Aligned - Internal
