## Crash short of runway, Boeing 737-400, G-OBME

**Micro-summary:** This Boeing 737-400 crashed short of the runway following an engine failure and incorrect shutdown of the good engine.

# Boeing 737-400, G-OBME: Main document

Report on the accident to Boeing 737-400 - G-OBME near Kegworth,  
Leicestershire on 8 January 1989

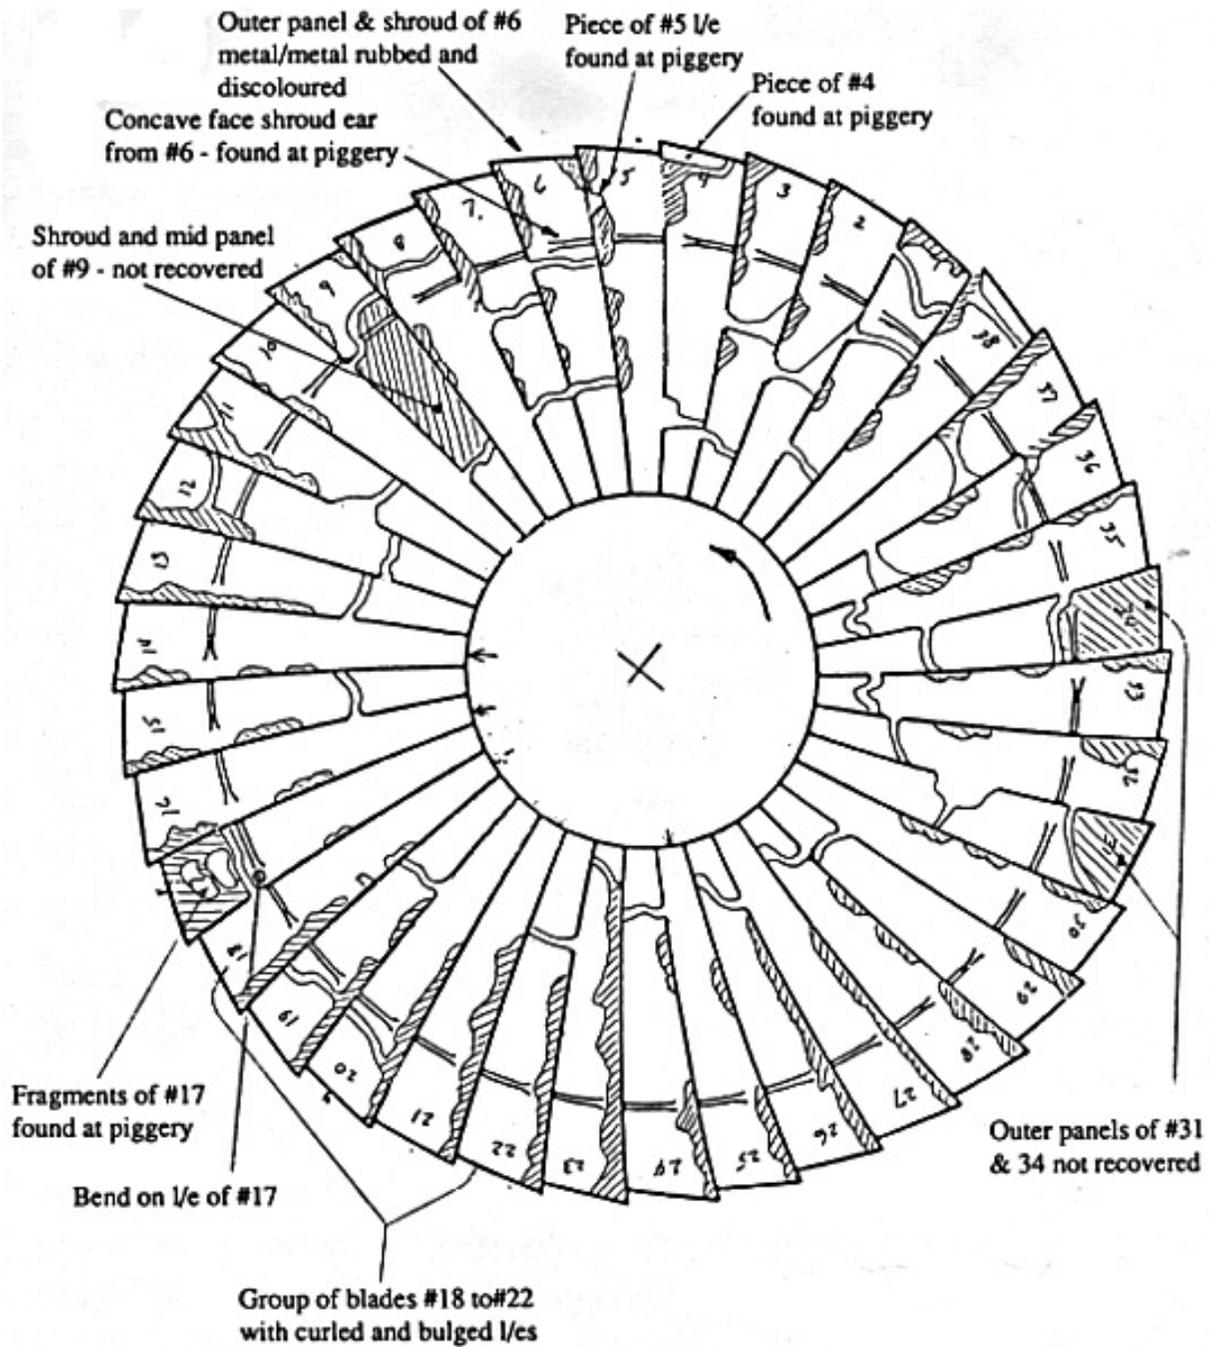
Fragmentation and other damage features of the fan of No.1 engine from G-OBME

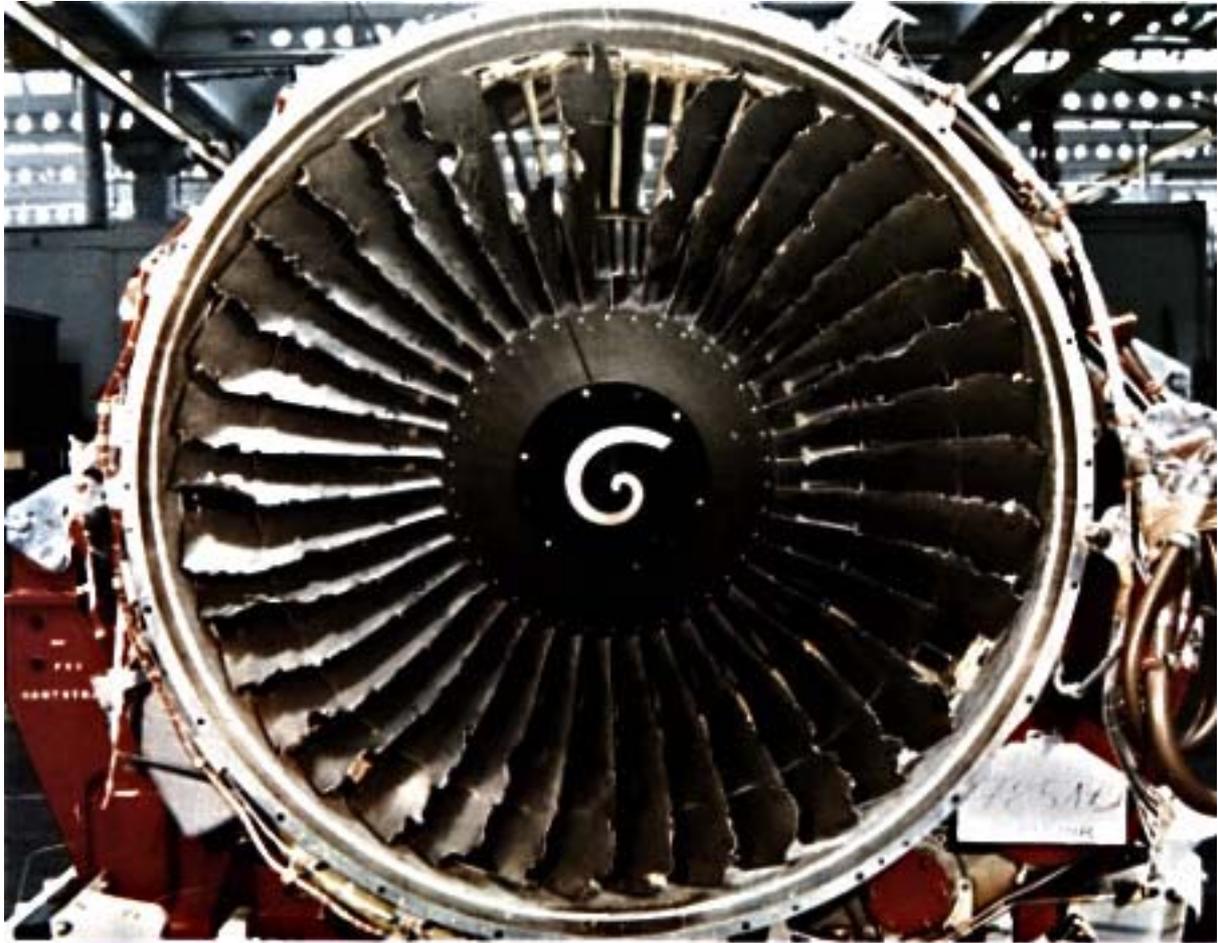
**Figure 4(a)**

**View on front of fan of G-BNNL after in-flight fan blade outer panel separation showing the very severe leading edge damage to all the remaining blades.**

**Note also, at the 12 o'clock position where a full blade and a half blade have been broken away.**

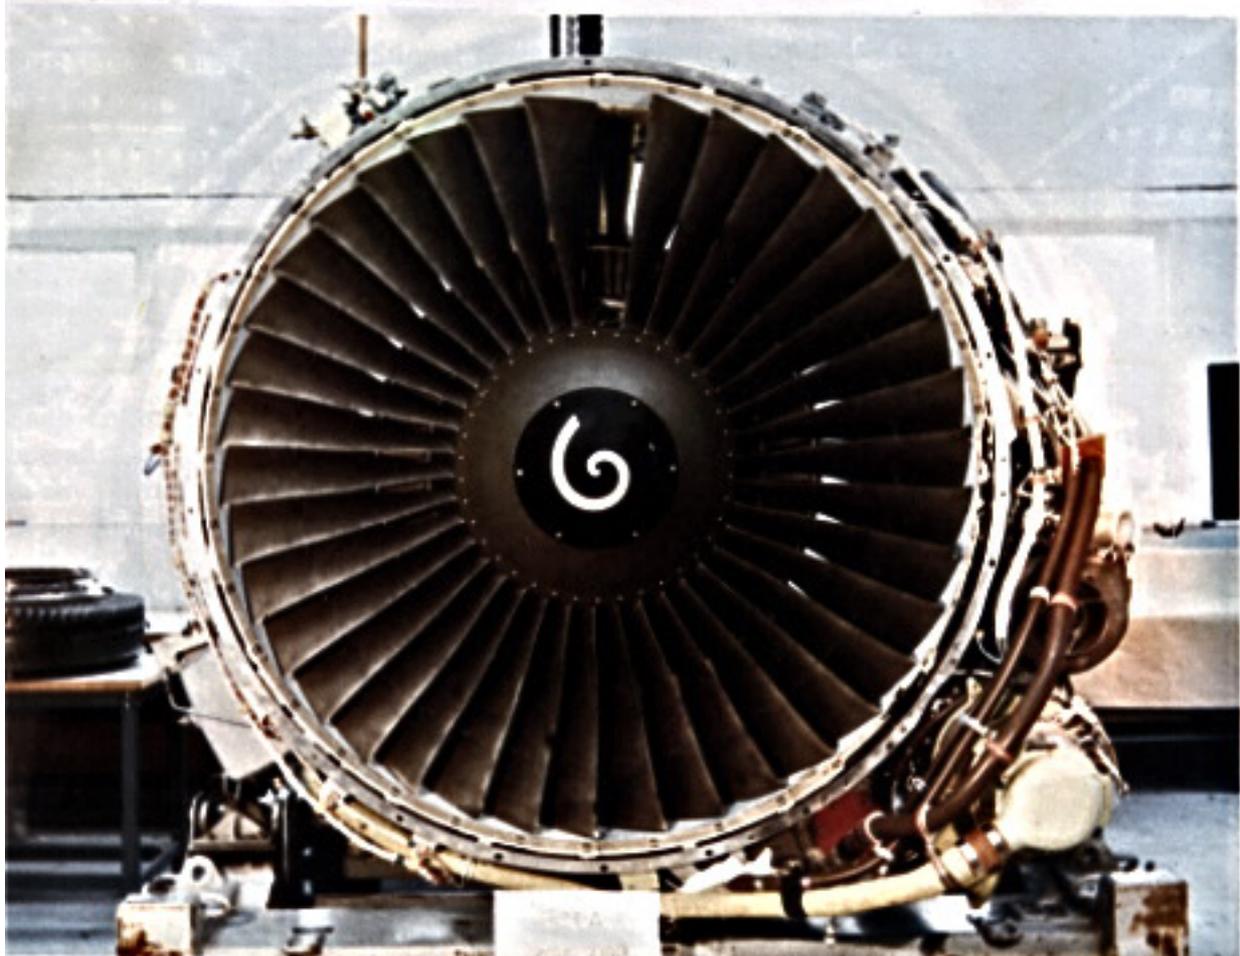
**Figure 4(b)**

**View on front of fan of G-OBMG after in-flight fan blade outer panel separation showing the nearly total absence of leading edge damage on all the remaining blades.**

**The blade which suffered outer panel separation has been removed from the 12 o'clock position.**

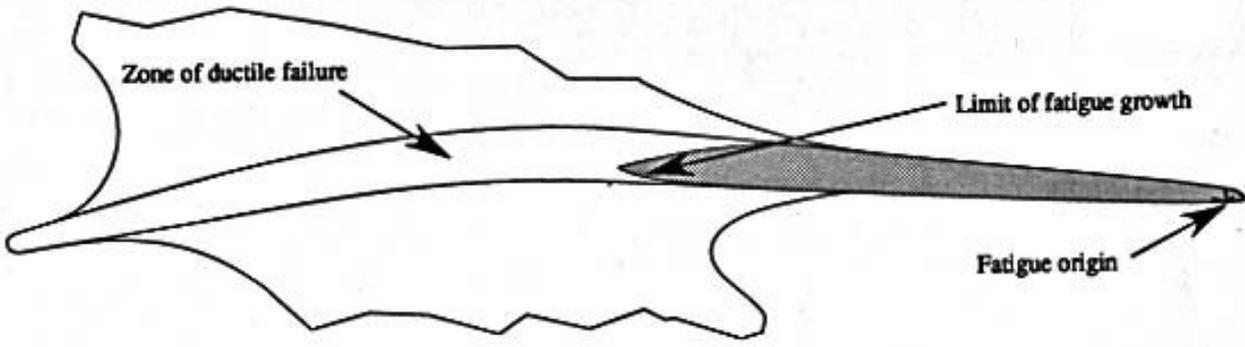
Features of fan blade fracture from G-OBME

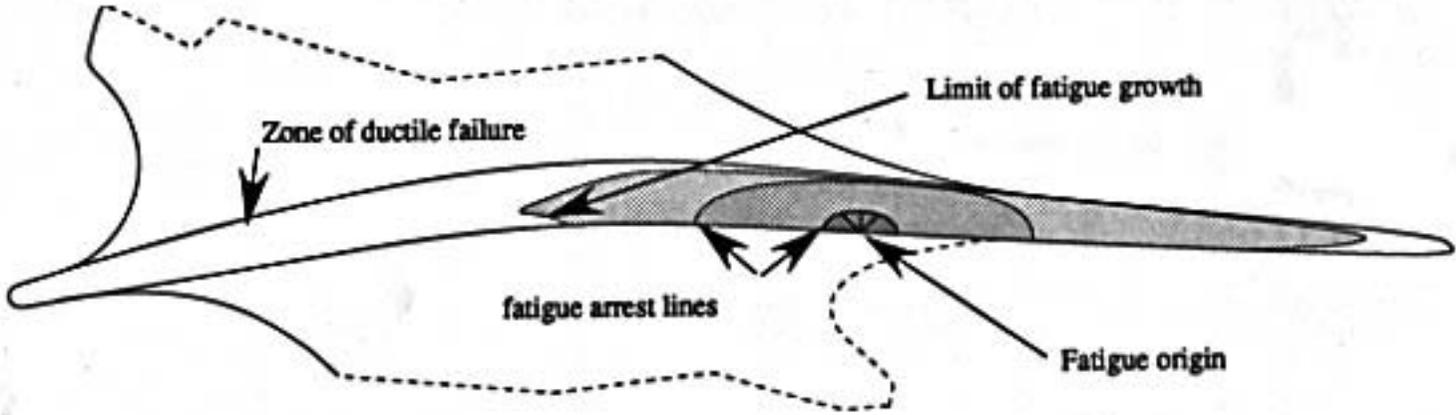
Features of fan blade fracture from G-BNNL

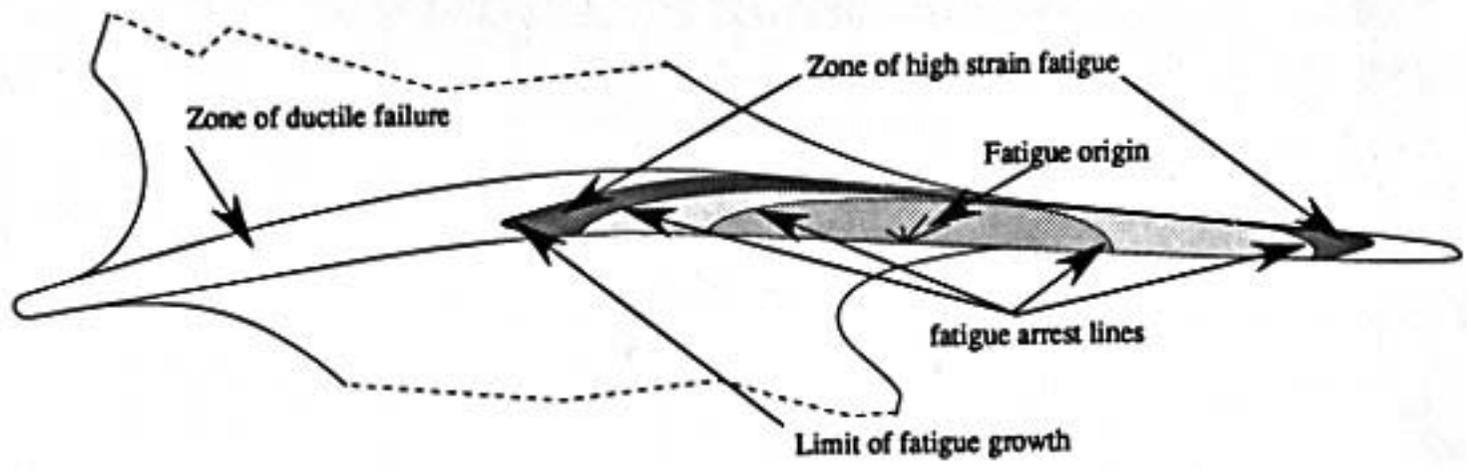
Features of fan blade fracture from G-OBMG

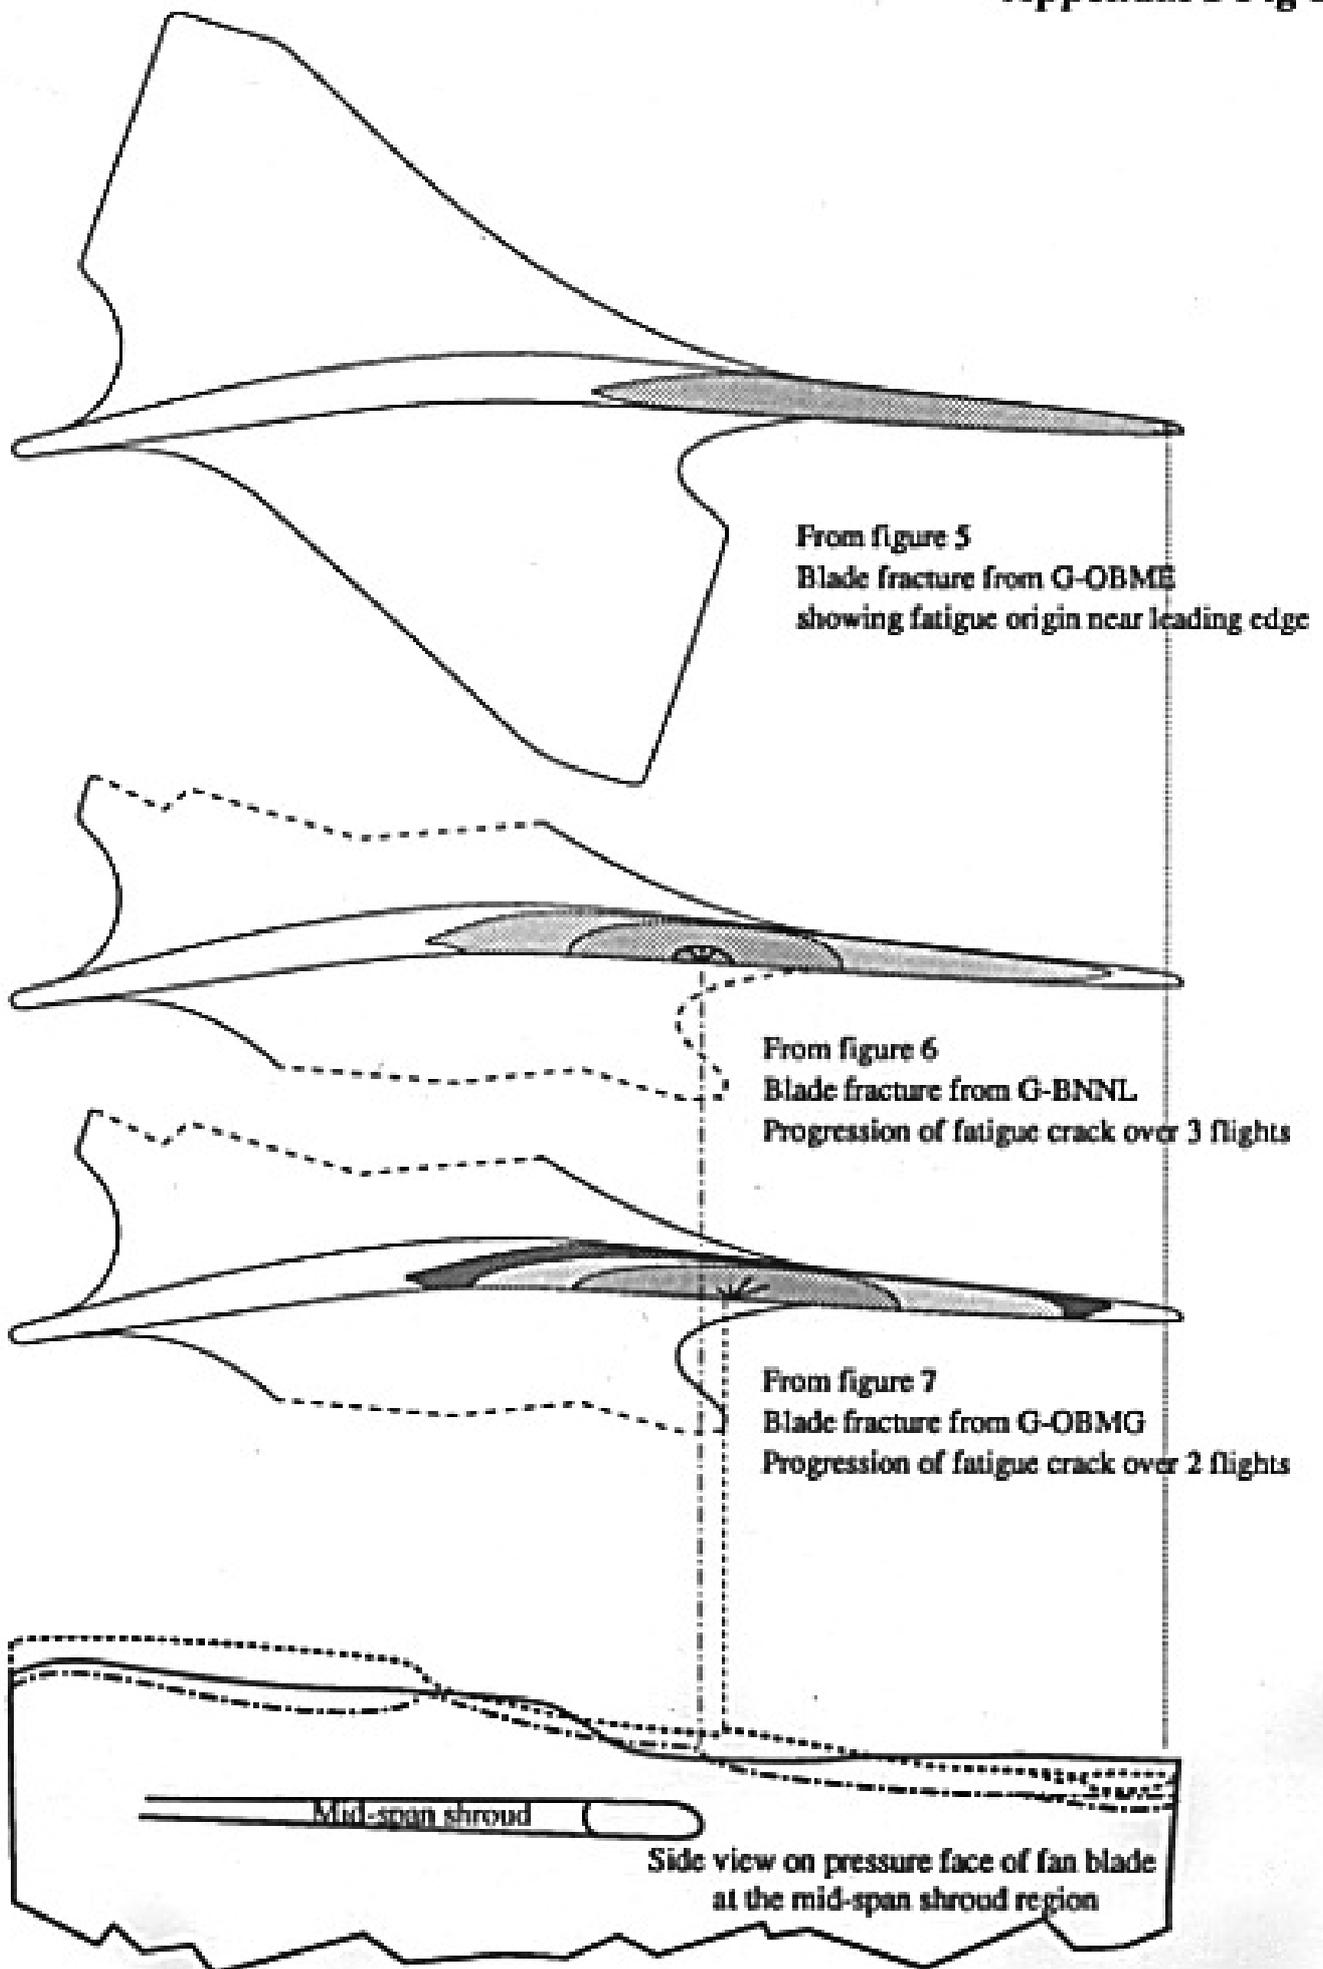
Comparison of fracture lines on 3 fan blades
