Ground collision, Airbus A340, A40-LB and Boeing 757-236, G-BIKG, 23 November 1995

Airbus A340, A40-LB and Boeing 757-236, G-BIKG, 23 November 1995

AAIB Bulletin No: 7/96 Ref: EW/C95/11/4 Category: 1.1

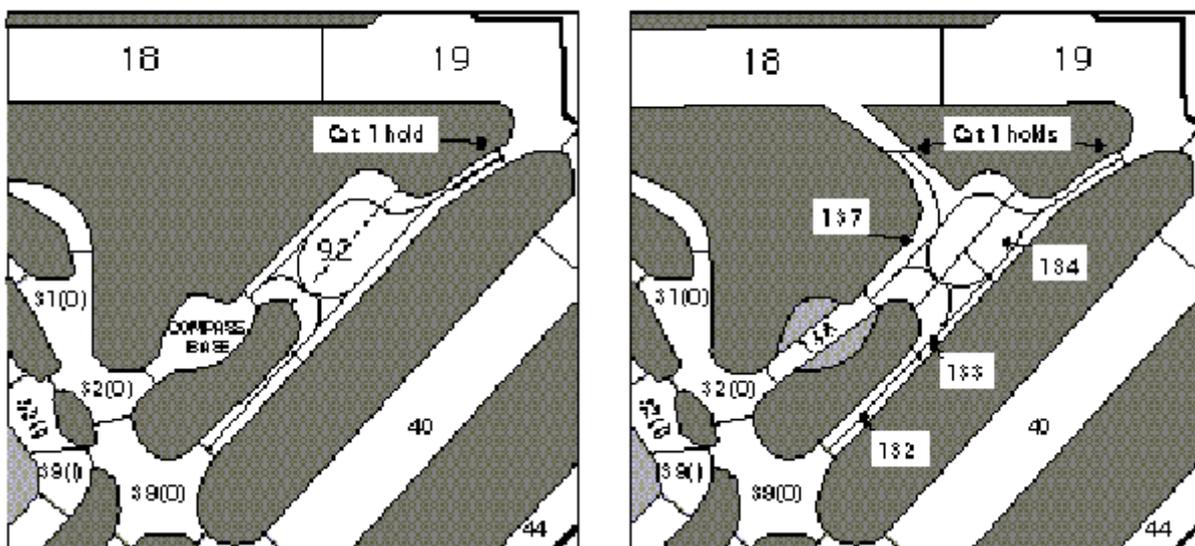
RUNWAY 27R HOLDING AREA BEFORE OCT 95 RUNWAY 27R HOLDING AREA ON 23 NOV 95

The accident occurred in the holding area for Runway 27 Right. During the autumn of 1995, a new access to Block 18 of Runway 27R was constructed as shown below. With the introduction of this taxiway the old holding area (Block 92) was subdivided into three new blocks and the compass base was moved to another part of the airport. Each block has a taxiway centreline marked on the ground by a yellow painted line and green lights. (For clarity only the centrelines within the holding area are shown in the diagram below). At the end of each block there are stop lines and red lights across the centrelines marking the extremity of the block.

The boundary line at the top of Block 137 in the right hand diagram is also the Cat I Hold line. The line was painted parallel to the runway and 105 metres from its centreline. This is also the edge of the runway strip. (The runway strip is defined in CAP168; essentially it is an area enclosing the runway which must be kept clear of obstacles). There was also a Cat II/III Hold parallel to and 137 metres from the runway centreline.

Within the holding area (the old Block 92), the parallel portions of the taxiway centrelines were 86 metres apart. The longest wingspan routinely encountered at Heathrow is 64.44 metres which belongs to the Boeing 747-400. Consequently, when on parallel taxiways, any aircraft can safely pass another if each remains over its respective centreline. At Heathrow the centrelines have to be sited so that when the cockpit of the most critical aeroplane for which the taxiway is intended is over the centreline, the distance between the outer edge of the main wheels and the edge of the pavement is at least 4.5 metres.

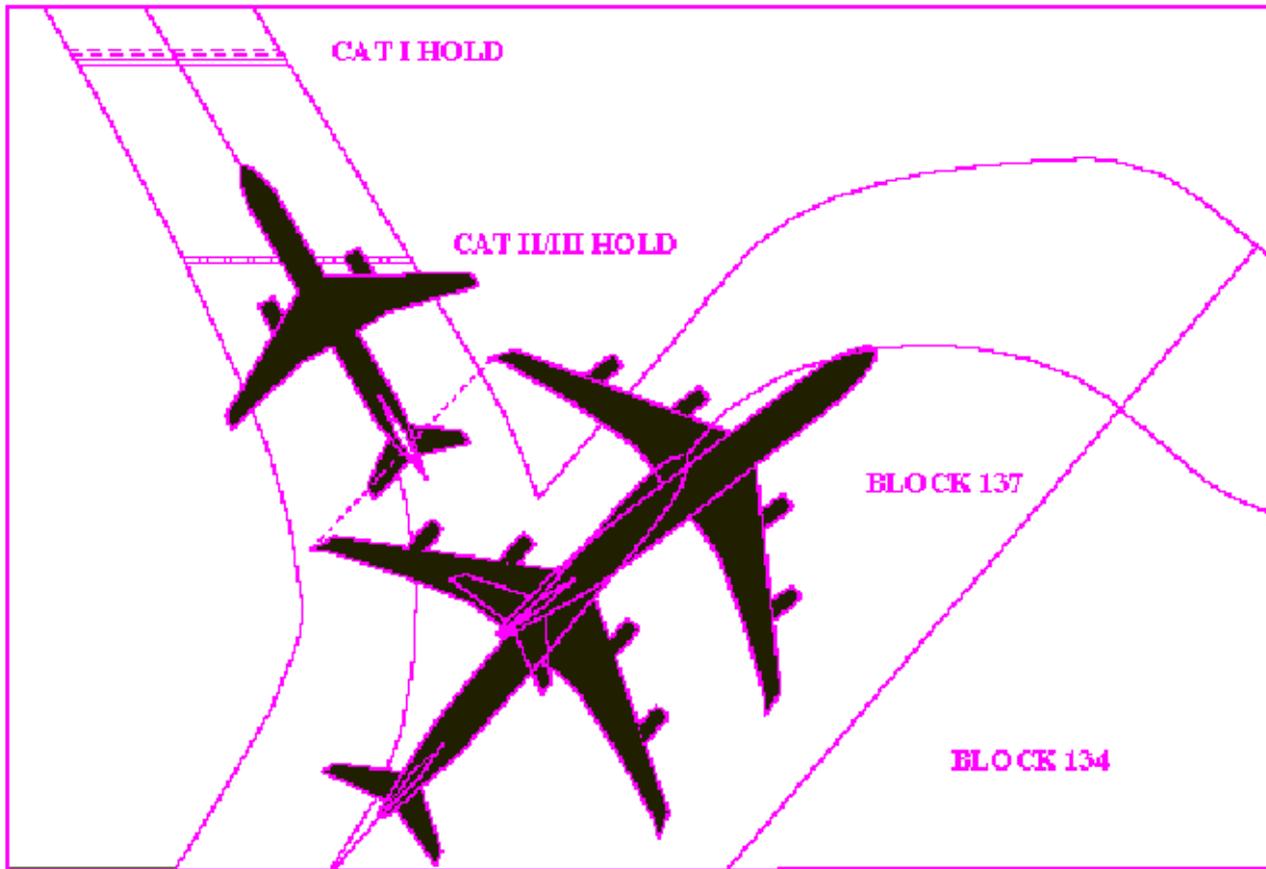
Measurements taken after the incident showed that the nose landing gear of G-BIKG was 23.6 metres (along the taxiway centreline) behind the CAT I stop bar and 8.6 metres ahead of the CAT II/III stop bar. Profiles of the two aircraft imposed on a plan view of the taxiways and holding area are shown below. The diagram shows that, with G-BIKG in its measured position and A40-LB in its final position, the contact measured on the winglet and rudder would have occurred with A40-LB on its taxiway centreline at the point of contact.
