## Engine damage in climb, Boeing 747-236B, G-BDXH, 21 May 1996

# Boeing 747-236B, G-BDXH, 21 May 1996

## AAIB Bulletin No: 4/97 Ref: EW/C96/5/9 Category: 1.1

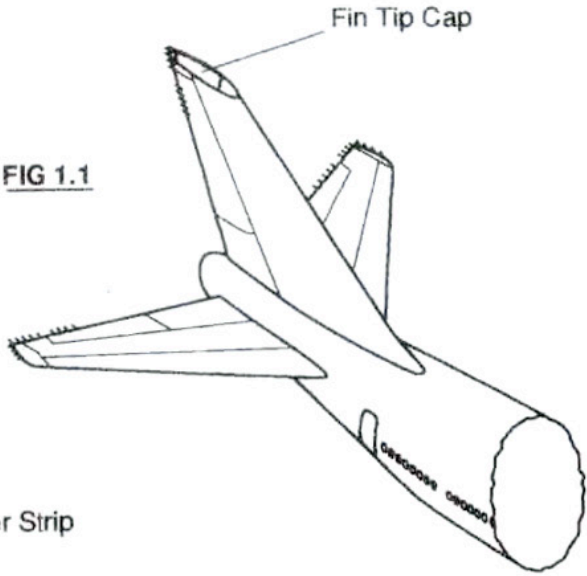
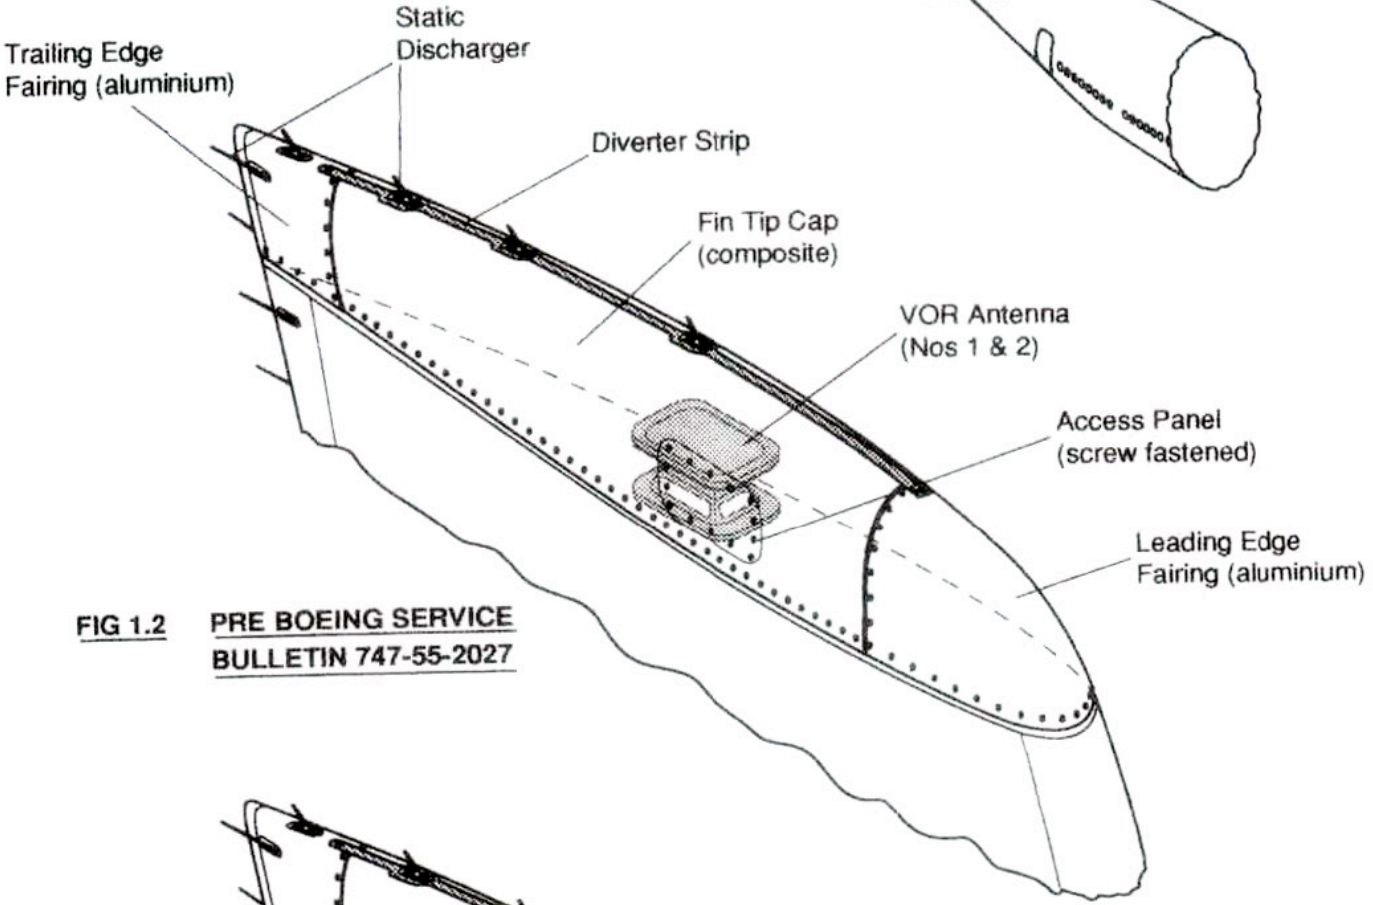
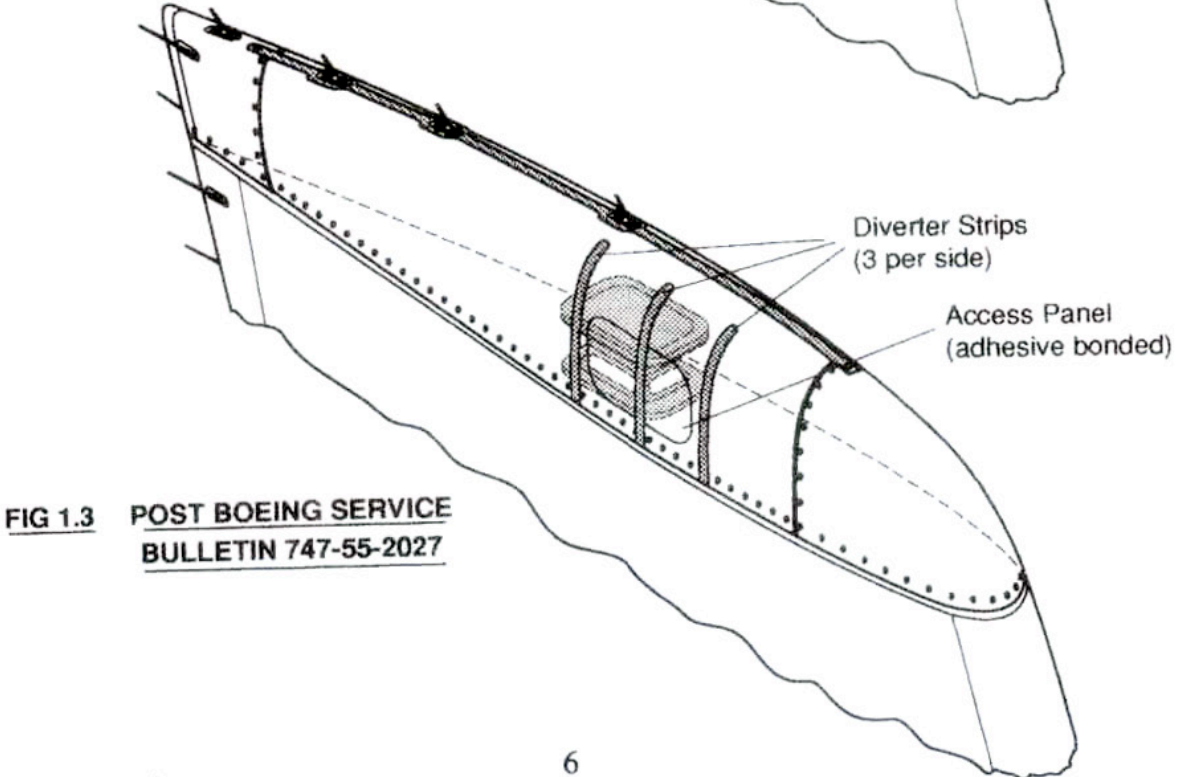
**FIN TIP CAP**

The top of the fin (Figure 1.1) is formed by three fairings (Figure 1.2) bolted to the upper edge of the aluminium skin of the main part of the fin, immediately above the topmost rib of the fin. A composite tip cap forms the main component; to this is riveted an aluminium leading edge fairing and an aluminium trailing edge fairing. The tip cap is of sandwich construction and consists of 0.38 inch thick plastic honeycomb bonded between an inner and an outer glass reinforced plastic

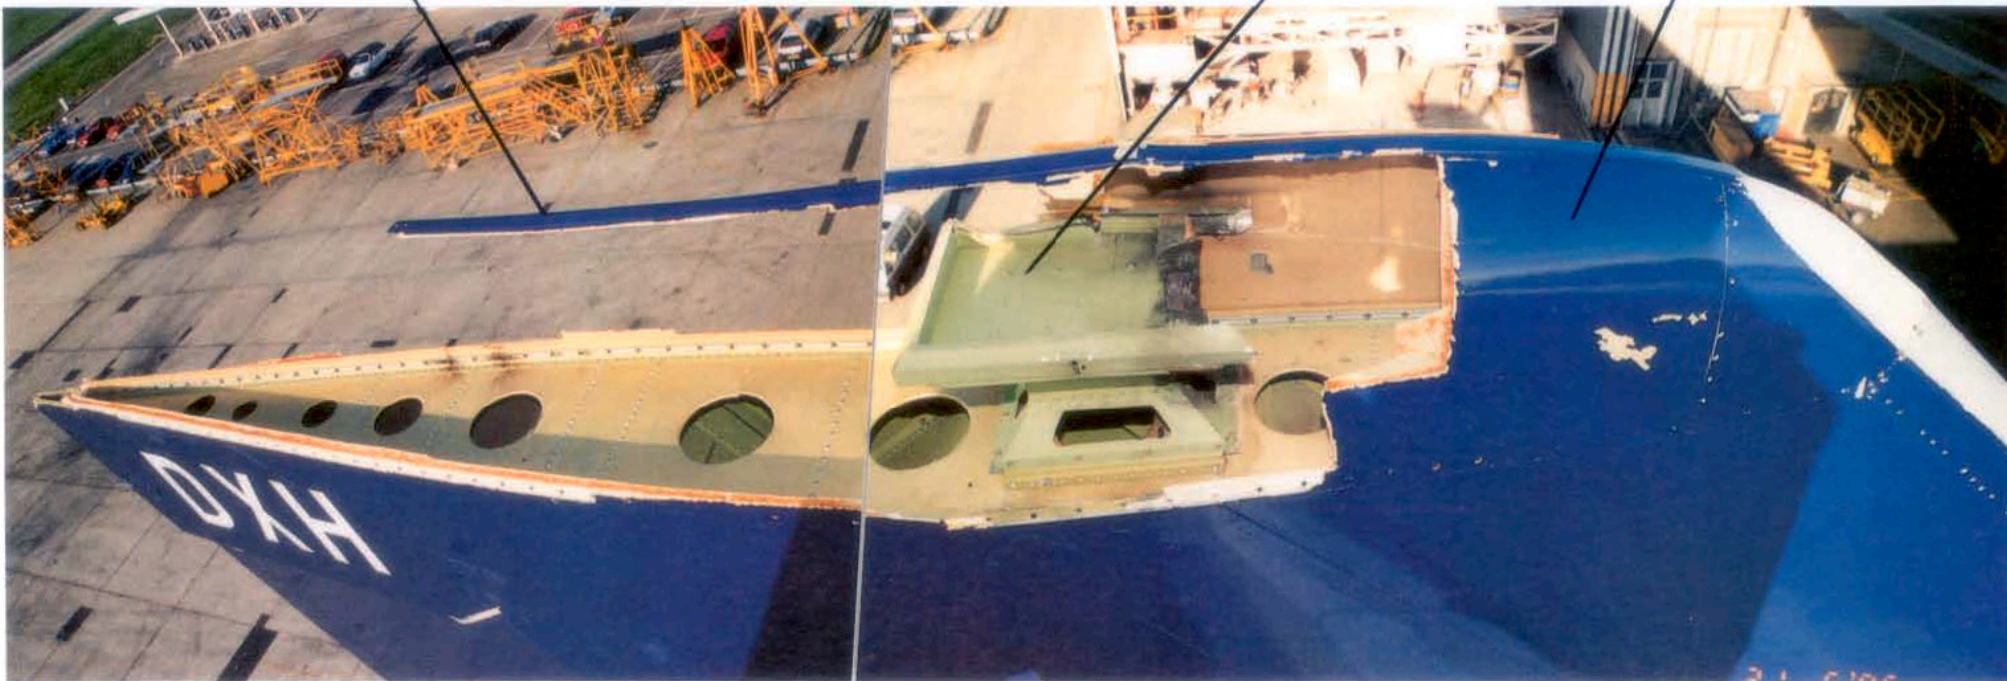
Fig 2

Virtually all of the fin tip trailing edge fairing and much of the tip cap (approximately 70%) were missing (Figure 2.1), including the VOR/LOC antenna access panel. The cap generally had fractured immediately above the fin attachment flange; signs of slight localised overheating were evident in the area of several of the screw fasteners in this area. The forward part of the cap remained in situ, together with the leading edge fairing and the whole of the diverter strip, which remained bolted to the leading edge fairing. The leading edge fairing had suffered minor deformation consistent with the effects of a forward overload applied in the region of the diverter strip attachment.

It was noted that there were no attachment holes for static dischargers present in the fin tip cap diverter strip and the evidence showed that none of the 3 static dischargers specified in the Maintenance Manual had been fitted. The operator did not believe that the presence of these static dischargers, intended to reduce radio receiver interference, would have any relevance to the likelihood of experiencing a lightning strike or to the severity of the damage if a strike occurred.

Fin Tip Cap Remains

The modification involved the removal and discarding of the VOR access panel fasteners from the forward, upper and aft edges of the panel and the attachment of the panel by adhesive bonding. Three vertical diverter strips were then to be bonded with adhesive to each side of the cap in the region of the VOR antenna (Figure 1.3). The Bulletin listed the kit cost as US\$590 and the total labour requirement as 10 manhours. A consequence of incorporating the modification would be that the whole fin tip cap would need to be removed to gain access to the VOR/LOC antennas.

The CAA, in conjunction with the aircraft manufacturer, give detailed consideration to requiring the incorporation of Service Bulletin 747552027 on UK registered Boeing 747 aircraft. (Recommendation made March 1997).

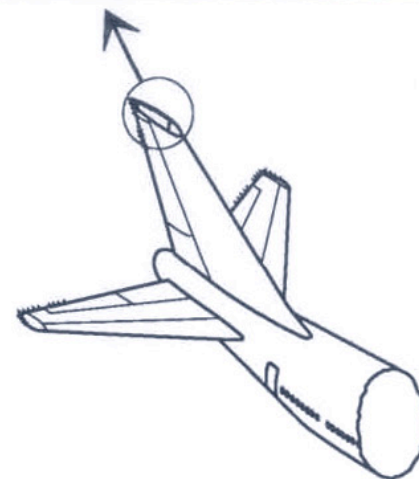
The VOR/LOC antennas had been considerably damaged, with the forward part broken up, heavily distorted and severely blackened (Figure 2.2). The two signal cables from the antenna had sustained severe overheating damage in the fin cap area.

VOR/LOC Antennas
