Crash at airshow, Lockheed P-38J Lightning, N3145X

Lockheed P-38J Lightning, N3145X

AAIB Bulletin No: 5/97 Ref: EW/C96/7/4 Category: 1.1

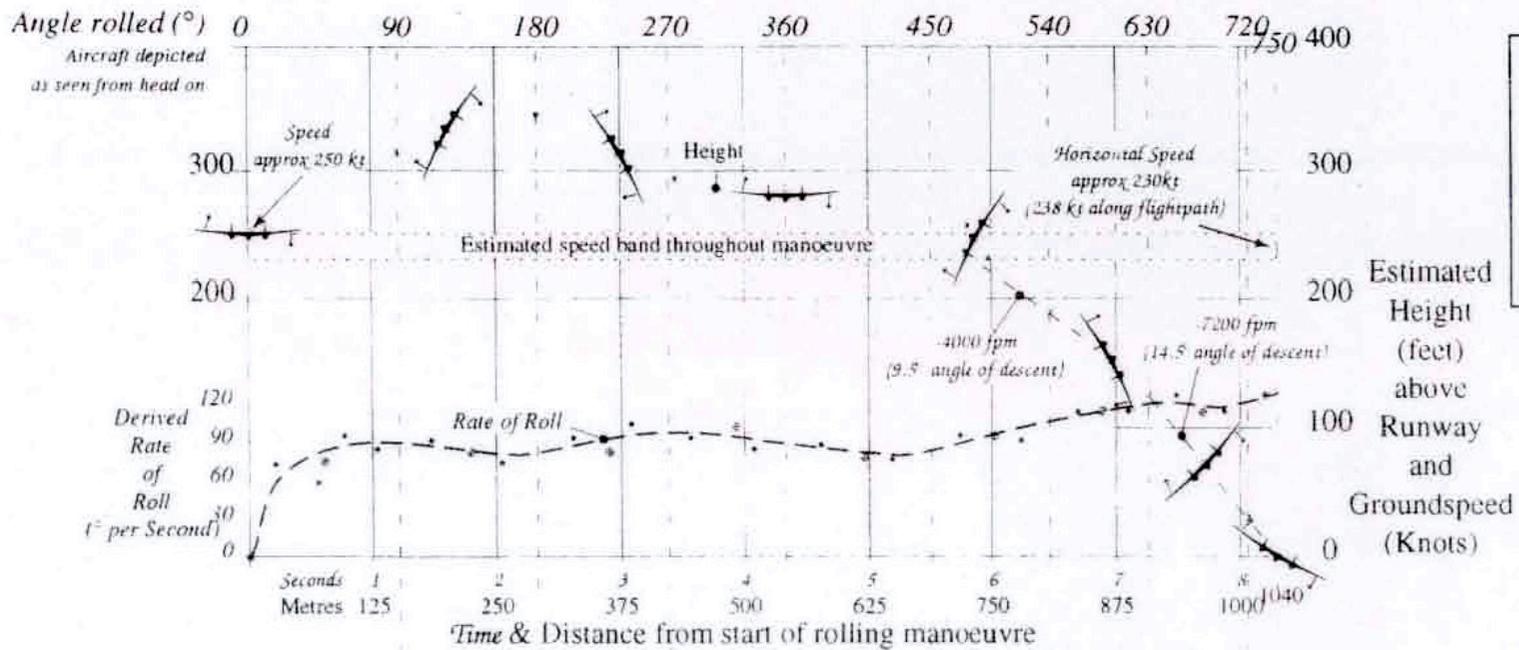
Video Analysis (Figure 1)

The analysis of the accident coverage showed that the aircraft had performed two continuous aileron rolls, taking 4.4 seconds and 3.6 seconds respectively to complete. This had been started at a height of about 250 feet above the runway, at a speed of about 250 knots and with an initial nose-up pitch attitude. The roll, to the left, was initiated by a rapid roll control input to produce a considerable aileron deflection. This aileron deflection remained more or less constant until the aircraft had completed about 675° of roll. At that point, the ailerons were returned to the neutral position where they remained until the aircraft struck the ground.

During the first roll the aircraft climbed to an apogee of about 360 feet when inverted, descending to about 260 feet by the time it was erect again. At this point the aircraft pitch attitude was approximately horizontal or very slightly nose-down. There was no pause before the second roll was executed. During this roll, the nose dropped progressively and an increasing rate of descent built up. At the inverted position the aileron position was observed to be being maintained in the almost fully (left roll) deflected position and a considerable elevator displacement in the 'stick back' sense was made. Considerable left rudder control was also added at this time and the roll rate increased. About 45° of roll before the aircraft became erect, the rudder and aileron inputs were moved to neutral, but were not applied in opposition to the roll. The rate of roll was seen to increase slightly as the aircraft rolled through wings level (from about 110°/sec to 125°/sec), with a rate of descent of about 7,200 feet per minute, to the point of impact. Ground speed at impact was assessed as 230 kt. The final angle of descent was 14.5°, giving a speed along the flight path of 238 kt.

Impact was seen to occur on the left wing tip at an attitude of about 30° left roll with the fuselage level in pitch. The aileron and rudder positions were approximately neutral and the elevator was deflected up.

Consideration of the flight profile (Figure 1) indicates that the start of the final manoeuvre occurred over the western end of the hard surfaced runway. At the end of the first roll, the aircraft was still in a location which was to the right (west) of the centre of the crowd. It is considered unlikely that the pilot would have intended to stop manoeuvring at this position as the display would then have appeared 'asymmetric' from the crowd's viewpoint.

Figure 1
 Graphical representation of aircraft's Height, Rate of Roll and Speed Relative to Airfield Ground Features derived from Video Analysis and site Wreckage Plot.
