## Elevator jam on takeoff, HS748 Series 2A, G-ATMI

# HS748 Series 2A, G-ATMI: Main document

Report on the accident to HS748 Series 2A, G-ATMI at Liverpool Airport on 16 August 1996

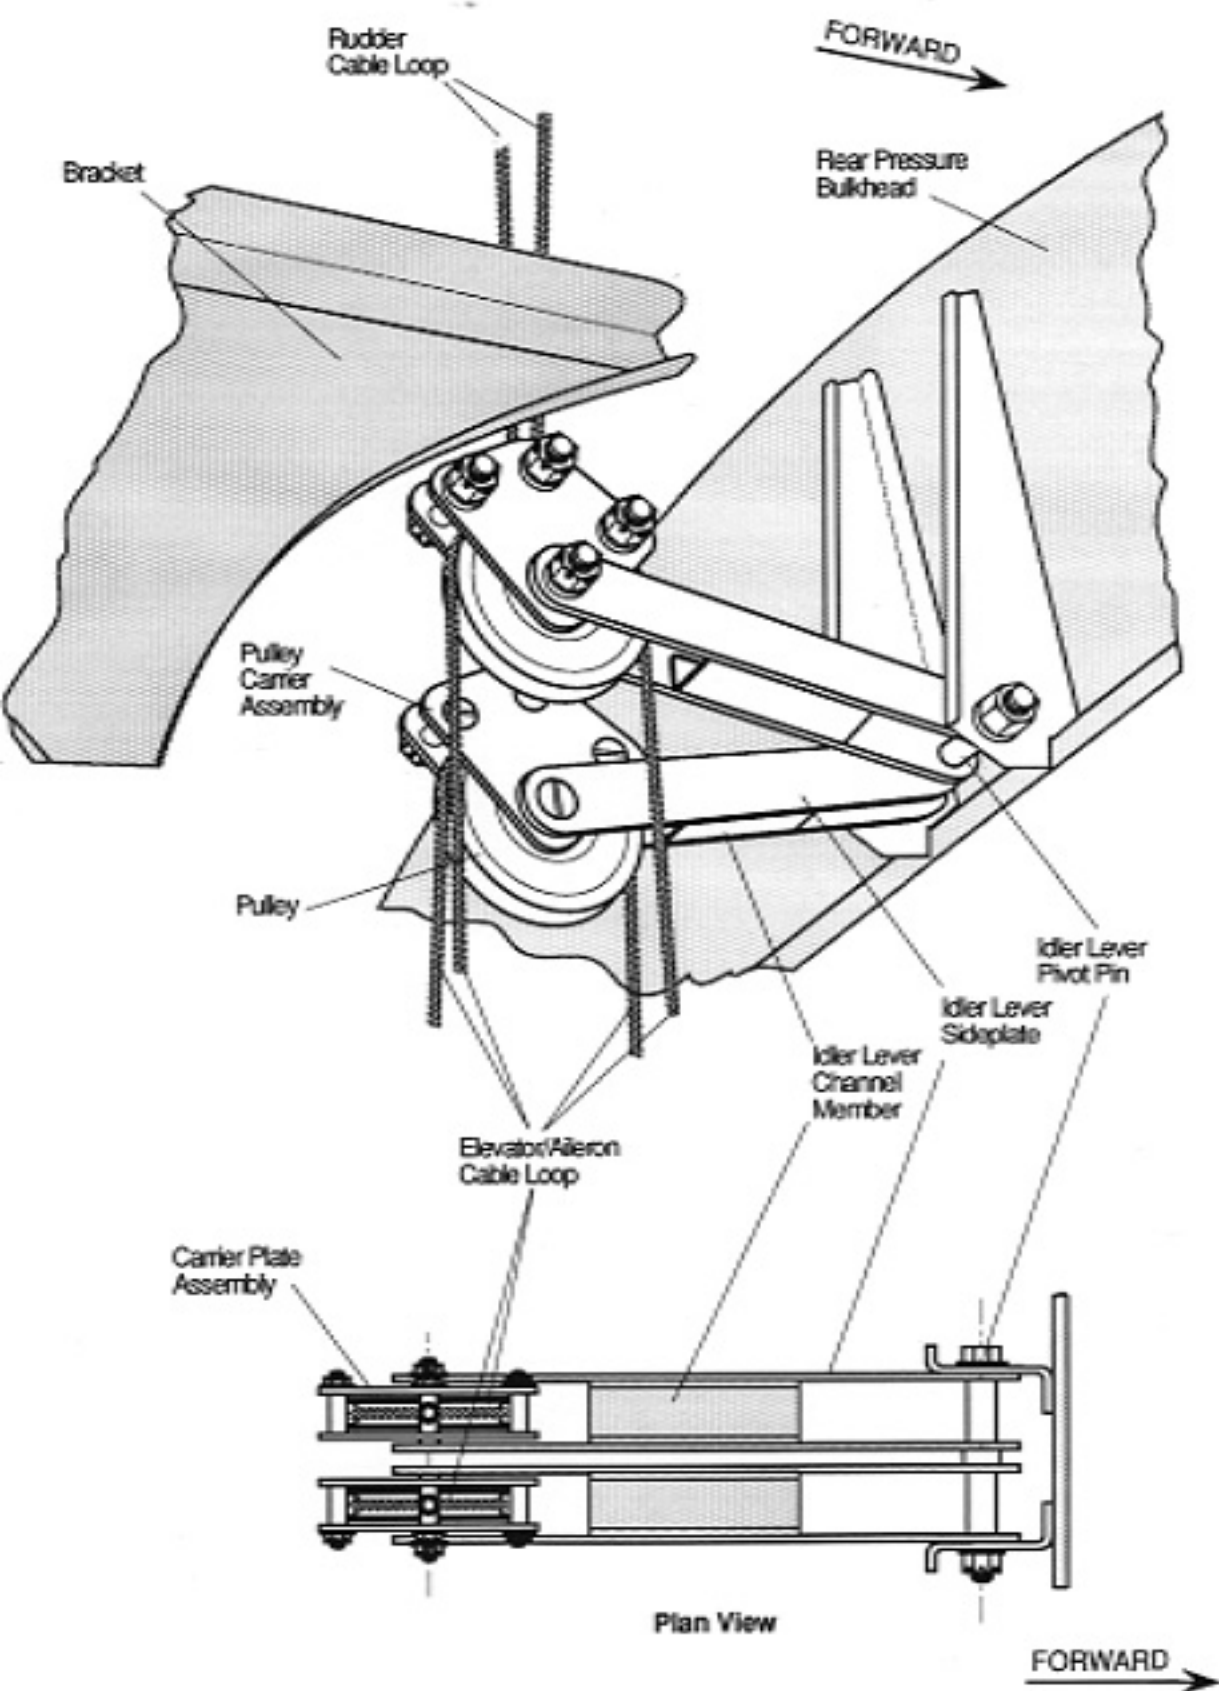
Fig 6

The contact occurred in two places; firstly between the pulley carrier assembly right sideplate (Figure 6) and the vertical web of the bracket; and secondly between the nut fitted on a bolt connecting the two sideplates of the carrier assembly and the horizontal flange of the bracket. It appeared that the former contact could have tended to cause the differential pulley to hang-up at the locked end of its travel when the pilot's lever was put from 'ON' to 'OFF'. Observation while operating the system suggested that it was unlikely that this could jam the idler lever, but the possibility could not be dismissed.

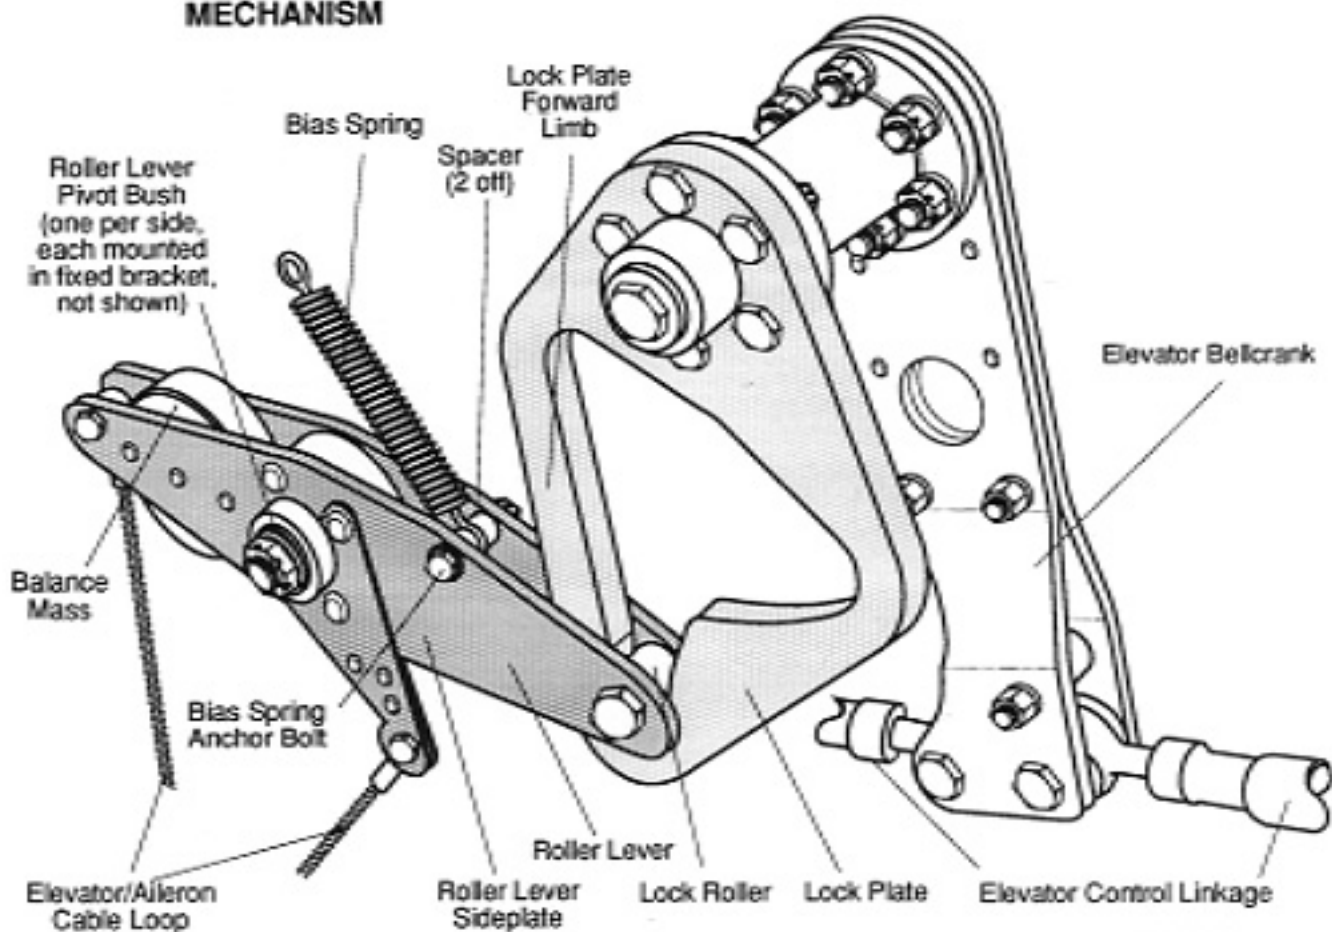
Fig 7.1

The elevator gust lock roller lever was found to be in firm contact with the side of the elevator lock plate (Figure 7.1). Extensive rubbing between the inner face of the roller lever sideplates and both side faces of the forward limb of the lock plate was apparent (Photo 4.2). This was indicative of the roller lever having operated for a prolonged period in a plane angled relative to the plane of the lock plate. On disassembly it was found that the bush for the roller lever pivot bolt intended to be fitted in the left-hand support bracket was absent (Figure 7.1, see Photo 5.2 and 5.3). This had resulted in a radial clearance of 0.05 inch between the 0.3 inch diameter bolt and the 0.4 inch diameter bracket hole on this side and it was apparent from associated witness markings that the system had operated with the left side of the bolt off-centre and in contact with the edge of the bracket hole. The IPC showed (Section 27-70, Figure 6 illustration and associated parts list at page 25) only one lever bush and one bracket bush per assembly. The BAe Aircraft Overhaul Manual (Section 27-70-1, Figure 2) showed two bushes per assembly.

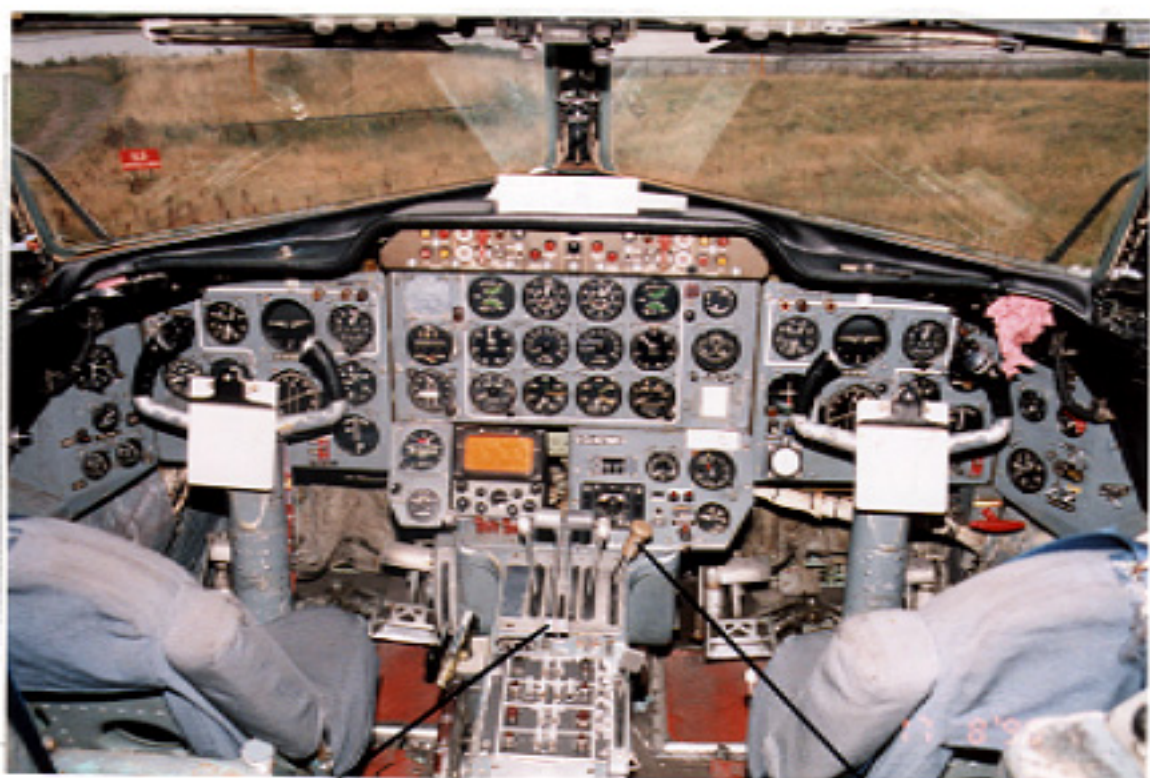
PHOTO 1.2 - FLIGHT DECK

Initial examination of the aircraft, before it had been moved, showed that the flight deck lever for the flight control gust lock system (Photo 1.2) was in its 'OFF' detent and the control column was rotatable over its full travel by apparently normal loads. All primary control trim settings were found close to neutral, flaps were at the selected position of 7.5° and the FFPS levers were at the withdrawn position. In situ calibration of the pitot-static system showed no major errors in the indication of either pilot's airspeed indicator.

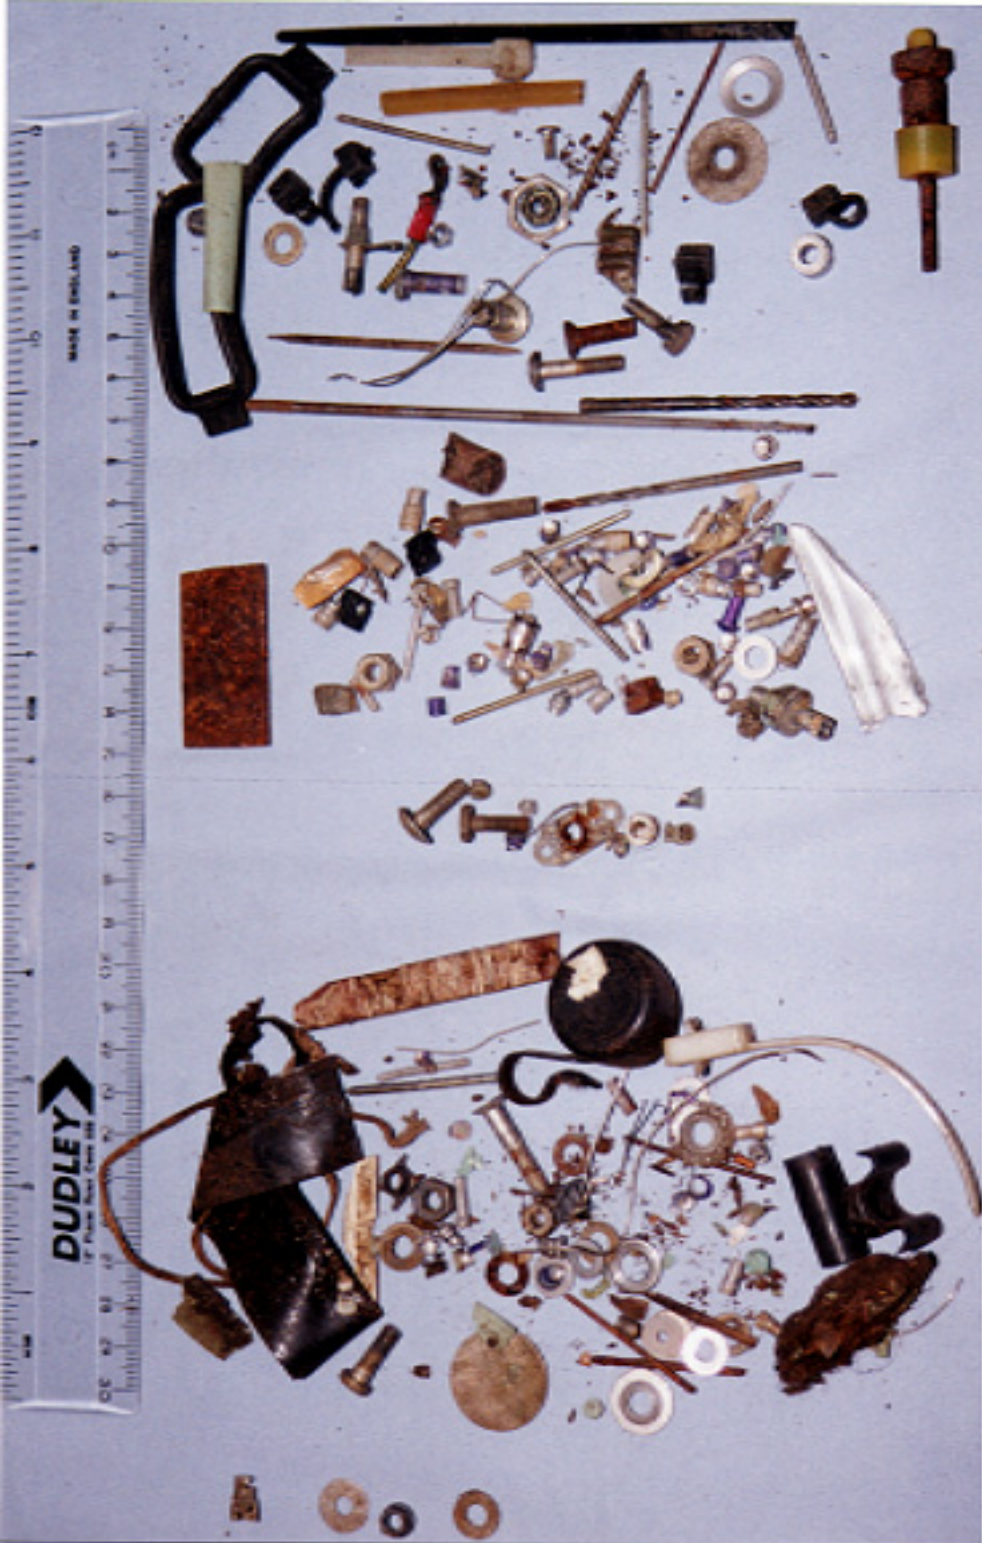
PHOTO 2 - DEBRIS RECOVERED FROM CABIN UNDERFLOOR AREA

Foreign objects were found in the flight deck underfloor region, in the tailcone, in the fin, in the tailplanes and, in large quantities, throughout the cabin underfloor region (Photo 2). They included numbers of nuts, bolts and washers, hundreds of portions of drilled-out rivets, three drills (one 2.5 inch long, 0.125 inch diameter), a 2 inch long riveting clamp and a 6 inch long, 0.1 inch diameter steel file. The most significant items found were a 1.7 x 0.9 inch rectangle of 0.13 inch thick steel lying on the lower boom of the floor beam at Frame 252FS, close beneath the elevator control cables; and a 0.9 inch long, 0.175 inch diameter bolt and a large rivet fragment both lying on the lower boom of the floor beam at Frame 180AS, close beneath the elevator control cable twin pulley mounted from this beam. However, close inspection revealed no evidence that any foreign

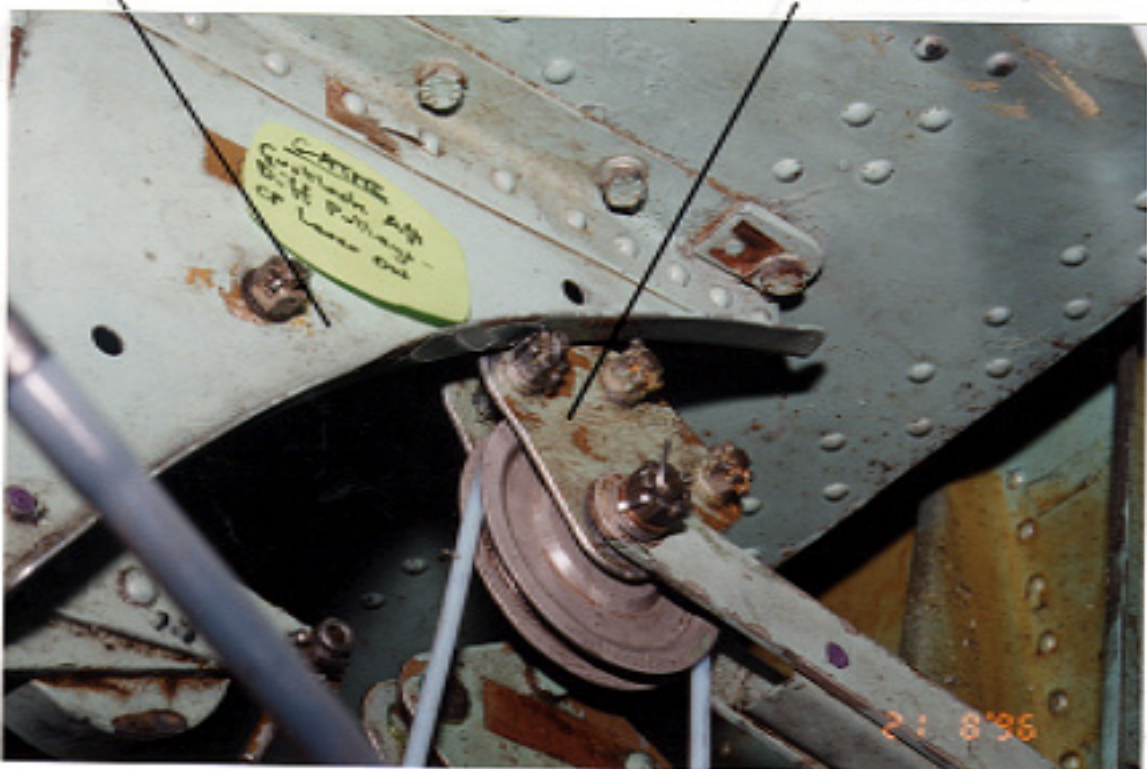
PHOTO 3.2 - AFT DIFFERENTIAL PULLEY FOUL ON BRACKET

The rigging of the control system was found to differ substantially from the AMM requirements in four places in the flight deck region, at the forward differential pulleys and at the aft differential pulley idler levers. In the latter case, this resulted in a foul of the right pulley carrier against a fixed

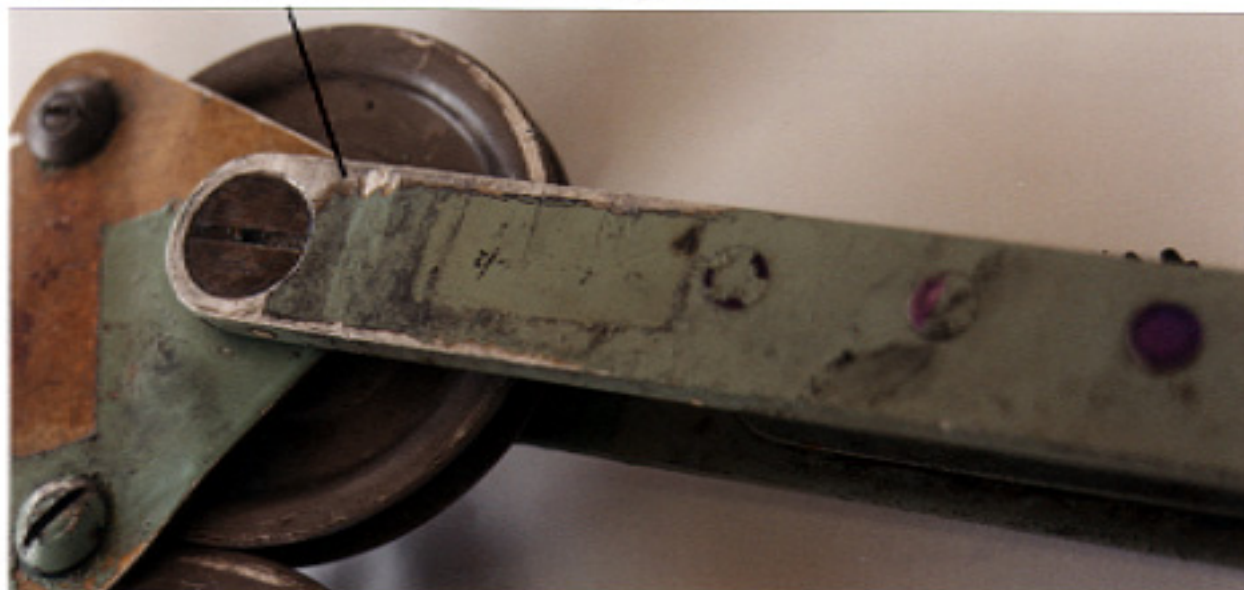
PHOTO 4.1 - RIGHT AFT DIFFERENTIAL PULLEY LEVER

The two aft differential idler levers were found to contact each other at mid-travel of the system and witness marks were found showing that prolonged rubbing had occurred (Photo 4.1). The right lever (Part No obliterated) was found with the web of its U-section component oriented downwards, ie not in accordance with the BAe Aircraft Illustrated Parts Catalogue (IPC), which illustrated both levers with the web upwards, but no evidence was found to indicate that this feature, of itself, had contributed to the fouling. However, the left lever appeared to have been constructed 'out of true', such that it canted out of the perpendicular and towards the right lever when both were installed on the pivot pin. The effect was somewhat diminished by a bend in both sideplates near the pulley end; the cause of the bend was not apparent. A contribution to the lever contact may have been made by appreciable play that was present between the right lever pivot holes and the pivot pin. Modification No 6897 (Service Bulletin (SB) No 27/83) 'Introduction of Improved Differential Lever Assemblies on Rear Pressure Bulkhead' listed the reason for the modification as:

It was apparent that the contact increased the friction in this part of the circuit. Evidence from operating the system suggested it was unlikely that this was sufficient to cause the idler levers to jam, but the possibility could not be dismissed. In the event of an idler lever hang-up and sudden release, it appeared possible for displacement of lock roller lever(s) to occur.

Rub Marks from contact with left Aft Differential Pulley Lever

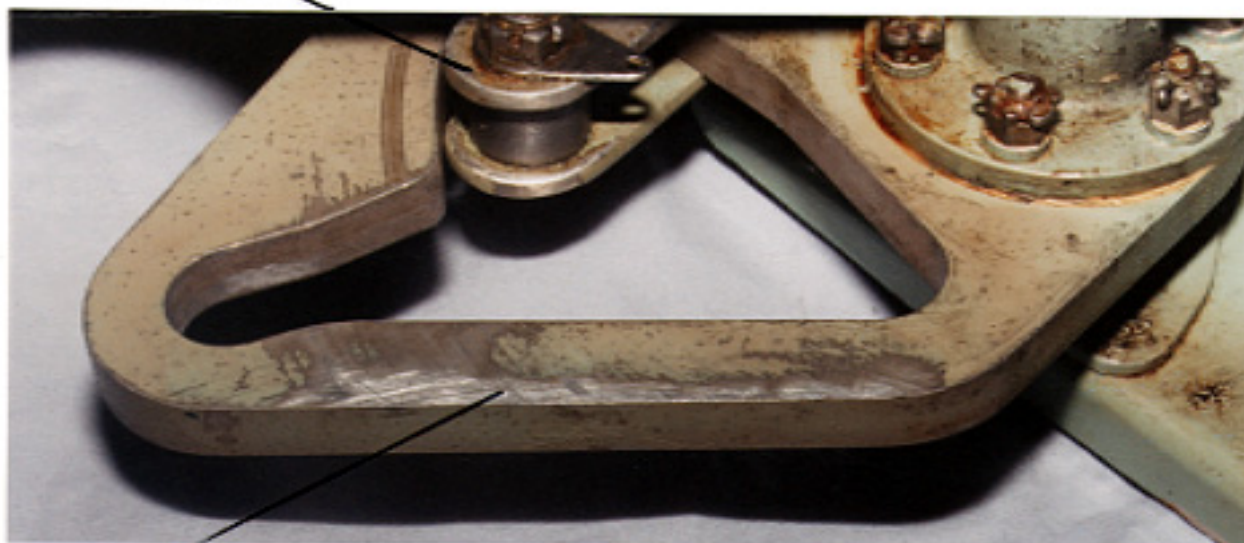
PHOTO 4.2 - ELEVATOR GUST LOCK LOCK PLATE

Rub Marks from contact  
with roller lever

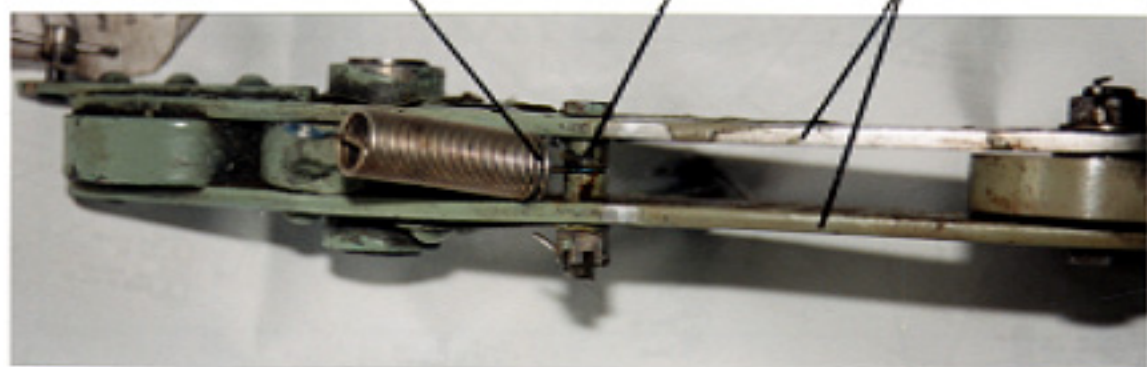
PHOTO 4.3 - ELEVATOR GUST LOCK ROLLER LEVER

It was also apparent that the two roller lever sideplates were bent inwards (Photo 4.3), reducing the 0.51 inch (13 mm) gap between them to 0.45 inch (11.5 mm) in places. This was clearly due to overtightening of the nut on the bolt that carried the roller lever bias spring. The bolt passed through the two sideplates and carried two spacers; in the absence of sideplate deformation the arrangement would have left a gap between the spacers as a location for the spring to freely pivot on the bolt. In fact, the spring anchor loop was found tightly clamped and unable to pivot, and the first coil of the spring had permanently distorted. The sideplate deformation increased the likelihood and severity of the contact between the roller lever and the lock plate.

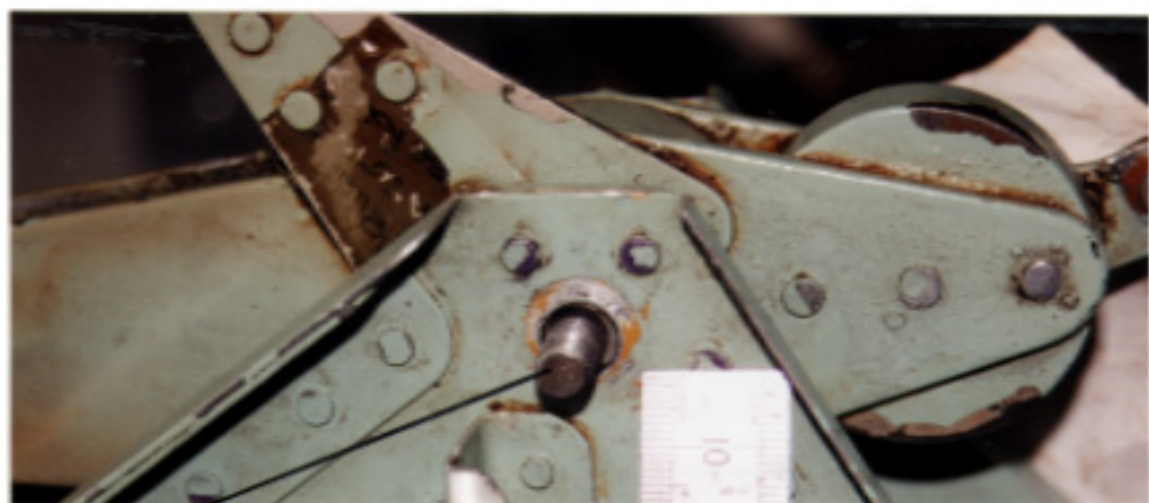
PHOTO 5.2 - ROLLER LEVER PIVOT - LEFT SIDE

The elevator roller lever bush which was found to be missing (section 1.12.5.5.4) was absent for the above configurations.

Roller Lever  
Pivot Bolt  
(bush absent)
