Loss of overwing slide, Boeing 747SP-100, N204 AE

Boeing 747SP-100, N204 AE

AAIB Bulletin No: 6/98 Ref: EW/C96/8/10 Category: 1.1

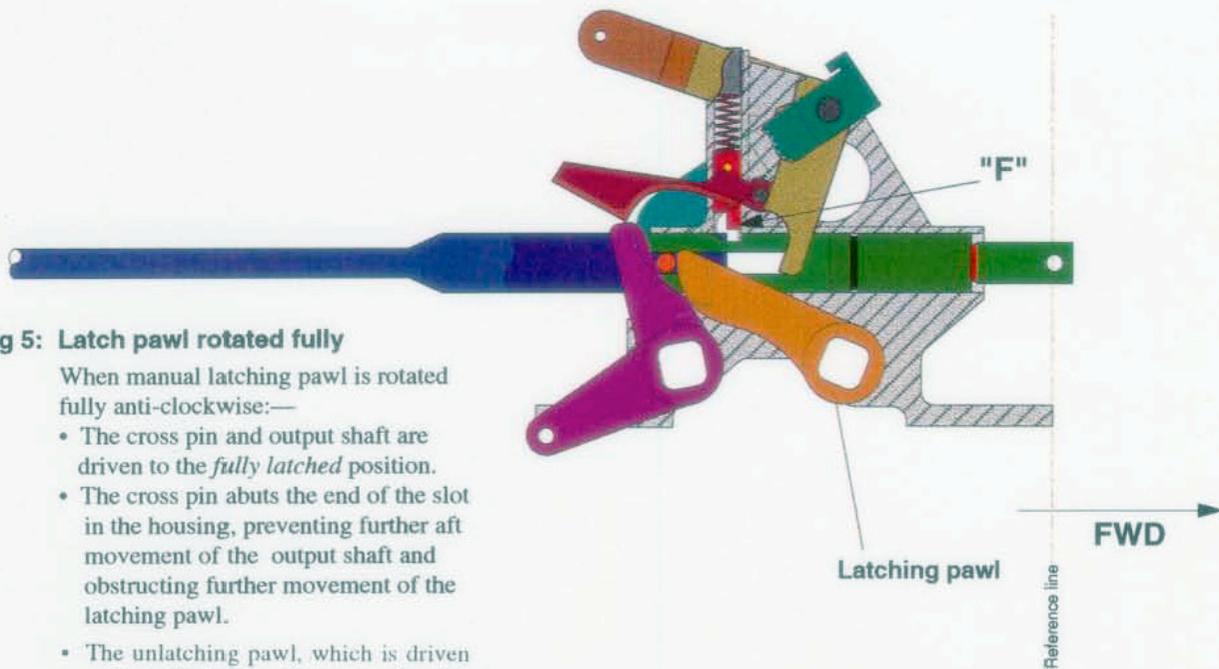
fig 5: Latch pawl rotated fully

When manual latching pawl is rotated fully anti-clockwise:—

- The cross pin and output shaft are driven to the *fully latched* position.
- The cross pin abuts the end of the slot in the housing, preventing further aft movement of the output shaft and obstructing further movement of the latching pawl.
- The unlatching pawl, which is driven anti-clockwise by the cross pin, stops moving at this point, leaving the pawl in the incorrect position as shown, with the lock pin lifter held in the raised position and the lock pin clear of the output shaft "F".

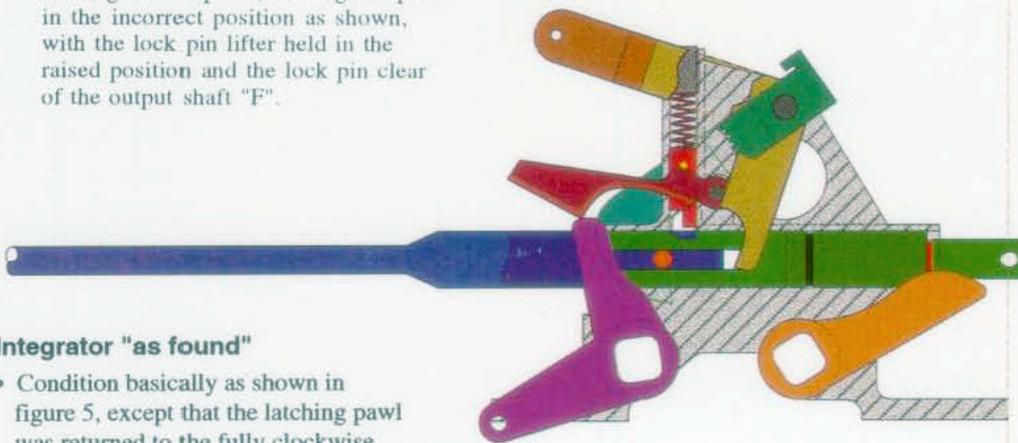
fig 6: Integrator "as found"

The integrator access door was opened and inspection of the integrator revealed that the manual unlatch pawl was incorrectly positioned; this being found rotated partially clockwise, toward the unlatch position, where it held the lock pin lifter in a raised position (see Figure 8). As a consequence, the positive lock pin had disengaged. This had evidently allowed the door latch mechanism to back-drive the output shaft slowly over time, eventually reaching a point where the latches released the door. The door had then fallen open under gravity, and had actuated the slide inflation mechanism. Figure 6 shows the state of the mechanism as found.

- Condition basically as shown in figure 5, except that the latching pawl was returned to the fully clockwise position.
- Lock pin was held clear of output shaft.
- System was left with no positive lock to prevent back-driving from the *latch end* of the system.
- Output shaft had migrated partially forward.

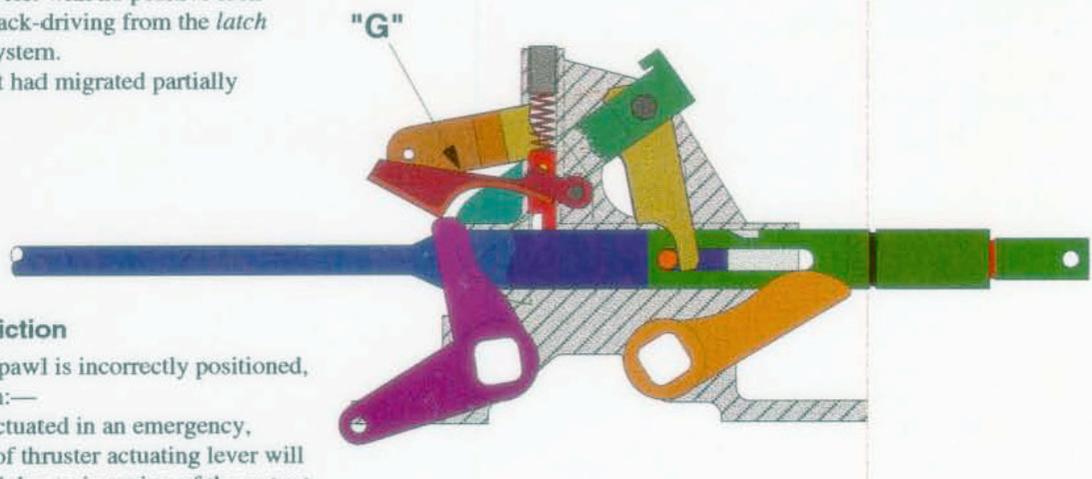
fig 7: Travel restriction

With the integrator in the as found condition shown in Figures 6 and 8, the misplaced unlatch pawl creates restrictions in the integrator mechanism which limit the available travel at several points within the mechanism. This could potentially inhibit or prevent deployment of the slide in an emergency. Figure 7 shows the mechanism at the limit of travel when the system is actuated in an emergency via the deployment cable. The incorrectly positioned lock pin lifter creates a foul between the underside of the thruster actuating lever and the top of the lifter at 'G' in Figure 7. This foul has the following effects:

- a) The thruster lever is unable to achieve full travel, potentially preventing the forward door thruster from firing.
- b) Forward movement of the cross pin beyond the position shown in Figure 7 is restricted by the bottom end of the thruster actuating lever, restricting movement of the output shaft and door latch mechanisms.
- c) The restricted motion of the latch mechanism limits movement of the connecting link to the aft door thruster, potentially preventing it from firing.
- d) The piston is prevented from reaching full travel, due to the restriction on cross pin movement.

If unlatching pawl is incorrectly positioned, as found, then:—

- If slide is actuated in an emergency, movement of thruster actuating lever will be restricted due to jamming of the output end of this lever against the raised (out of position) lock pin lifter at "G".
- Jamming of thruster actuating lever stops further movement of the cross pin, which restricts travel of the piston and output shaft.

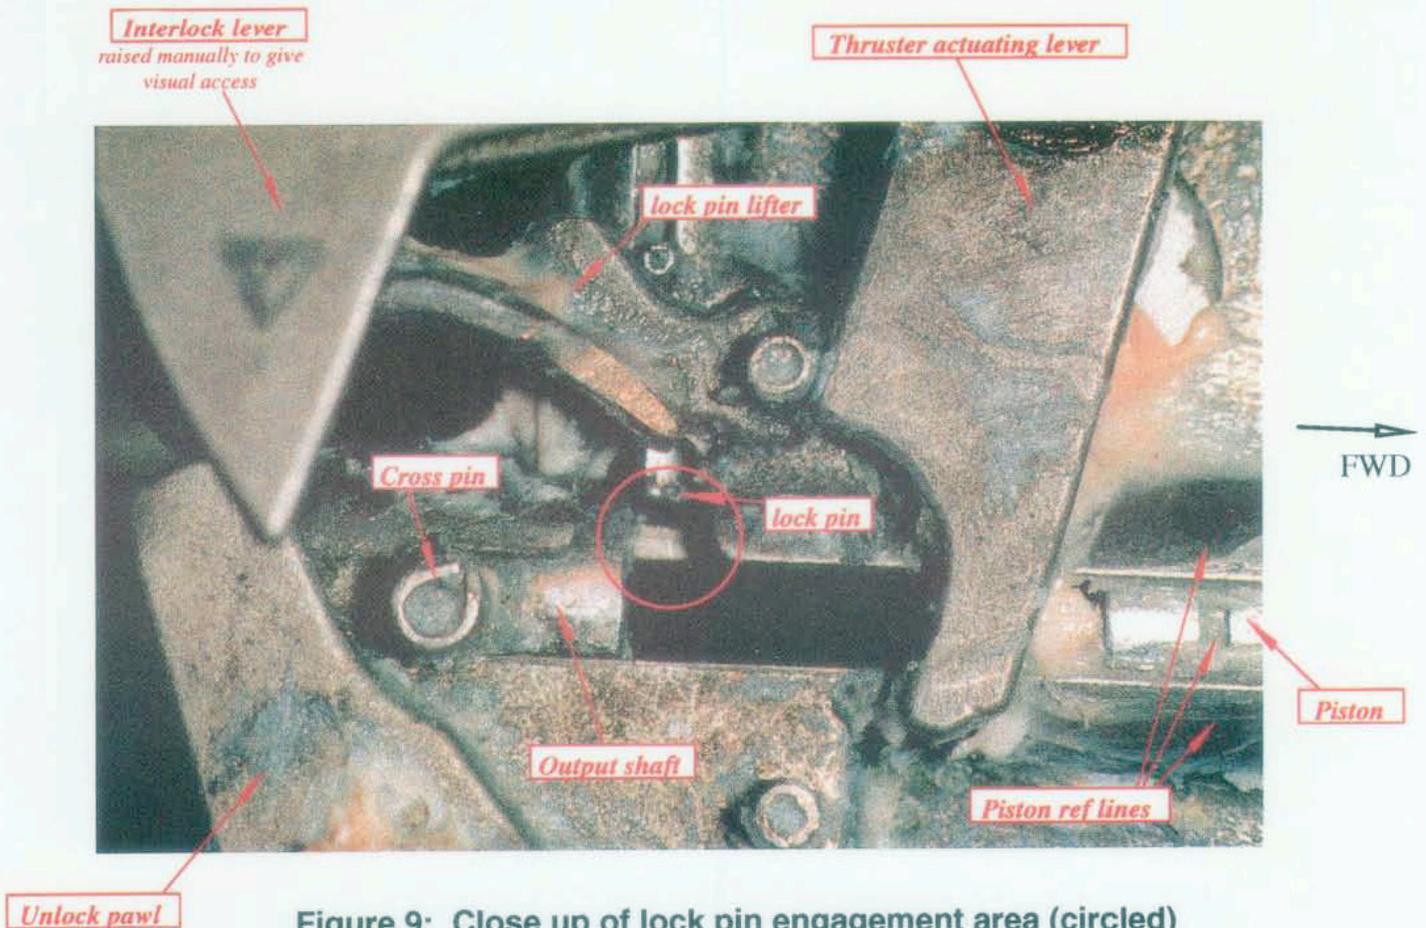
Figure 9 shows a close up view of a typical in-service unit which has been set up to replicate the condition found on the subject aircraft. The difficulty of judging accurately the state of the lock pin is clearly apparent.

Figure 9: Close up of lock pin engagement area (circled) of typical integrator unit: lock pin is not engaged

Recommendation 98-23

The FAA and the manufacturer should review the maintenance practices and instructions pertaining to servicing of the off-wing slide systems on Boeing 747 series aircraft so equipped, with a view to:

- 1 Introducing a more reliable and consistent means of checking for secure latching of the off-wing slide compartment door.
- 2 Introducing a more reliable and consistent means of confirming that the integrator positive lock pin is fully engaged.
- 3 Ensuring that in the event of any inadvertent (even very small) movement of the slide actuating cable, the system integrator is subject to a full check for integrity of the lock mechanism.
