Insecure door in flight, Boeing 747-236B, G-BDXK

Boeing 747-236B, G-BDXK

AAIB Bulletin No: 5/97 Ref: EW/C96/11/2 Category: 1.1

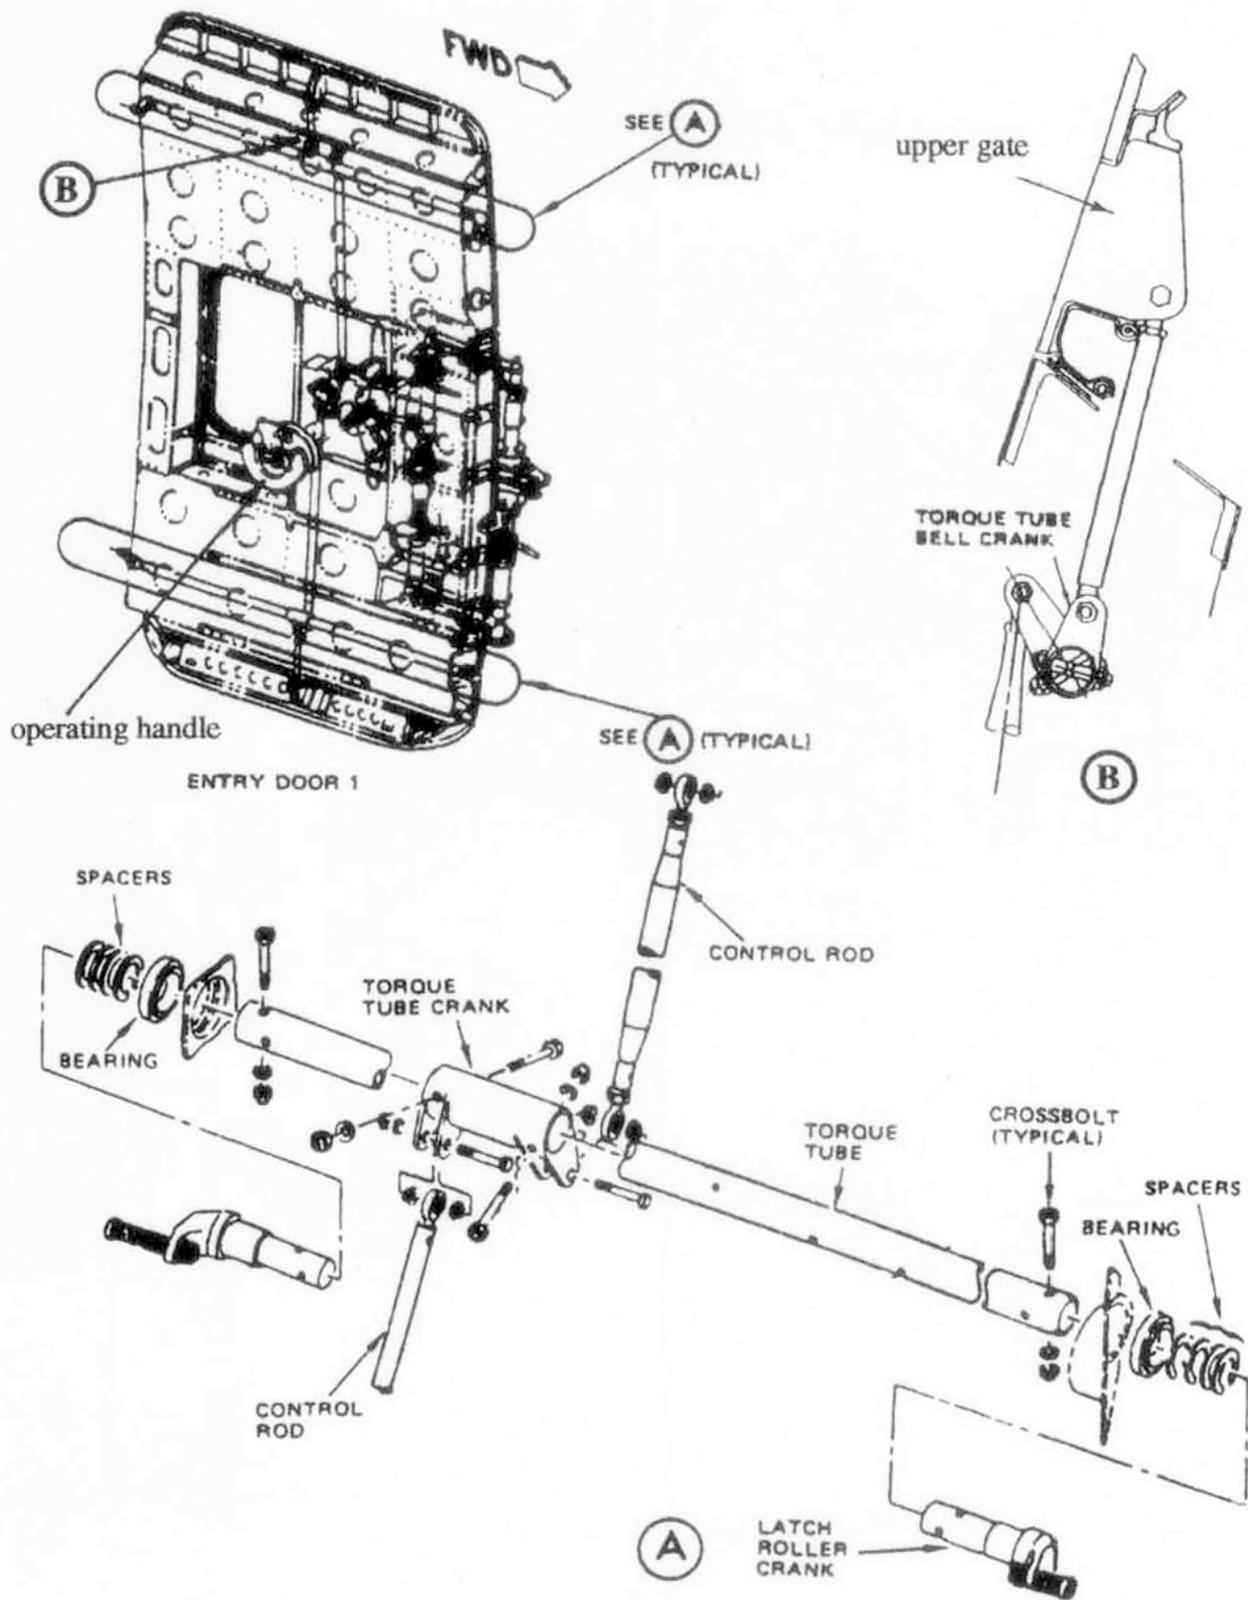
FIGURE 1. Principal components of main entry door

All the main entry doors share the same principles of operation, with doors 2 and 4 having identical latch roller cranks and torque tubes, which constitute the significant components in this incident. A diagram of the door is attached at Figure 1, which shows the principal features. The operating handle is attached to a crank mechanism. Rotation of the handle causes linear motion in the two adjustable control rods emanating from the crank mechanism, and in consequence, rotation of the upper and lower torque tubes. Latch rollers at each end of both tubes engage with cam slot plates attached to the door frame. The "door open" microswitch is located on the lower aft cam slot plate. Additional adjustable control rods on the torque tubes are connected to the upper and lower "gates", which are hinged sections of the door skin, located top and bottom. These fold inwards thereby reducing the door dimensions to less than the door aperture, thus allowing the inward movement of the door. When the door handle is moved towards the fully closed position, the door is pulled into the aperture by the reaction of the latch rollers against the inboard edge of the cam slots. When the door is flush with the fuselage skin, the bellcranks on the upper and lower torque tubes are just about to go into their over-centre positions and the upper gate is resting against a step on the inboard surface of the fuselage skin. The final part of the handle rotation pulls the door into position so that the torque tube bellcranks roll over into an overcentre position. Eighteen door stops (nine either side) are abutted against load bearing lugs on the inside of the door frame. Thus pressurisation forces push the door firmly against the lugs, in accordance with the concept of a "plug" door. When the door is opened, the initial rotation of the handle disengages the latch rollers. The handle mechanism is linked to the door hinge, and further handle rotation moves the door bodily a short distance inwards, into the cabin. The door then turns through approximately 90° so that it can be swung outwards, trailing edge first through the aperture, and forwards against the fuselage side.

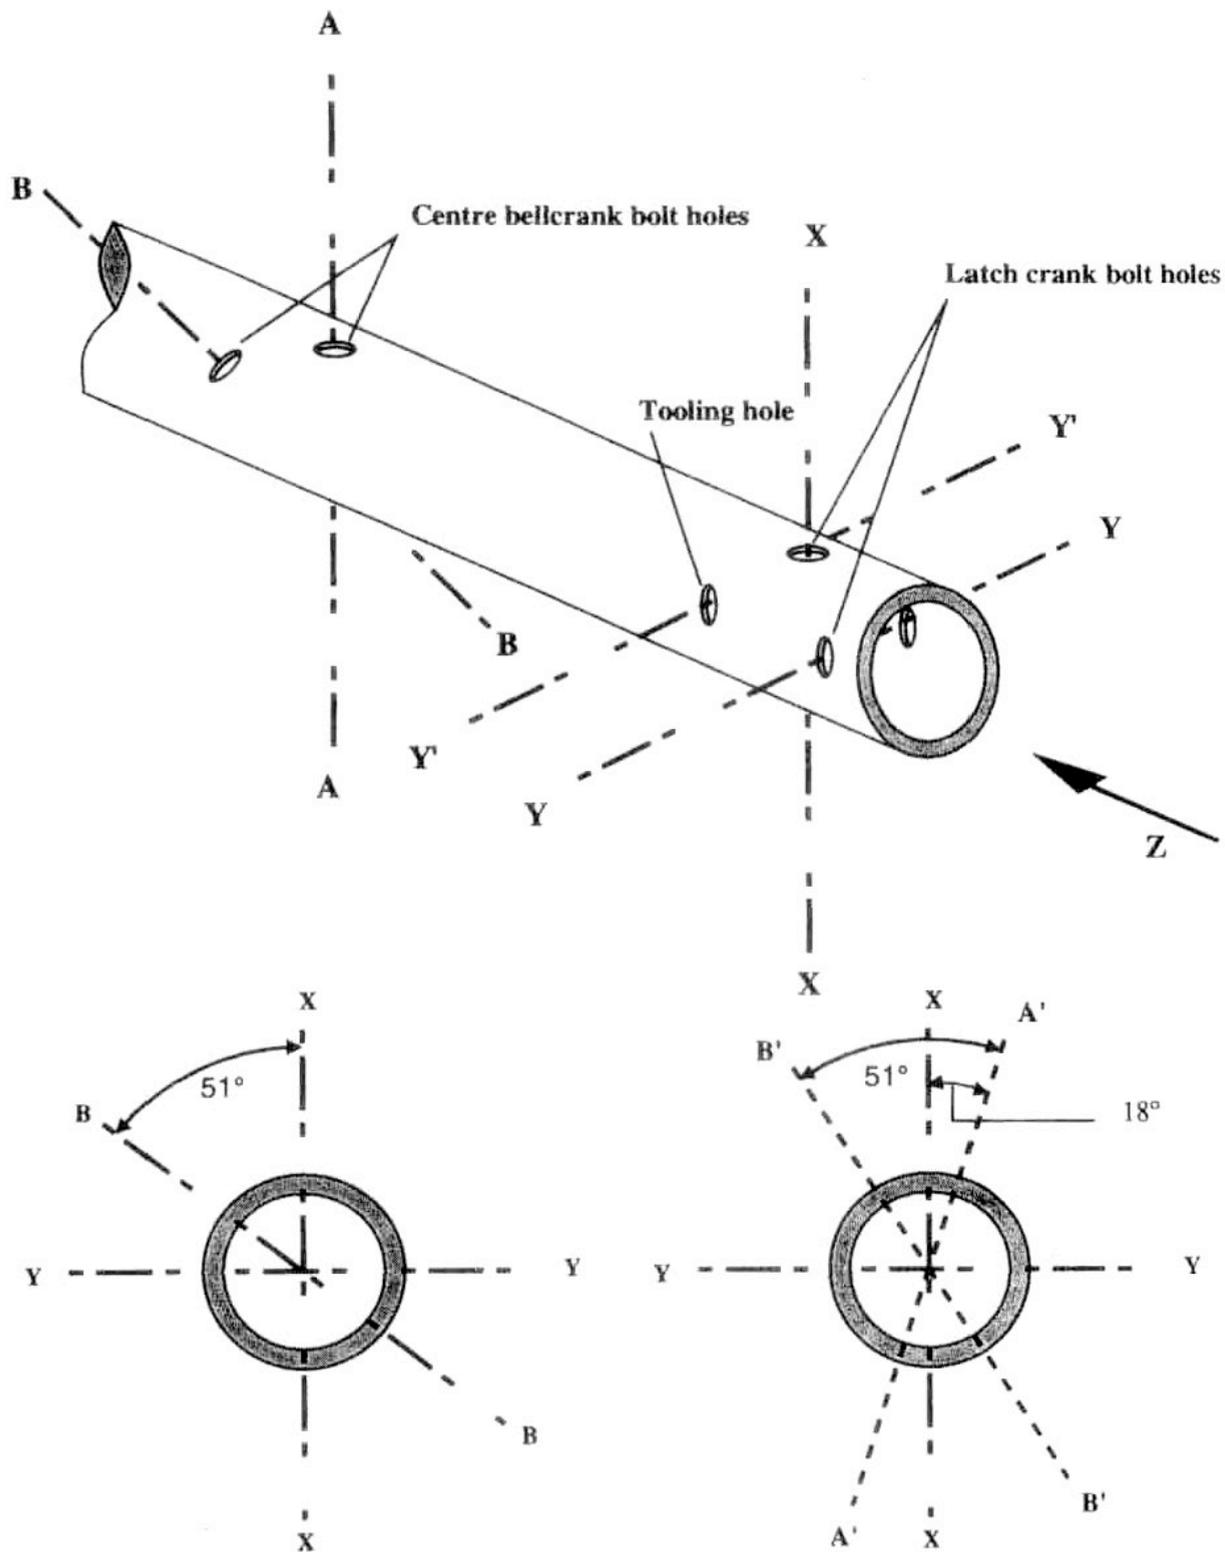
FIGURE 2. Diagram of door torque tube, showing relative positions of holes

On arrival back at Gatwick on 2 November, the aircraft was removed from service for investigation. Following removal of trim components, the aircraft was pressurised in an attempt to reproduce the defect. At 0.6 psi it was found that the door handle moved towards the unlock position. After comparison with another door, the engineers discovered that the upper torque tube that had been installed on 26 October had been drilled such that there was an incorrect angular relationship between two sets of holes. Each latch roller crank is retained in the end of the torque tube by a pair of bolts, one at 90° to the other, located across the tube diameter. Another pair of holes is drilled in the centre of the tube for the purpose of attaching the operating bellcrank. A tooling hole is drilled at either end of the tube, inboard of the latch crank bolt holes. When the replacement torque tube was compared with the failed one, it was found that the axes of the bellcrank boltholes had been drilled with approximately 18° of circumferential displacement from their correct position. As a result it would have been impossible to rig the door correctly, although the angular error could be largely compensated by extreme adjustment of the control rods attaching to the torque tube. Figure 2 shows a sketch of the tube, together with the relative positions of the various holes.

The design of the door is such that unlike the upper gate, the lower gate is not in a "hard" contact with the sill during the final part of the latching sequence thus giving rise to a non-symmetrical distribution of loads in the upper and lower torque tube linkages. The aircraft manufacture stated that 80% of the overcentre lock loads are generated by the correct relationship of the upper torque tube, its associated door gate and control rods. The remaining 20% is created by the lower latching mechanism and the latch rollers locating overcentre. Unless all the components are installed in the correct relationship to each other, the latching sequence will not operate correctly. The angular position of the centre bellcrank on the torque tube, with the 18° error, meant that it would not have been possible for the linkage to achieve the correct overcentre lock required to keep the door latched, even by utilising the full extent of the adjustment available in the control rods. The manufacturer additionally stated that without the overcentre lock, but with the correct rigging adjustments, it is possible that the door would remain latched during normal operations. However the latching mechanism would have been susceptible to movement with the slightest disturbance. It is possible

To drill the centre bellcrank mounting holes in the torque tube, the LAE marked their positions after obtaining the necessary angular relationships from the Maintenance Manual, and also by comparison with the old tube. Once satisfied, the new tube was installed in the door and the latch cranks bolted into position. After alignment with the marks made on the door frame during disassembly, the LAE instructed the engineers to drill the centre bellcrank holes. It must be presumed that the angular error arose at some point in the marking/alignment process, possibly as a result of mis-reading the drawings in the Maintenance Manual.

View on arrow Z. NB: axes XX and AA are shown coincident, although AA was in fact rotated approx 1° anticlockwise from XX

End view of wrongly drilled torque tube, showing 18° displacement of bellcrank bolt holes

The aircraft continued to experience problems with the door, as described earlier, culminating in the incident on November 2. When the drilling error became apparent, another torque tube was obtained and drilled off in the main workshops using a vertical milling machine incorporating a dividing head and a digital dial test indicator. The door was subsequently reassembled and rigged with no problems, the handle pull-off load now being 25 lbs, as required by the Maintenance Manual. The aircraft was returned to service with no further door problems since being reported.
