Uncommanded roll, Boeing 737-236, G-BKYI

Boeing 737-236, G-BKYI

AAIB Bulletin No: 1/98 Ref: EW/C96/11/3 Category: 1.1

Aircraft Type and Registration:	Boeing 737-236, G-BKYI
No & Type of Engines:	2 Pratt & Whitney JT8D-15A turbofan engines
Year of Manufacture:	1984
Date & Time (UTC):	8 November 1996 at 0820 hrs
Location:	Approach to Runway 27L London Heathrow Airport
Type of Flight:	Public Transport
Persons on Board:	Crew - 6 - Passengers - 82
Injuries:	Crew - None - Passengers - None
Nature of Damage:	None
Commander's Licence:	Airline Transport Pilot's Licence
Commander's Age:	45 years
Commander's Flying Experience:	Approximately 12,000 hours (of which 5,000 were on type) Last 90 days - 110 hours Last 28 days - 50 hours
Information Source:	AAIB Field Investigation

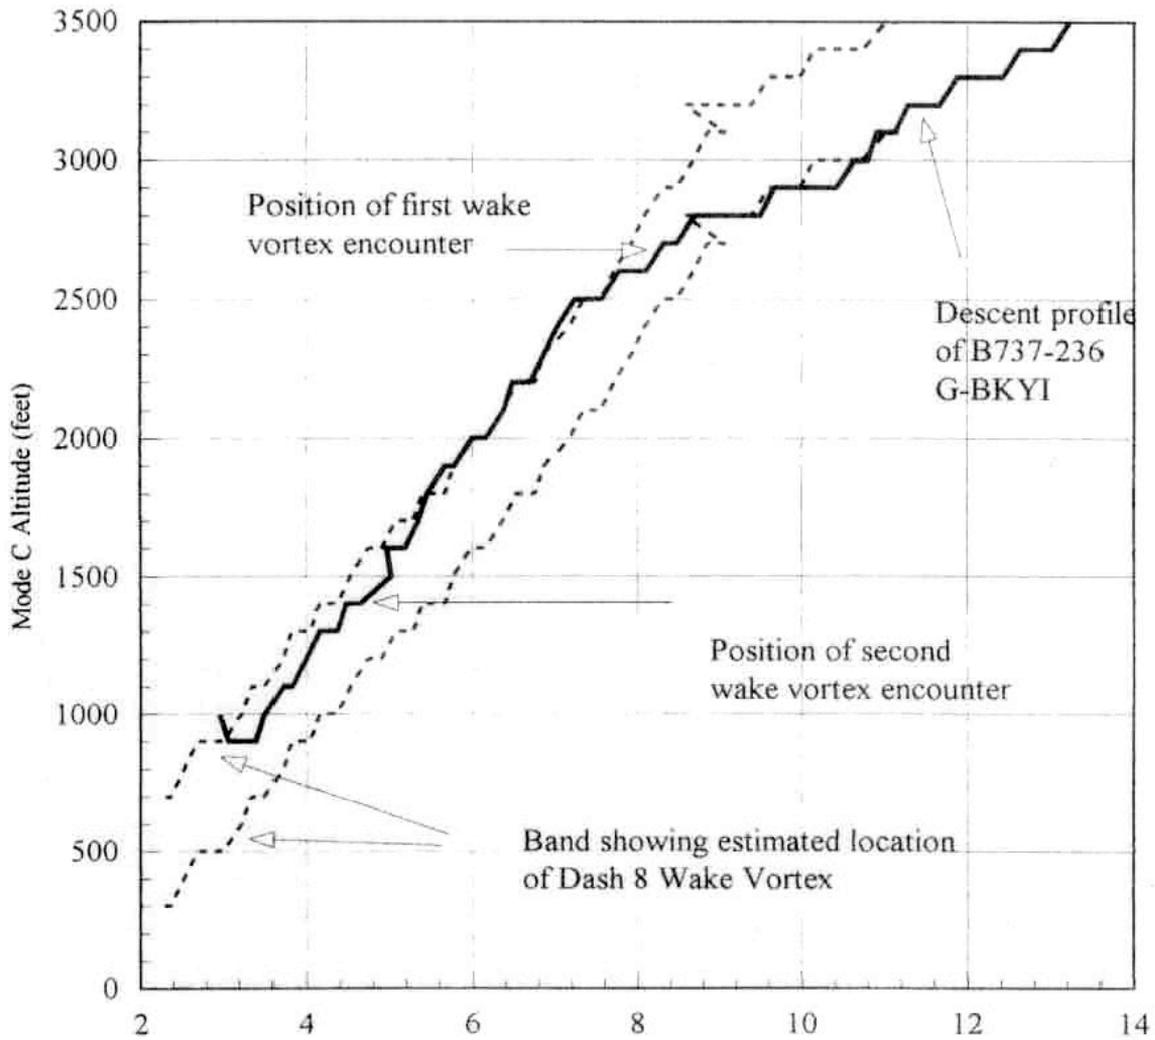
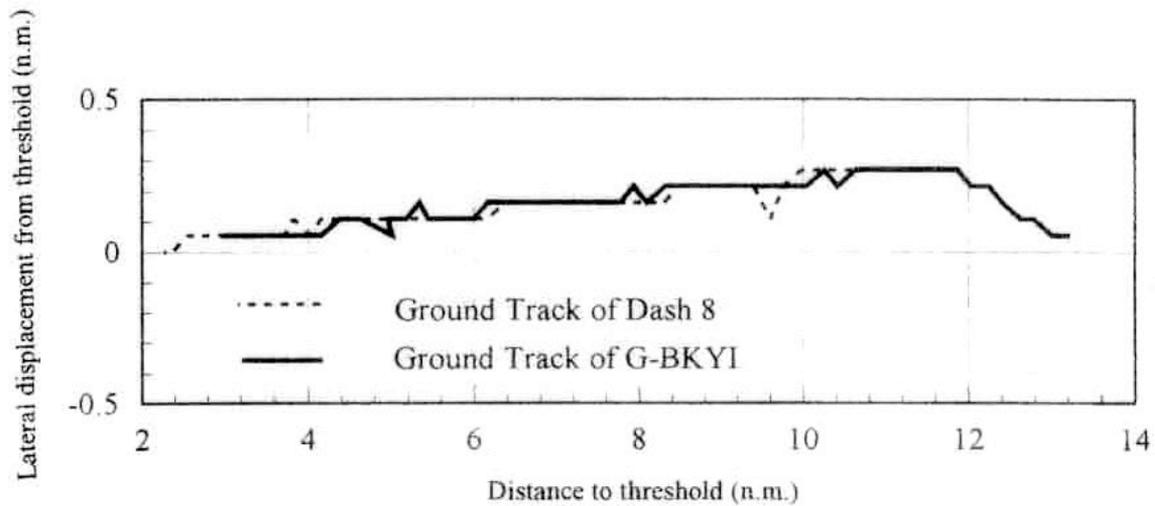
Figure 1 shows the approach path of the incident aircraft and the DHC Dash Eight. The first uncommanded roll event occurred at 8.1 nm from touchdown, when 'YI was 2.9 nm behind the Dash Eight (60 seconds elapsed time). The second uncommanded roll event occurred at 4.5 nm from touchdown when 'YI was 2.8 nm behind the Dash Eight (56 seconds elapsed time).

In Figure 1, the position of the wake is therefore represented by a band, and the figure shows that the path of 'YI was coincident with the estimated location of the wake at around the altitude of the recorded uncommanded roll events.
