Nosewheel failure on landing, Boeing 757-225, G-OOOV, 27 January

Boeing 757-225, G-OOOV, 27 January

AAIB Bulletin No: 4/98 Ref: EW/C97/8/1 Category: 1.1

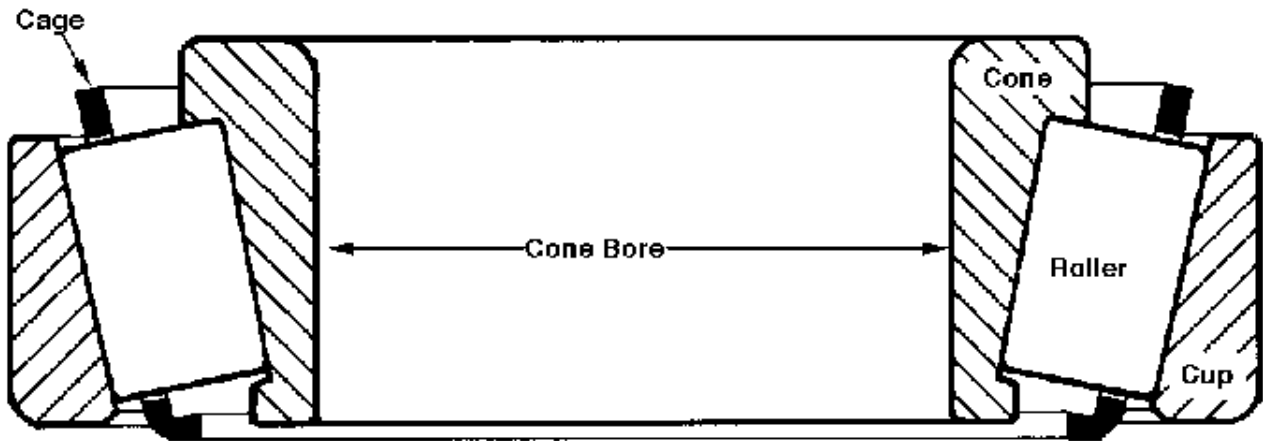
The bearing was visually examined by a representative of the manufacturer in the presence of AAIB. With the exception of water corrosion on the cone bore the inboard bearing was in reasonable condition. The outboard bearing was severely distressed with most of the debris exhibiting plastic deformation from softening at the high temperatures experienced during the bearing failure.

Fourteen rollers out of a full complement of 27 were available for examination. The spherical grinding on the ends of some of the rollers was nearly undamaged indicating that wear at this sliding contact area had not been a problem before the rapid collapse of the bearing. The bearing cone also exhibited sections of thrust rib in relatively undamaged condition, again endorsing a rapid collapse. Several rollers showed line etching caused by water corrosion, and, in some cases, fatigue damage at these sites of corrosion.

It was concluded that the outboard bearing had collapsed rapidly. This is characteristic of a cage failure and may be caused by corroded and fatigued, spalled roller bodies wearing or 'machining' the cage arms until they are sufficiently weakened to break. Corrosion of bearings on a variety of nosewheel applications is a well known phenomenon as the bearings are generally not backed up with a brake pack which helps shield main wheel bearings from water ingress.
