Loss of separation, Boeing 747 and Gulfstream G IV accident report

Aircraft Incident Report No. 4/98 (EW/C97/7/1)

AIRPROX (C): Boeing 747 and Gulfstream G IV Report on an incident near Lambourne VOR on 3 July 1997

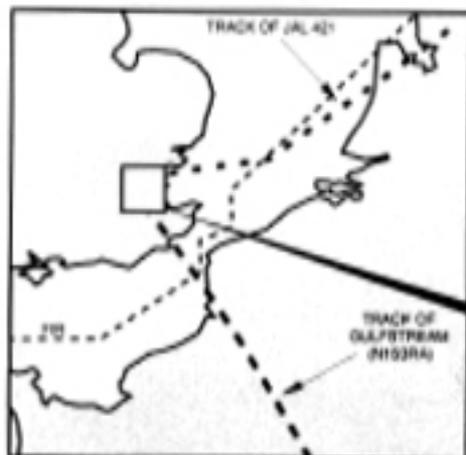
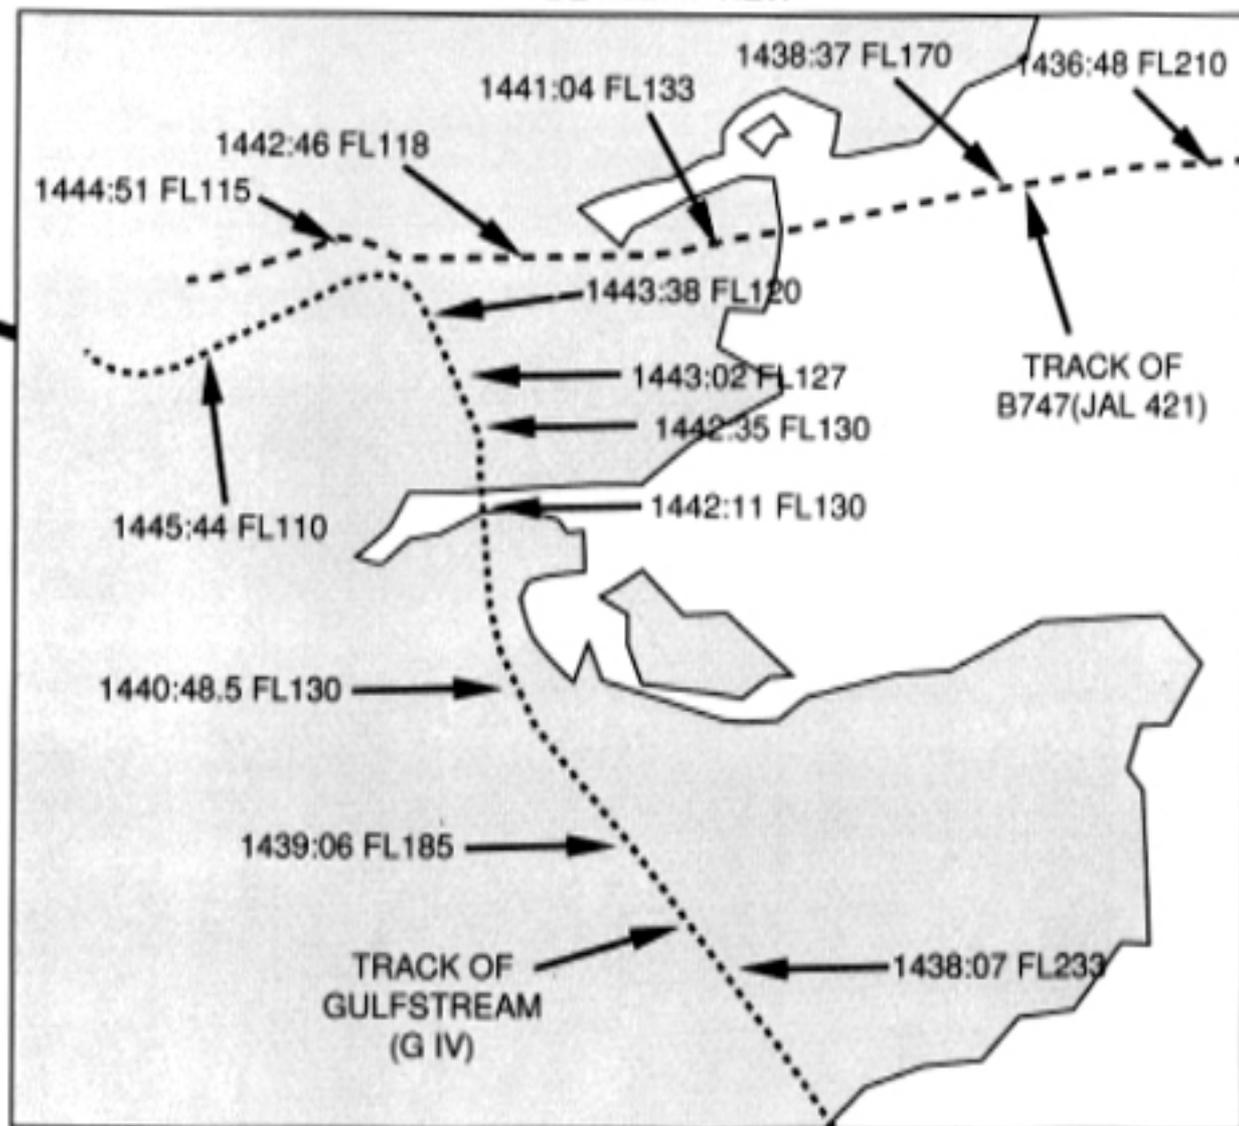
MULTIRADAR PLOT (HEATHROW 23CM / DEBDEN) OF JAL 421 AND GULFSTREAM (N153RA)

The aircraft were converging at right angles to each other, the B 747 on a westerly track towards LAM VOR and the Gulfstream on an assigned radar heading of 340°. The respective tracks and relevant timings are shown in Appendix 1. The B 747 had been transferred to LL INT N from TC LAM descending to FL 110 and was then further cleared by LL INT N to FL 90 whilst attempting to decelerate. When TC NE / LAM considered that the B 747 had vacated FL 120, based on his observation of the flight's Mode C readout on his radar display, he cleared the G IV to that level. However, whereas the G IV descended rapidly to FL 120 the B 747 actually stopped its descent at FL 117 resulting in a serious loss of separation. TC NE/LAM was first warned of the developing situation by the crew of the G IV who relayed information generated by their TCAS; the LL INT N controller was alerted by the activation of the Short Term Conflict Alert (STCA): 'avoiding action' instructions were then issued to both flights. Vertical separation was further reduced when the B 747 climbed back to FL 122, in response to a RA message generated by the TCAS. The minimum separation was 0.83 nm horizontally and 100 feet vertically. Four seconds later the vertical separation increased to 200 feet with a corresponding horizontal separation of 0.66 nm.

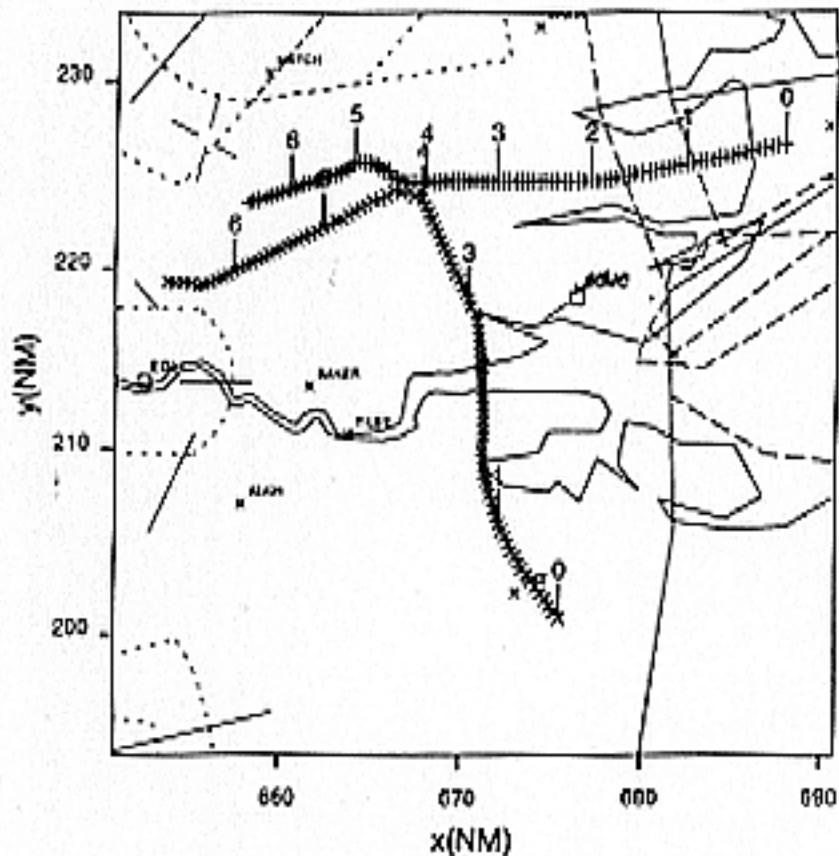
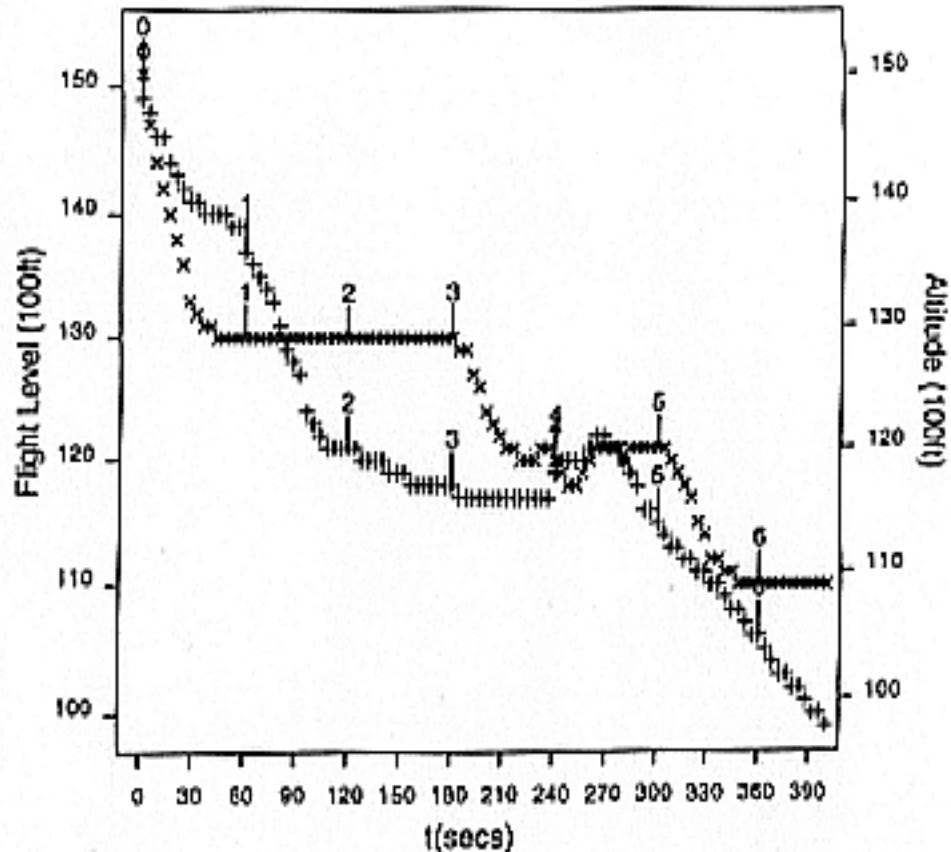
03/07/97 - 14:39:54

Incident occurred
9 nm NW SPEAR
