In-flight electrical problems, Boeing 767-322ER, N653UA

Aircraft Accident Report 5/2000 (EW/C98/1/3)

Report on the accident to Boeing 767-322ER, N653UA at London Heathrow Airport on 9 January 1998

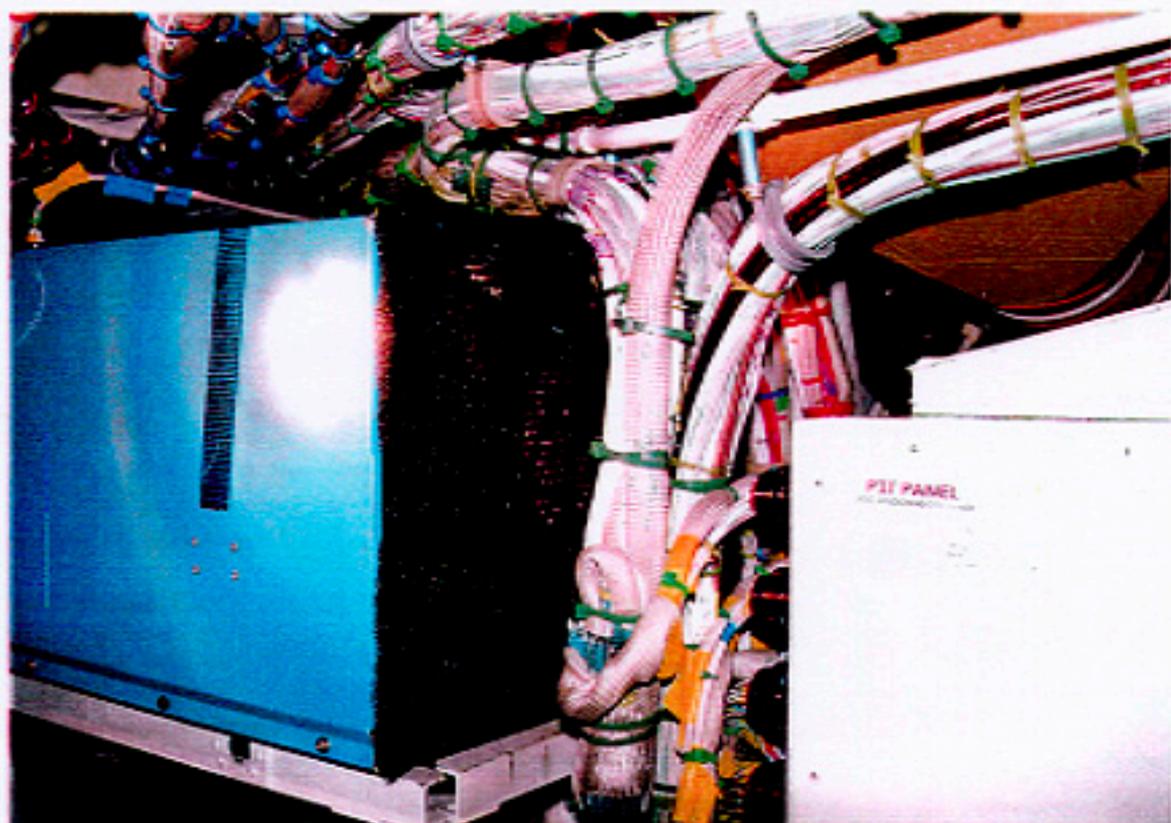
The blue painted cover for the chiller unit was made from a single sheet of aluminium folded to form the top and two sides of the box, and its attachment flanges. A natural consequence of this construction was that where the top corner folds intersected, as illustrated in Figures B-4a and B-4c, it was necessary for a small corner bend relief hole to be drilled (and de-burred) in this location to prevent tearing or cracking at what would have been an otherwise impossibly tight bend radius. The general design rule for the diameter of such corner relief holes was that they should be three times the thickness of the associated sheet material. Examination of these corners on the chiller unit, which appeared to conform to this design standard, revealed an understandable level of handling damage, with small areas of missing paint and bruised edges on the aluminium sheet. However, one edge of the sheet at the upper/aft outboard corner was 'burred' in such a way as to form a sharp edge, as illustrated in Figure B-4b. It was also evident that this edge would have been 'leading' whenever the chiller had been moved in an outboard direction, such as when being installed. It was also evident that the position of the damaged insulation on the wires illustrated in Figure B-3 was adjacent to this corner of the chiller when in the installed position.

General view, looking forward and outboard, of the aft inboard corner of the galley chiller unit (blue) in relation to the wiring looms. Crew emergency oxygen bottle is located beneath chiller.

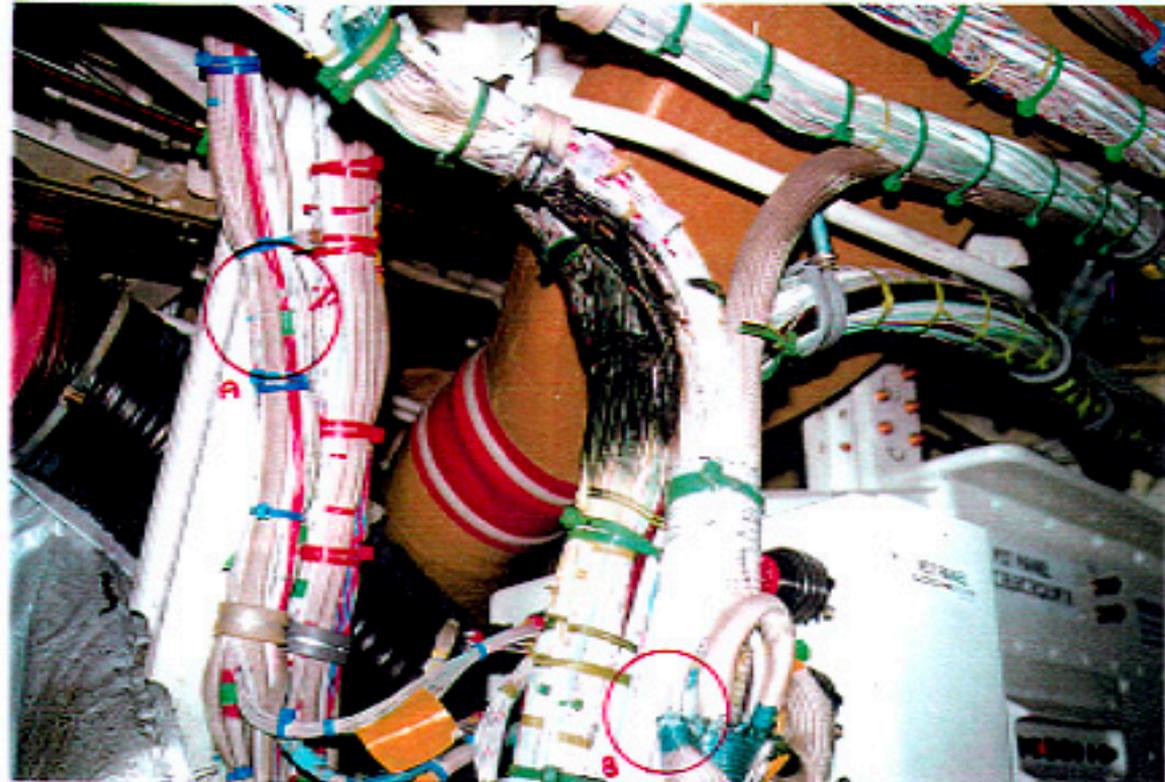
Removal of the light blue painted chiller allowed access for inspection. This indicated that the primary event appeared to have occurred within one loom and that arcing and burning of wires around the inner surface of the curved section of this loom had occurred over a length of some 6 inches, as shown in Figure B-2. There was also copious evidence of copper spatter from the failed wires on the filter, on other wires and also on airframe insulation blankets below this area. A general examination of the unaffected wiring looms above and around the chiller location revealed a few minor nicks and areas of insulation abrasion but in one area, on a loom directly outboard of the failed loom, the insulation of three wires had been sufficiently damaged to expose their underlying insulation. The surface of an adjacent glass fibre sleeve also showed signs of damage in this area. The damage, the location of which coincided with the plane of the chiller top surface, is illustrated in Figure B-3 where it may be clearly seen to have been caused by 'mechanical' rather than 'electrical' means.

General view of damaged wires after chiller removal, with partially failed loom nearest the camera. Areas identified A and B exhibit wire damage not directly related to the loom failure (see Figure B-3). Of significance, damage at A is approximately at the same height as the failed section of loom.

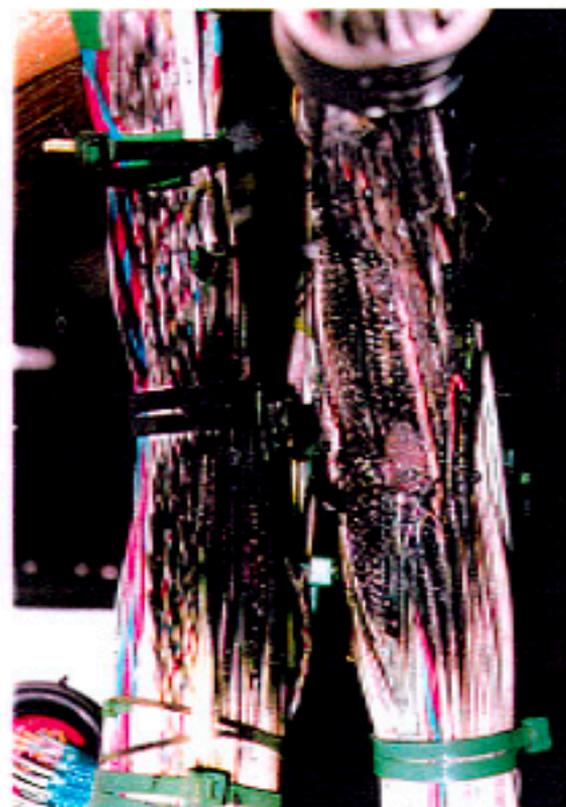
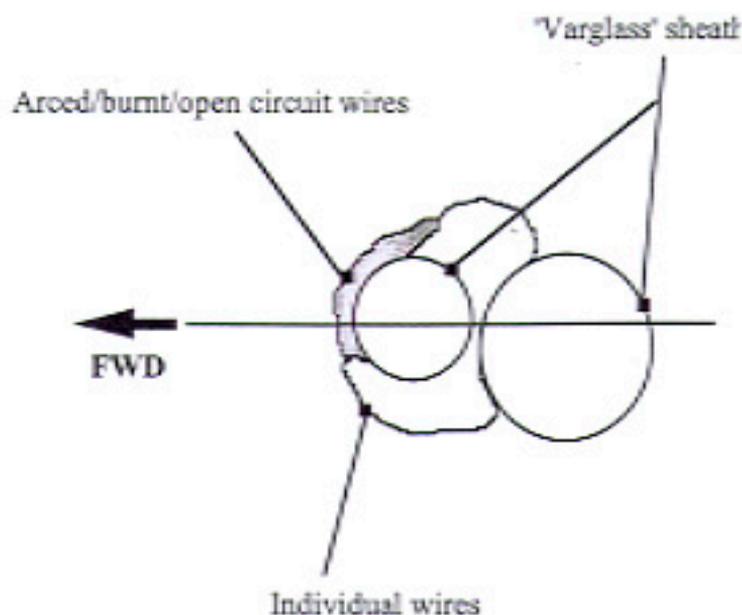
A sketch of the cross-section of the loom is shown in Figure B-2, along with photographs of the damaged loom before disturbance, where it may be seen that it was comprised of individual wires, small bundles of wires laced together and two major bundles contained within separate woven glass fibre sheaths. Apart from separating discrete groups of wires within the loom, it was evident that these sheaths conferred an extra measure of physical protection to the wire group. It was also evident that many of the individual wires around the inside surface of the curved section of this loom had suffered various failures over a length of some 4 to 5 inches, and that two main areas were present where arcing of conductors had taken place. The apparently more extreme arcing event was located towards the lower limit of the damage, some 2 to 3 inches below the level of the chiller top surface, where several 22 gauge wires terminated at the same point with molten and re-solidified ends to their conductors. This was coincident with a 'hot spot' on the surface of the woven glass fibre sleeve embedded within the loom and to which globular deposits of copper had adhered. This location was also co-incident with a green plastic cable tie, the remnants of which had remained attached to the loom by several melted and re-solidified ends.

Detail view of failed areas of loom, and the adjacent heat affected loom. Above is a sketch of a cross section of the failed loom at the identified position.

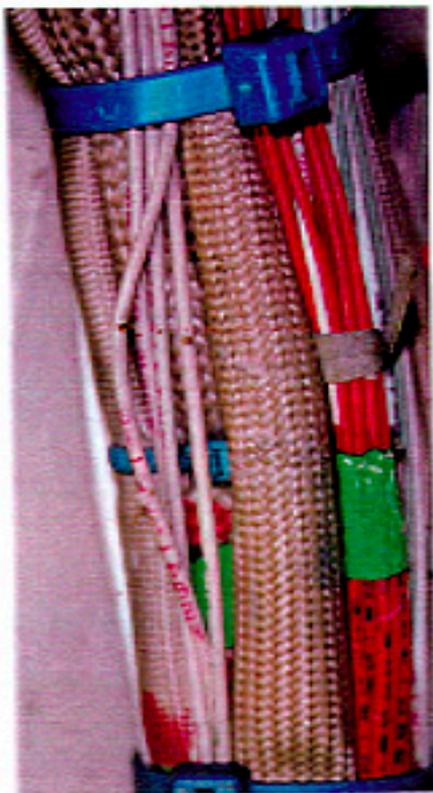
Wire damage at location A in Figure B-2. Three wires affected in addition to scuffing of braided sheath.

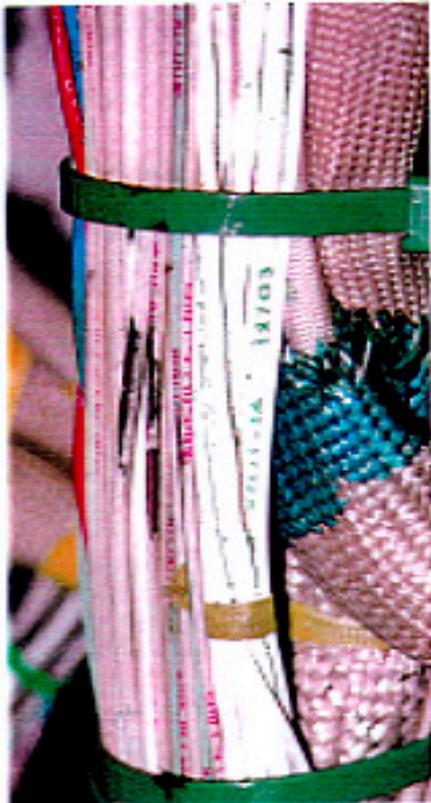
Abrasion of insulation topcoat at location B in Figure B-2.

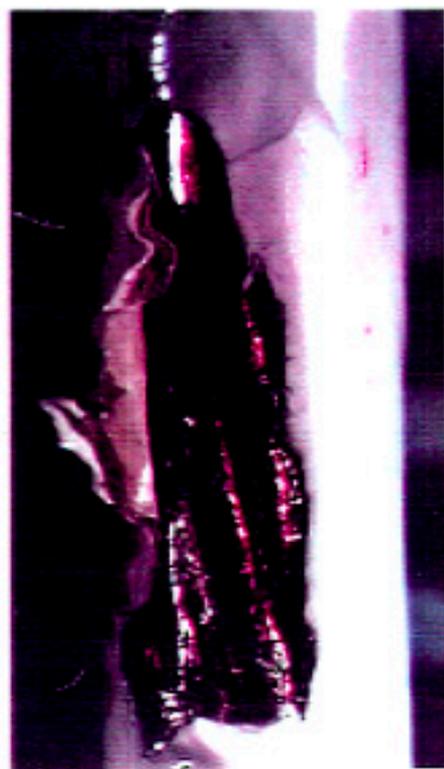
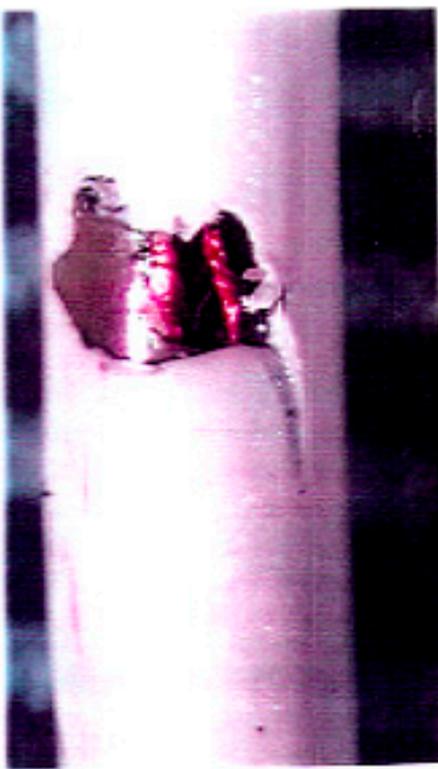
Details of 'cutting/slicing' damage to the outer insulation of two of the wires shown above left, leading to exposure of the polyimide insulation.

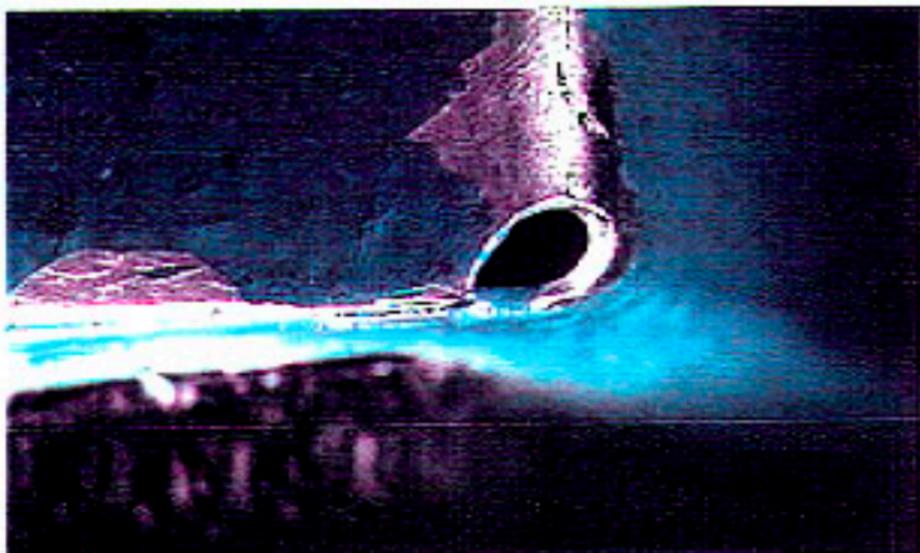
General view, above, of the top aft outboard corner of the chiller box showing the chipped paint, nature of construction and general bruising and, below, a detail of the burred 'sharp' edge.

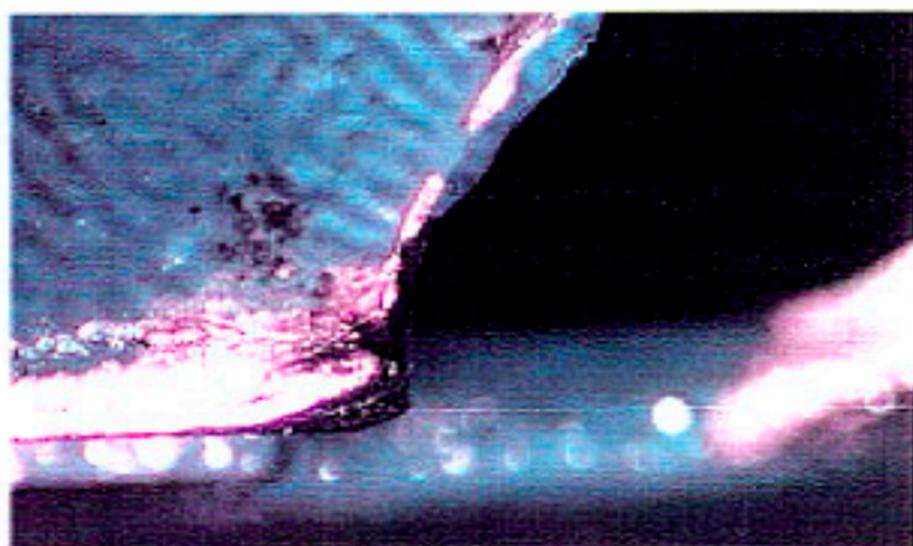
b

For comparison, below, a view of a top corner from the front of the chiller where three folds intersect. No exposed sharp edges were apparent.

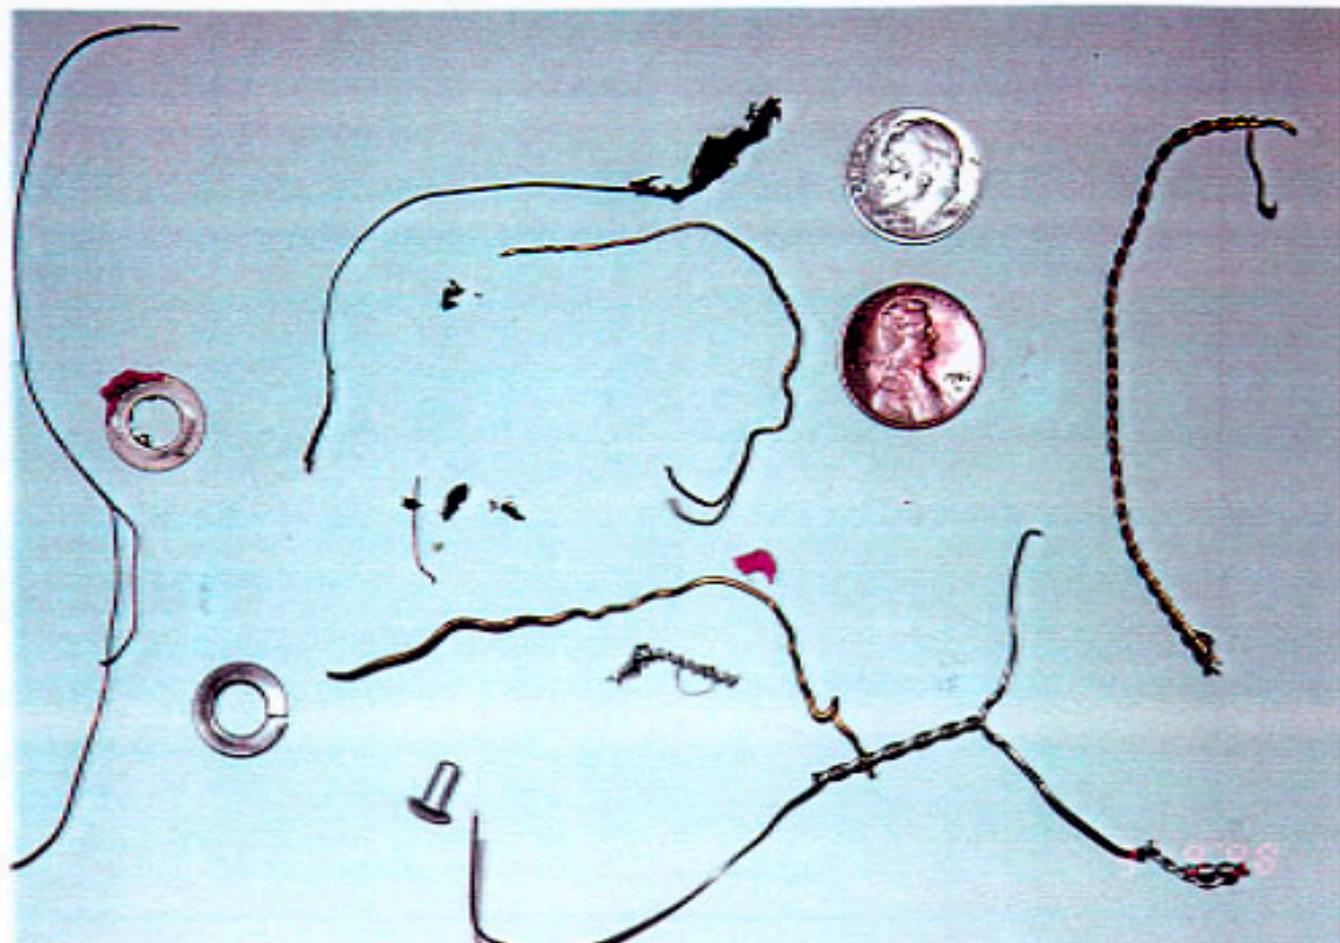
Further metallic debris was also found in the form of small curled aluminium swarf, typical of that produced from the drilling of holes. Samples of this swarf were found not only in the lower parts of the airframe, but in areas above the chiller, on ledges formed by the structure of the airframe, in the roof of the bay and on top of, and within, some electrical distribution boxes. Examples of this debris are shown in Figure B-5, together with an elemental spectrum of a typical piece of such swarf derived from a scanning electron microscope (SEM) examination. (This and other SEM tests are described later in section 1.12.3.8).

Above: Sample of conductive debris remove from immediate environment of chiller in the E&E bay of N653UA. Below: SEM analysis of typical swarf found in this region. (See also Figure D-1)

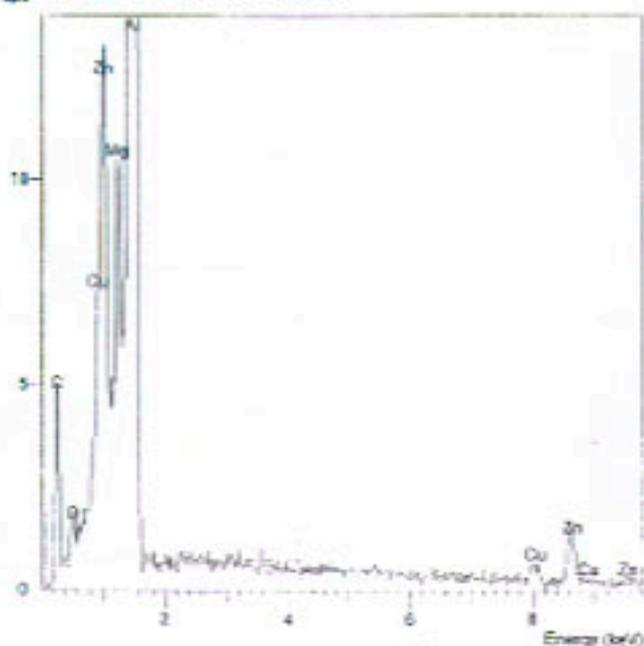
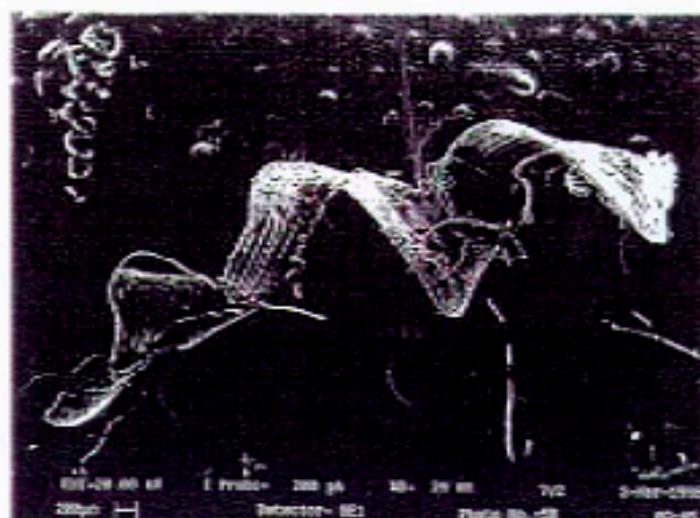
Debris from floor below damaged busbars - micrograph and EDX spectrum of aluminum swarf 7/2

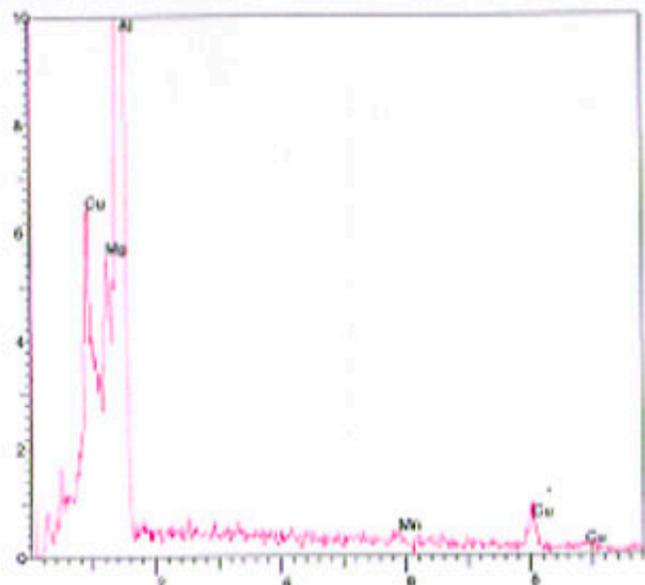
Debris from vacuum box - micrograph and EDX spectrum of aluminium swarf particle 1/10

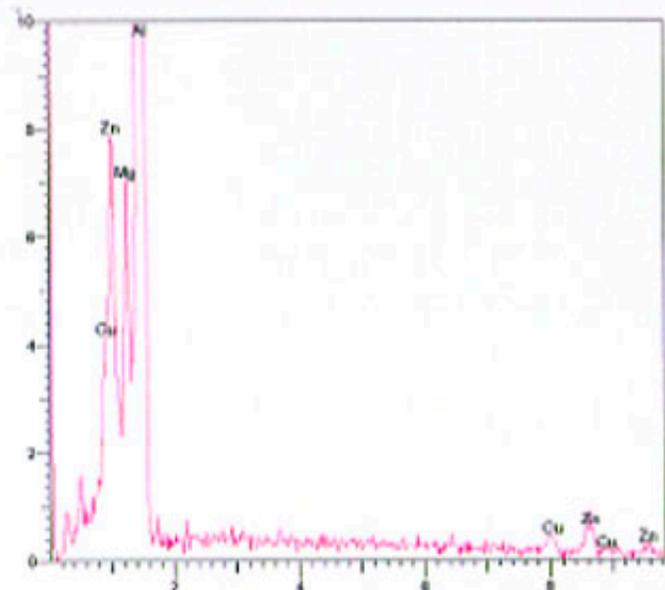
Debris from vacuum box - micrograph and EDX spectrum of aluminium swarf particle 1/8

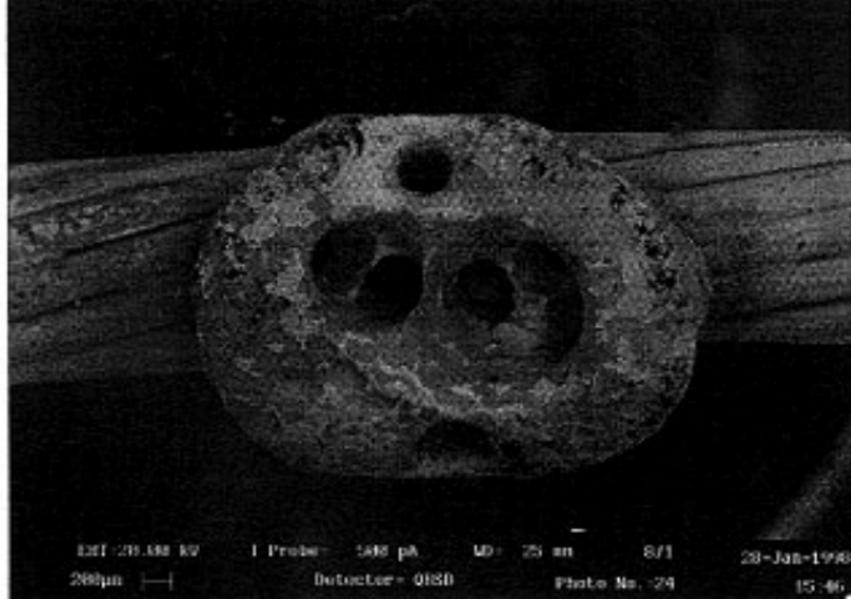
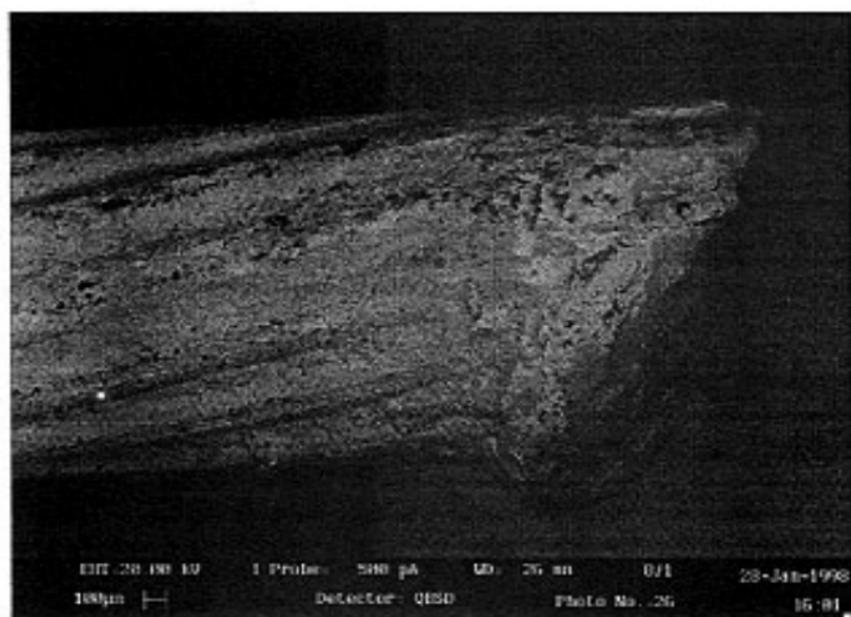
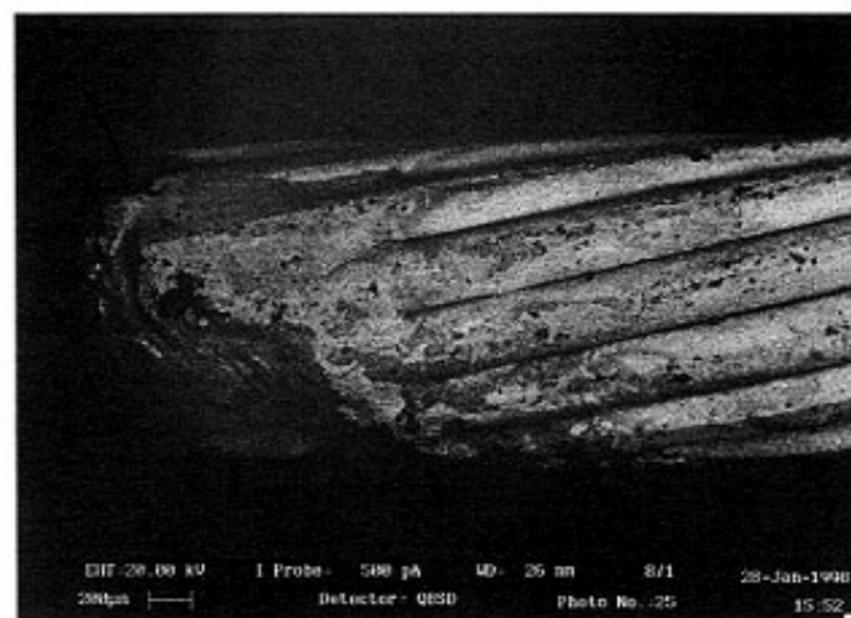
Debris from shelf below damaged harness - copper conductor

Upper micrograph - central globular attachment to conductor
Central micrograph - one end; Lower micrograph - other end

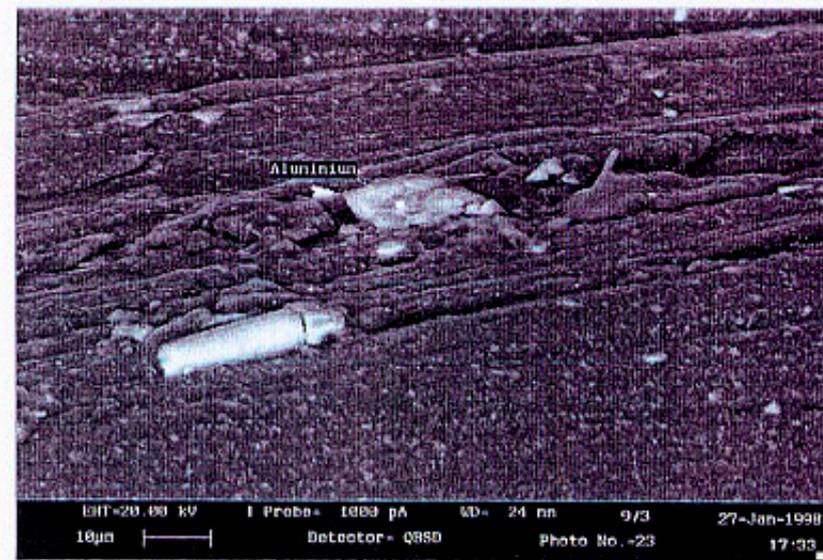
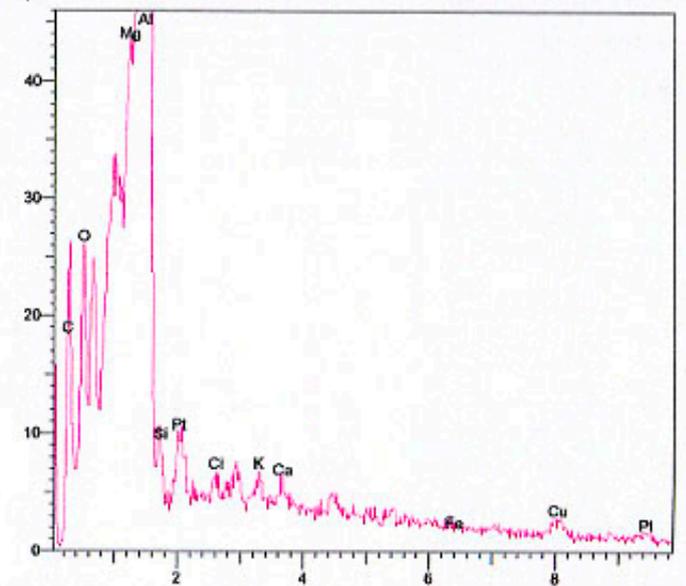
Wire from outboard harness - micrograph and EDX spectrum
 of embedded aluminium in insulation of wire, 9/3

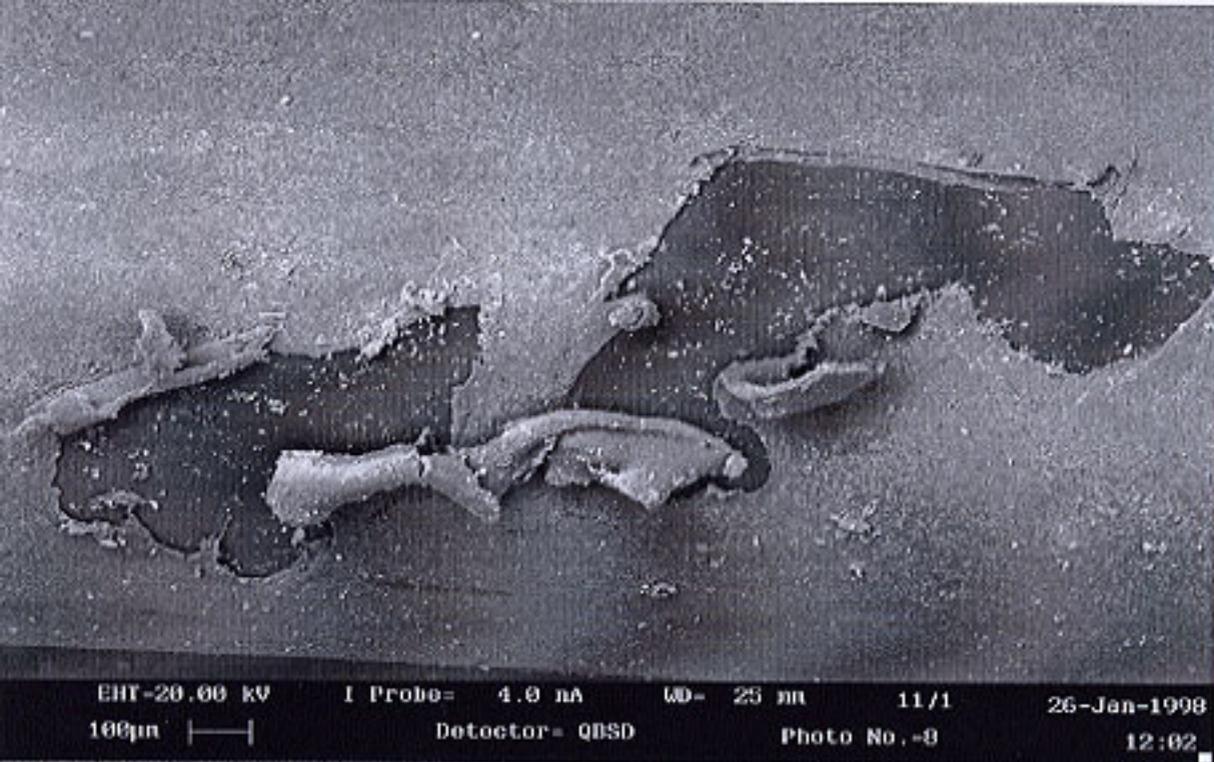
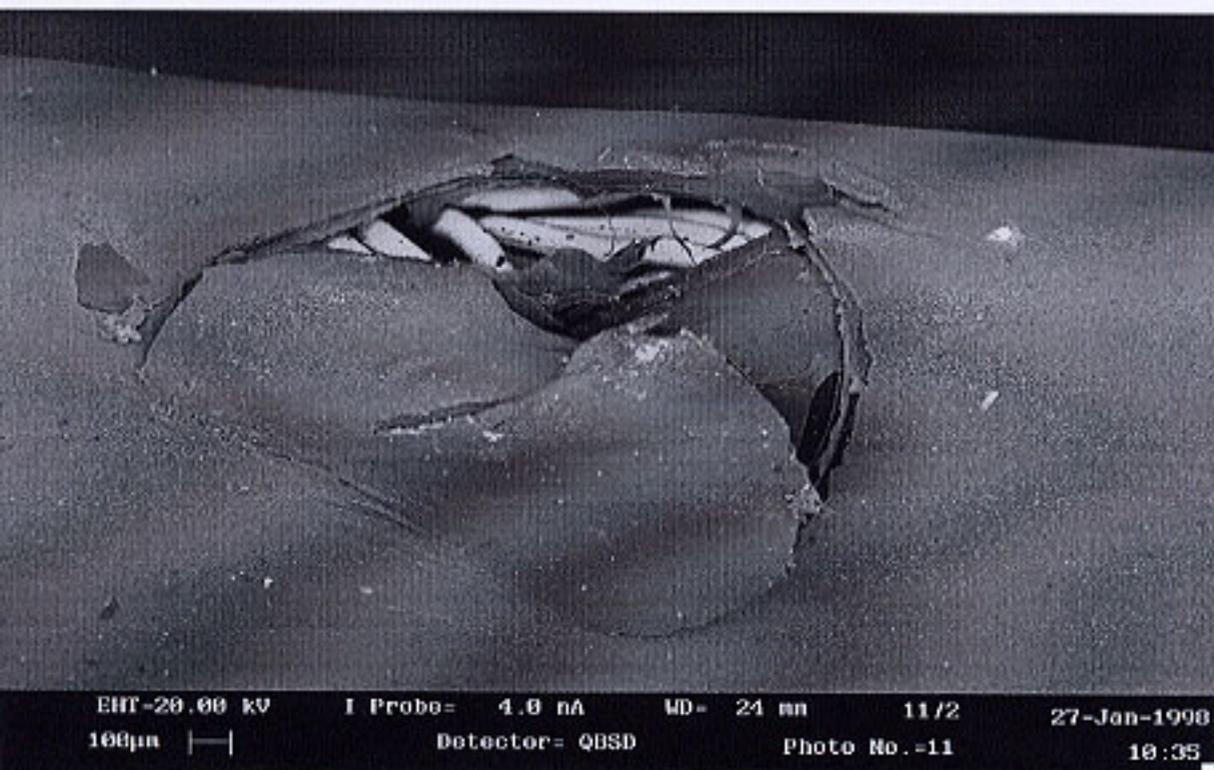
Wire from harness which suffered electrical failure
Mechanical damage at a distance of ~ 10 mm from blackened area

Upper micrograph - wire 11/1; Lower micrograph - wire 11/2

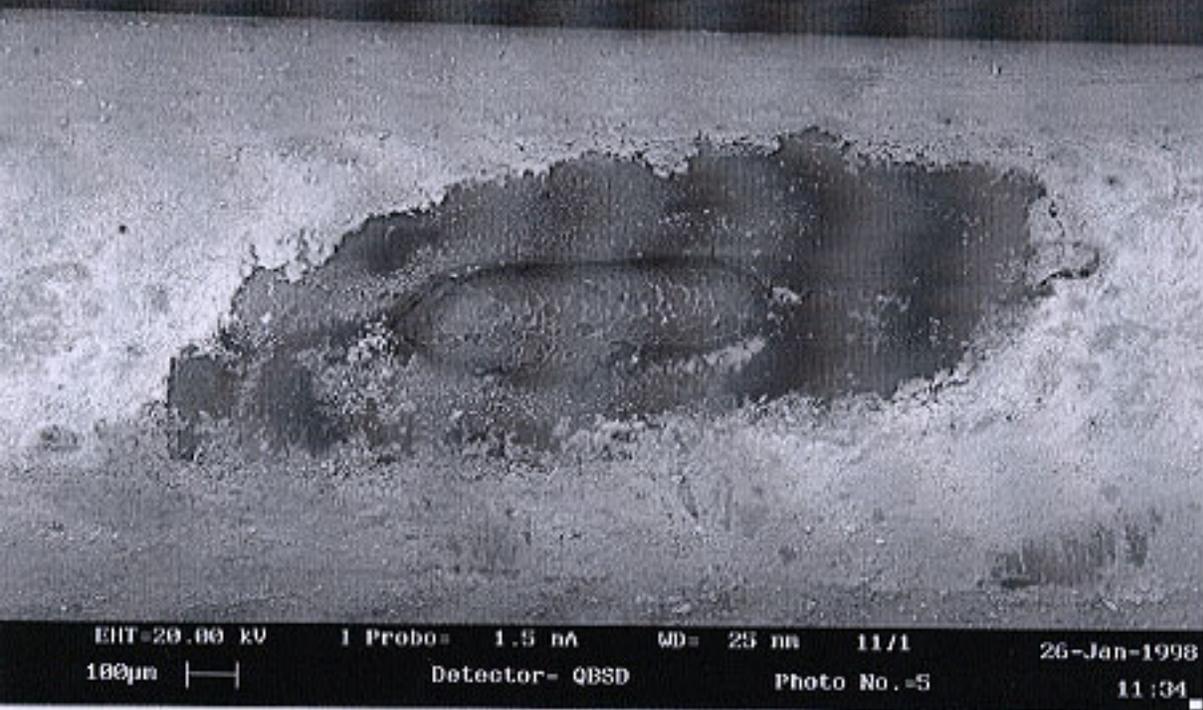
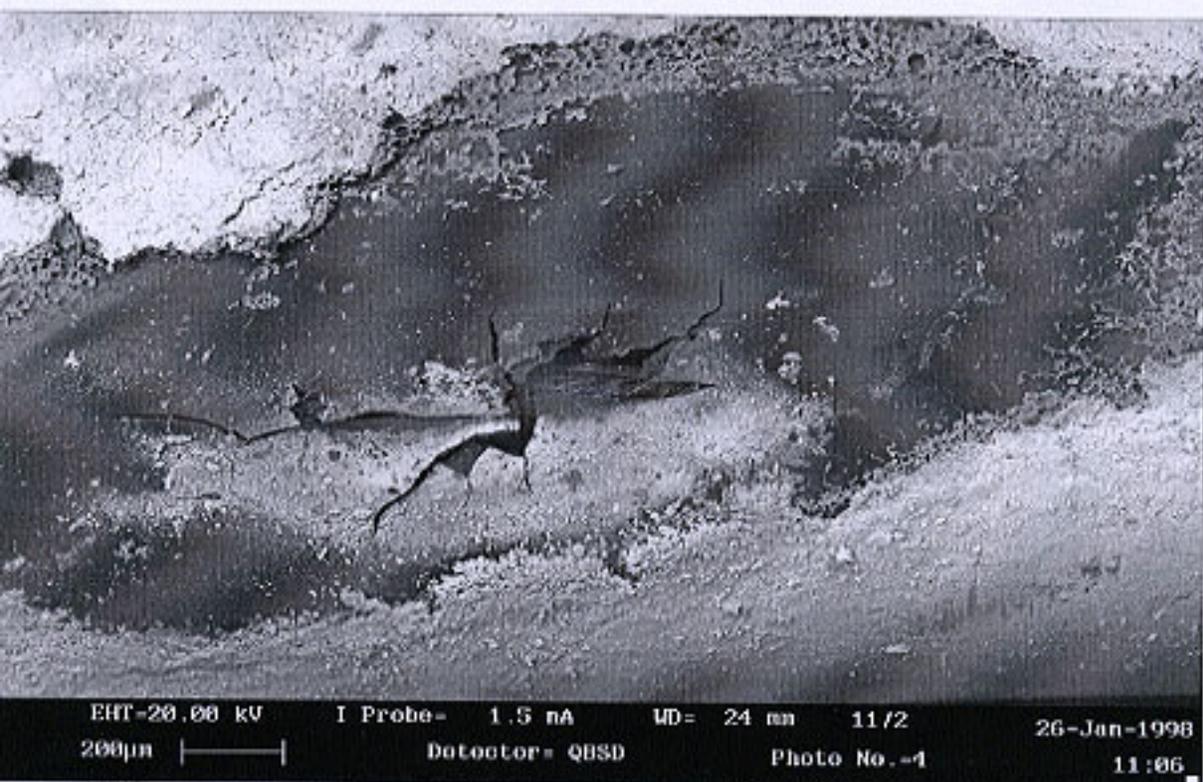
Wire from harness which suffered electrical failure
Heat damage at a distance of ~ 10 mm from blackened area

Upper micrograph - wire 11/1; Lower micrograph - wire 11/2

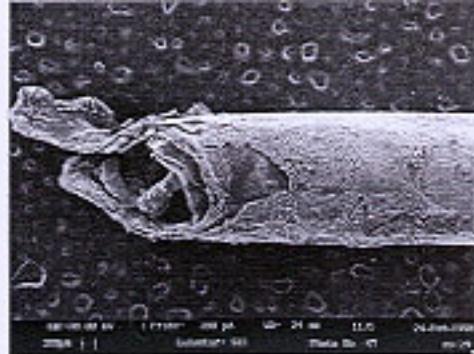
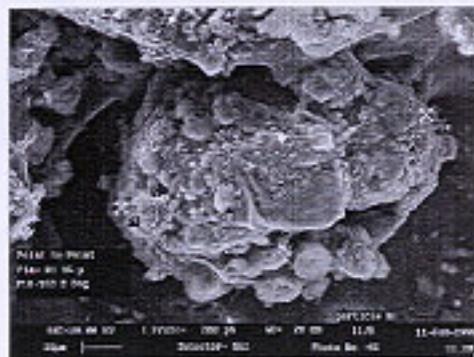
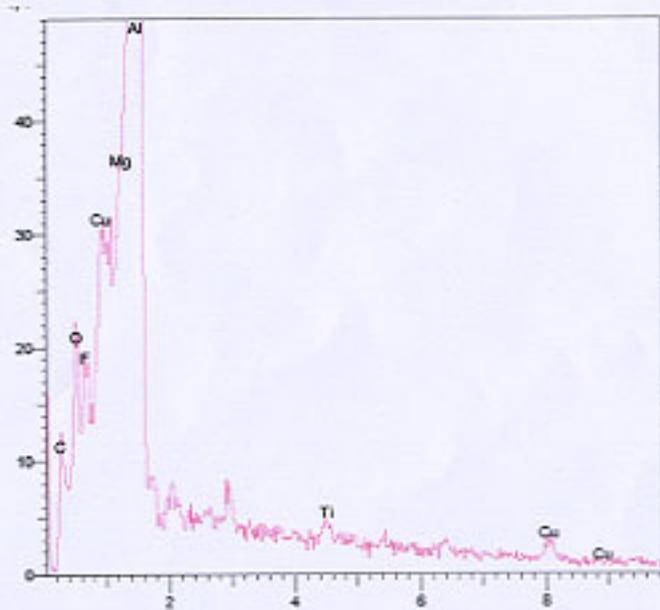
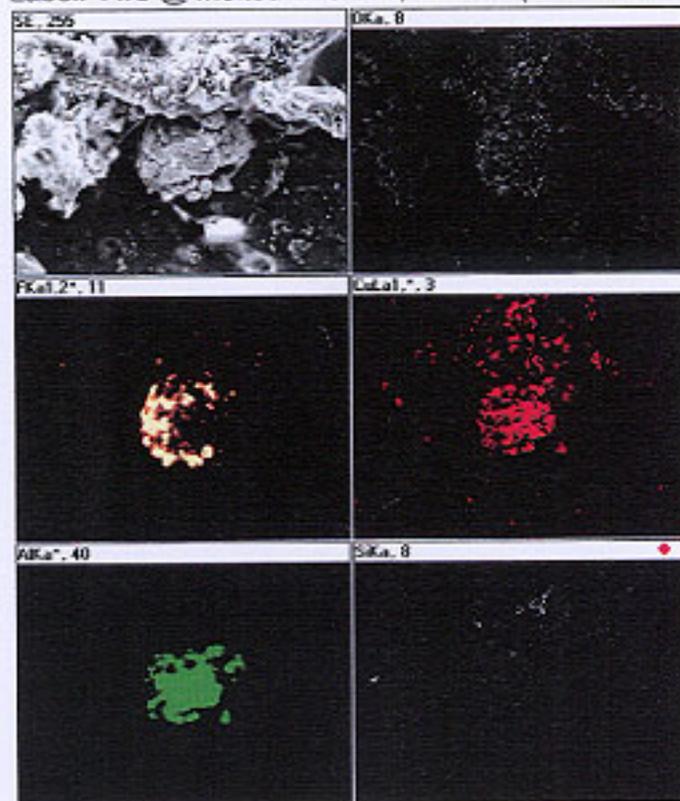
Wires from harness which suffered electrical failure

LHS: micrographs and EDX spectrum of aluminium sphere on insulation of wire 11/5

RHS: Element maps of aluminium sphere on wire 11/5

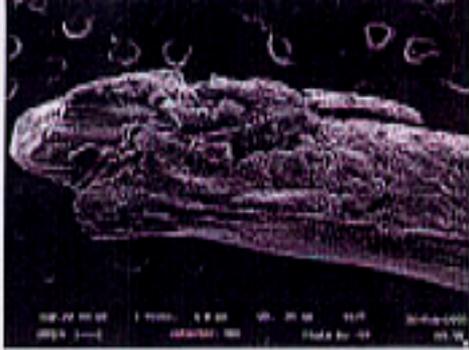
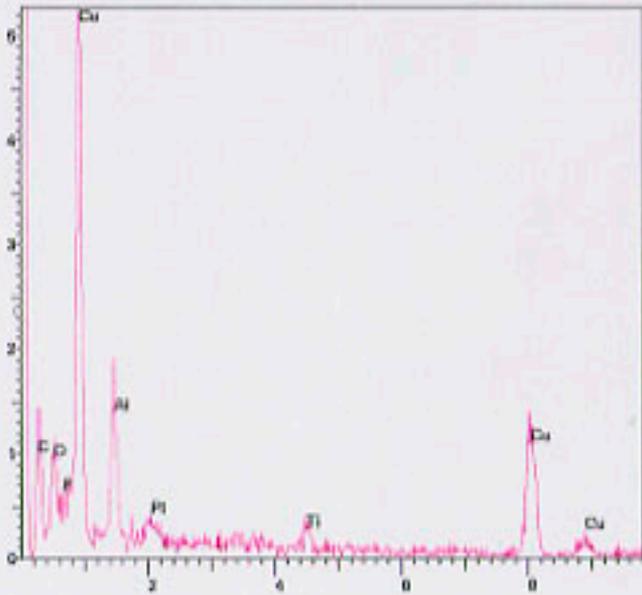
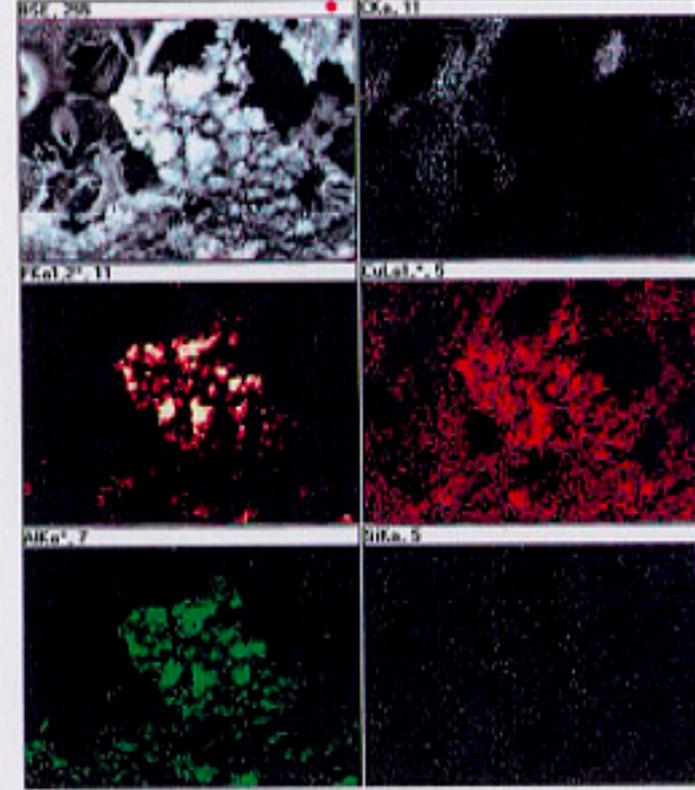
Wires from harness which suffered electrical failure

LHS: micrographs and EDX spectrum of aluminium and copper 'dust' on insulation of wire 11/7

RHS: Element maps of aluminium nodules on wire 11/8

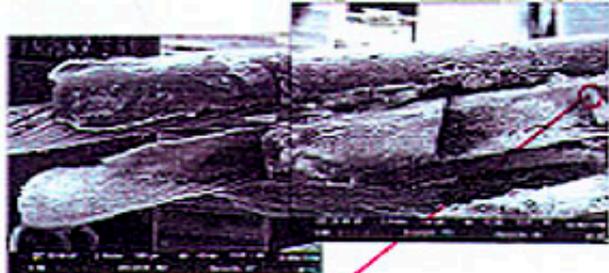
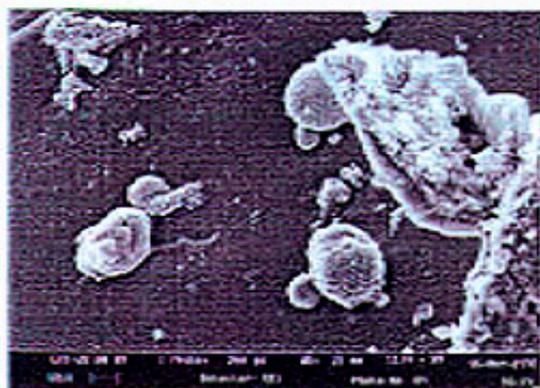
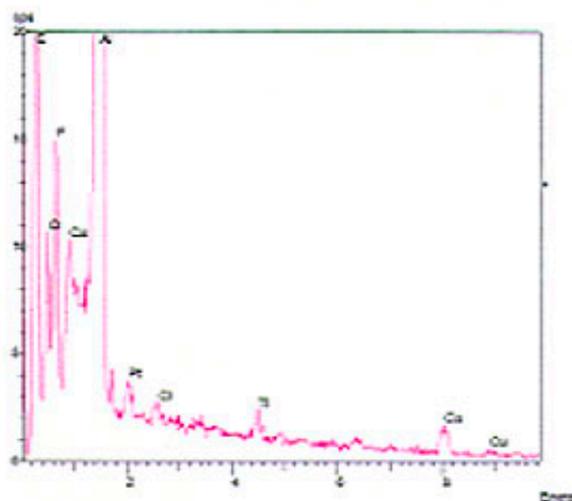
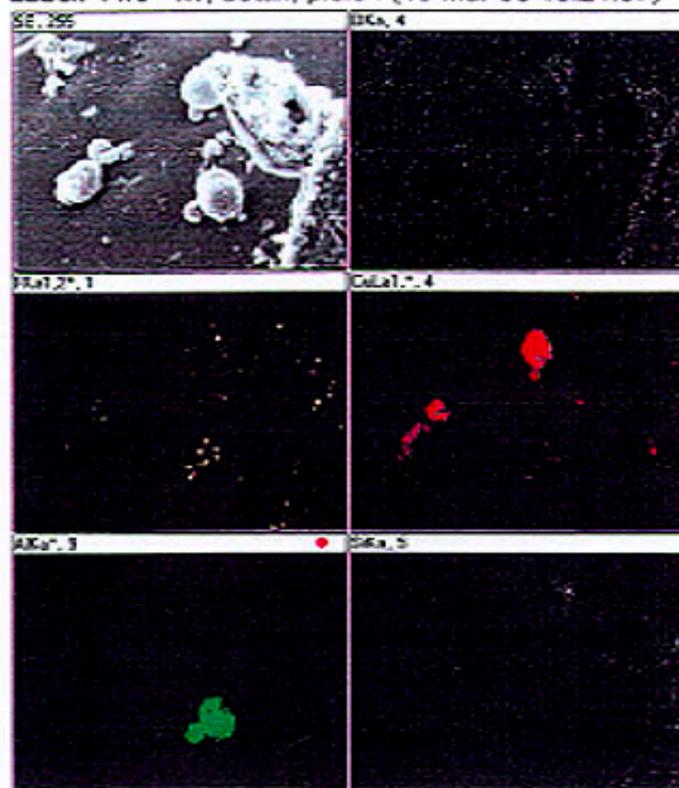
Wire from harness which suffered electrical failure

Micrographs and EDX spectrum of aluminium spheres on insulation of wire 11/9
 Upper micrograph - location @ O; Lower micrograph - detail

Element maps of aluminium and copper spheres on wire 11/9

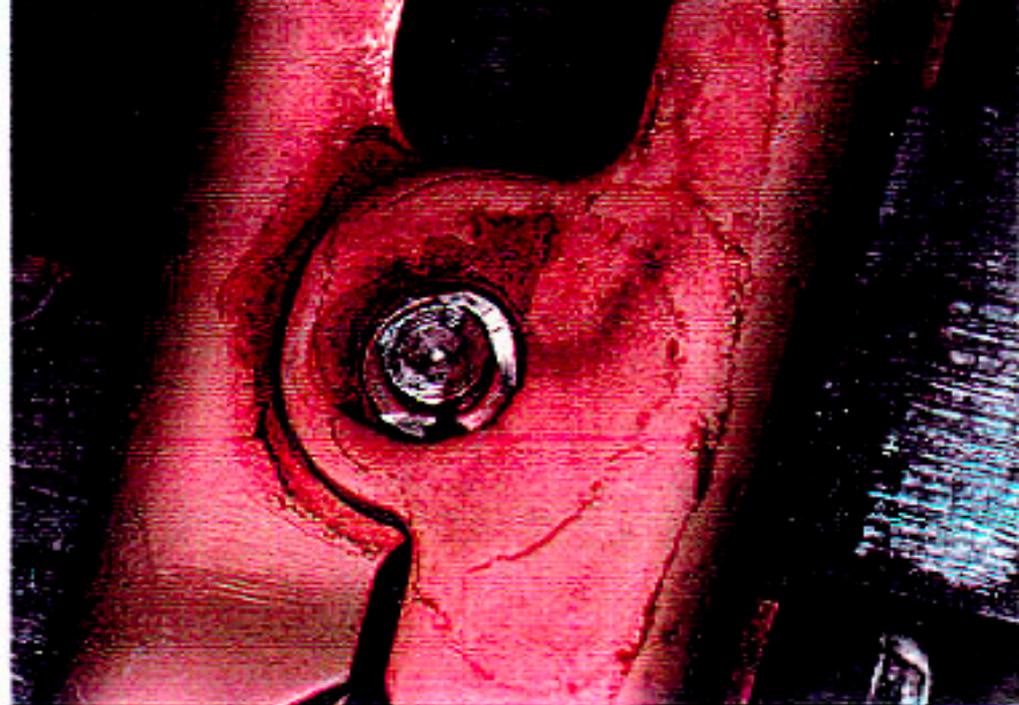
Detail of damage to top of stepped pivot pin, No 3 right side latch.

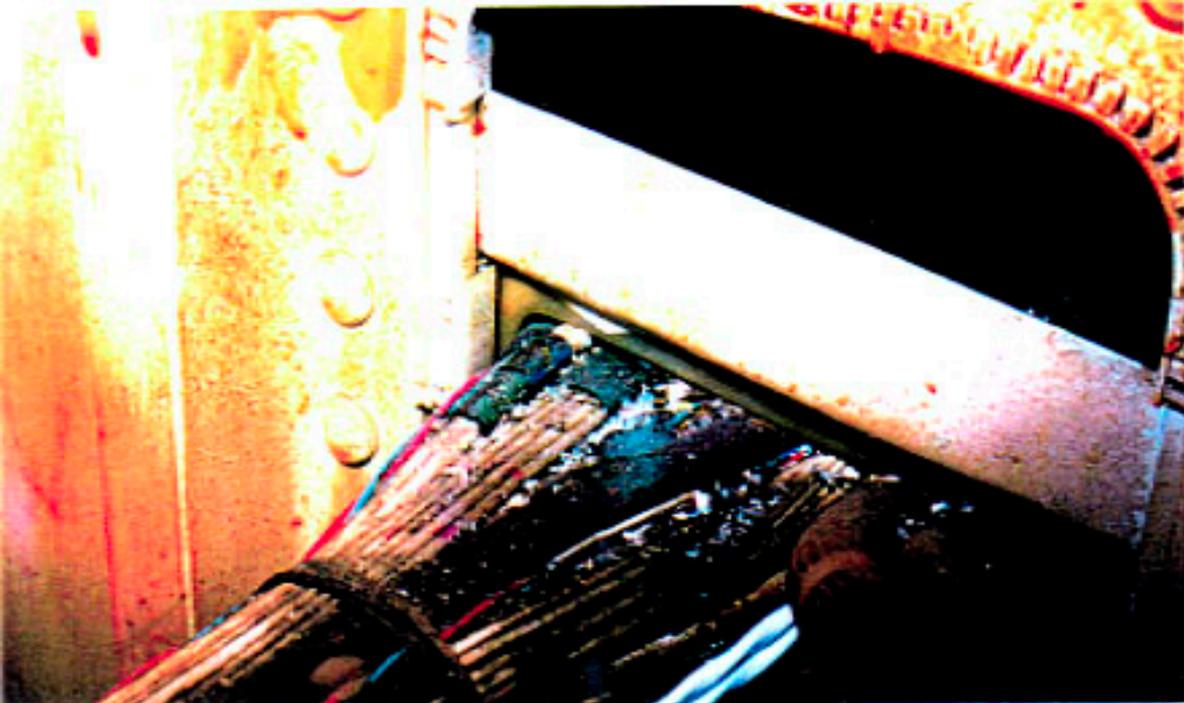
Contamination of wiring looms by drilling swarf, found in a retired B747, above, and an A300, below.
