## Crash after takeoff, Boeing 747-2B5F, HL-7451

**Investigative Body: Aircraft Accident Investigation Board (AAIB), United Kingdom**

## S2/2000 - Boeing 747-2B5F, HL-7451

### AAIB Special Bulletin No: S2/2000

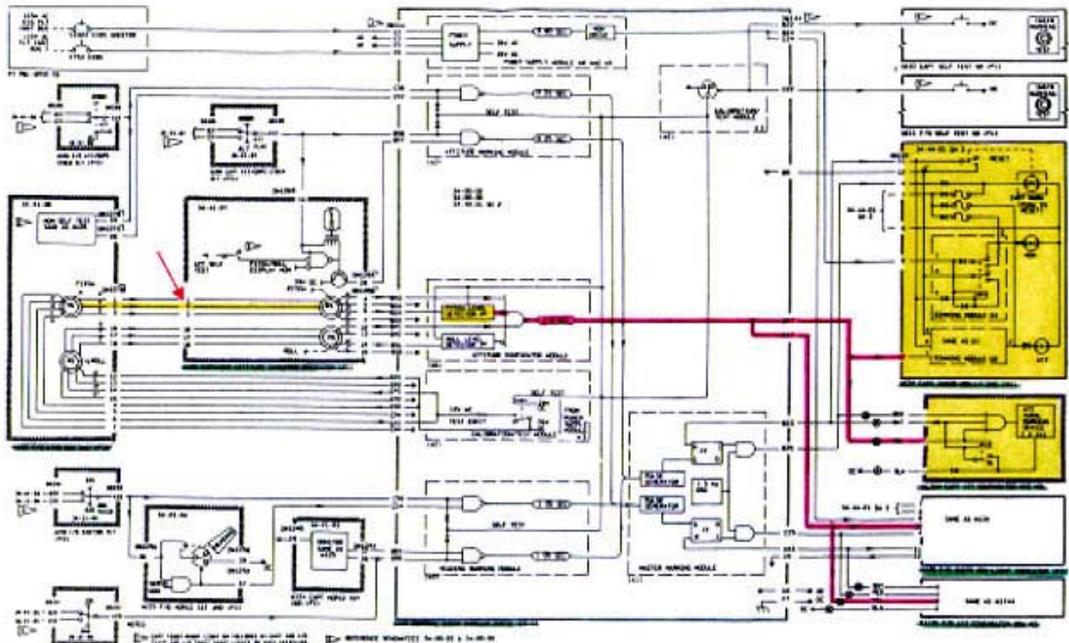
### Appendix D - Figure 1 - Central Instrument Warning System Schematic

Location of 'displaced' pin No 2, plug J1, arrowed

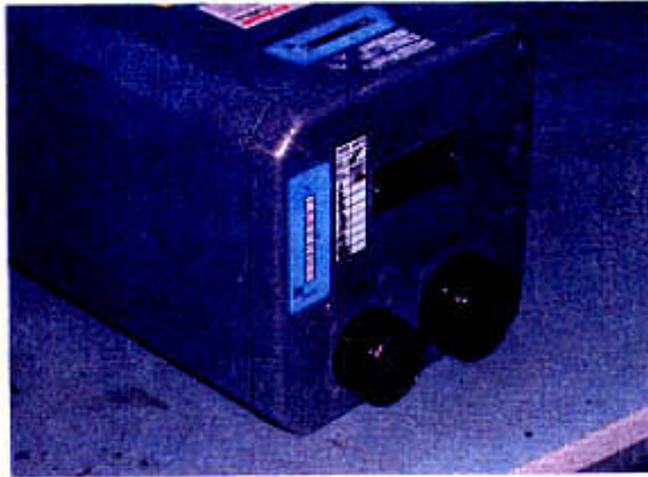
Appendix D  
Figure 2

Illustrating location of multi-pin connectors J1 and J2

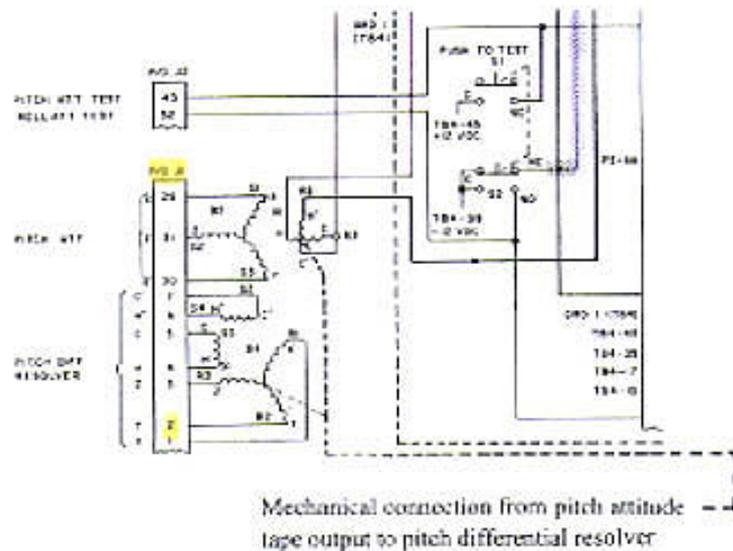
Section of Indicator Circuit Diagram Showing Internal Wiring from Connector J1 pin 2

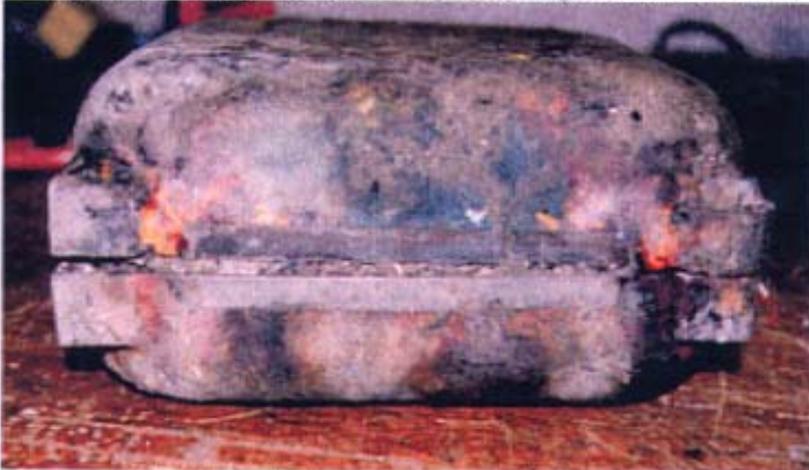
The crash protected thermal enclosure containing the tape was found in the impact crater one week after the accident. It had become separated from the rest of the unit that was also found within the crater. The ULB was found completely detached approximately 10 metres from the edge of the crater. The front panel was never found. Appendix G, Figure 1 shows the damage. The enclosure itself had suffered an impact severe enough to break two of the bolts that secure the two halves of the enclosure together, allowing partial separation (see Appendix G, Figure 2). This could have allowed heat to penetrate the enclosure, but on examination the tape itself was essentially undamaged (Appendix G, Figure 3).

Crash Protected enclosure (showing separation of the two halves)

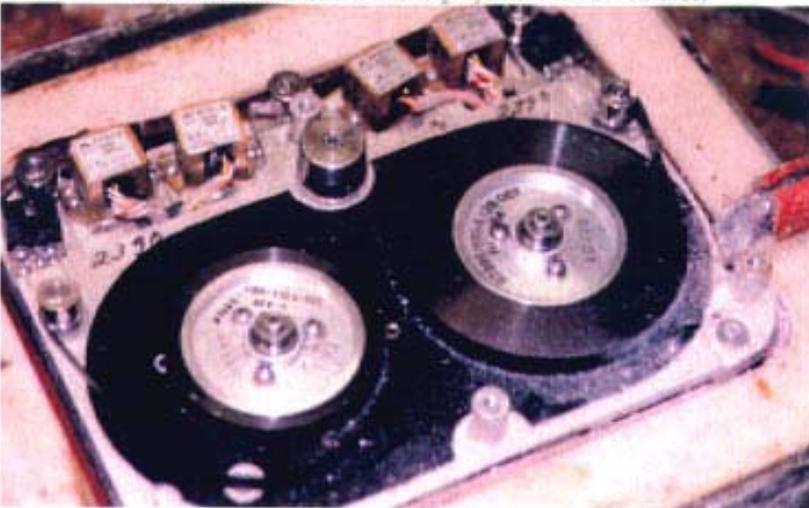
Magnetic tape inside crash protection

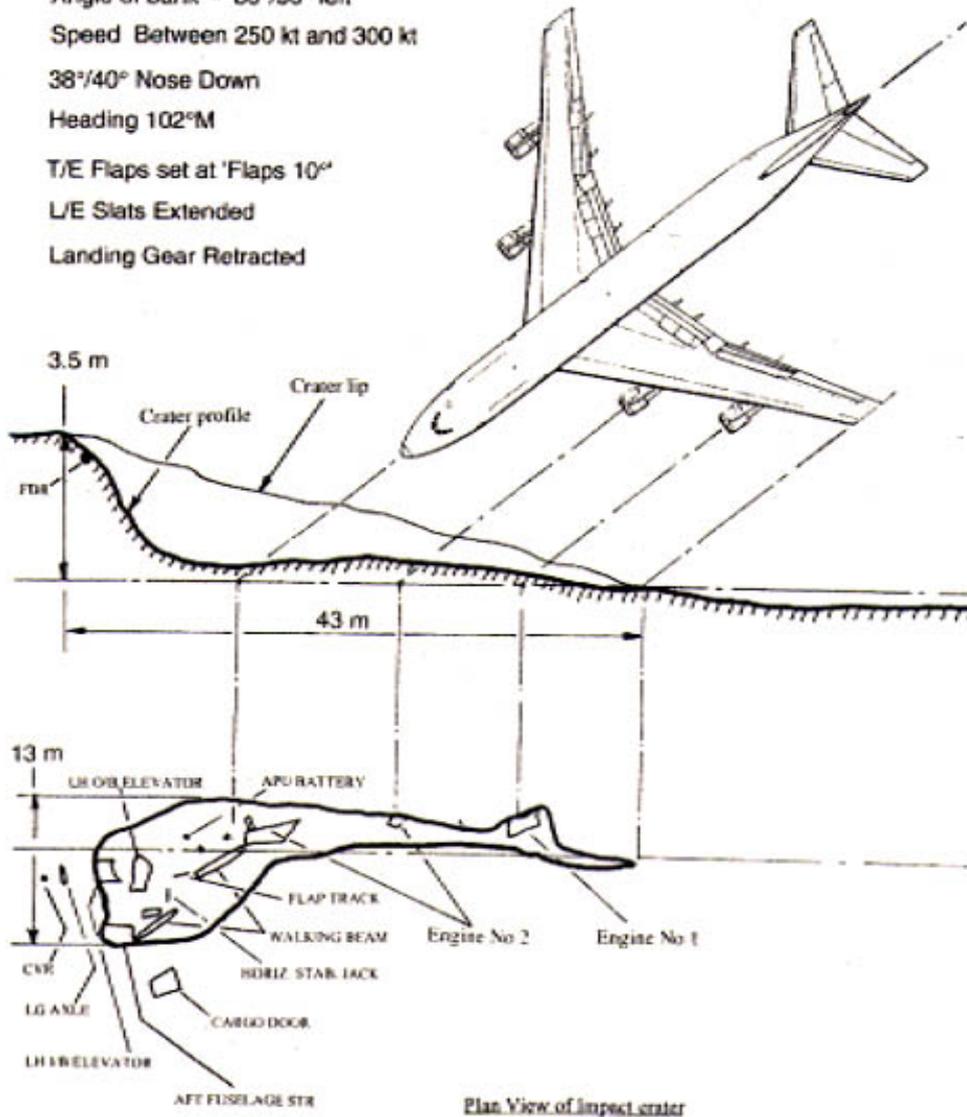
Angle of bank - 80°/90° left  
Speed Between 250 kt and 300 kt  
38°/40° Nose Down  
Heading 102°M  
T/E Flaps set at 'Flaps 10'  
L/E Slats Extended  
Landing Gear Retracted

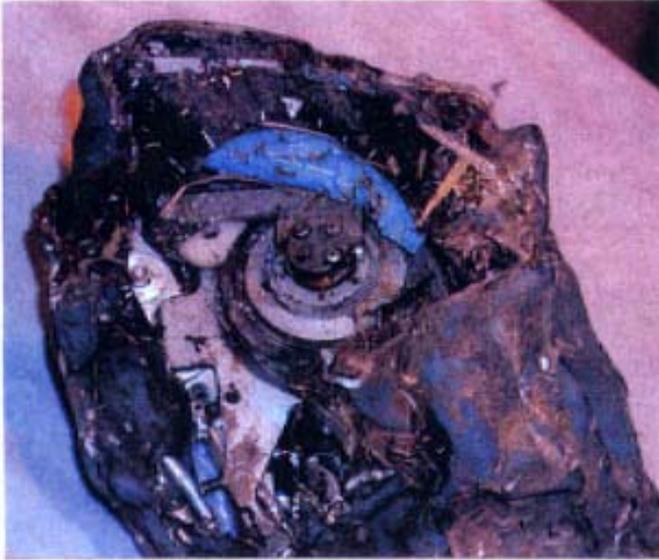
Figure 1

**FRONT VIEW OF INDICATOR AS FOUND**

(Compare with Appendix O Figure 1)

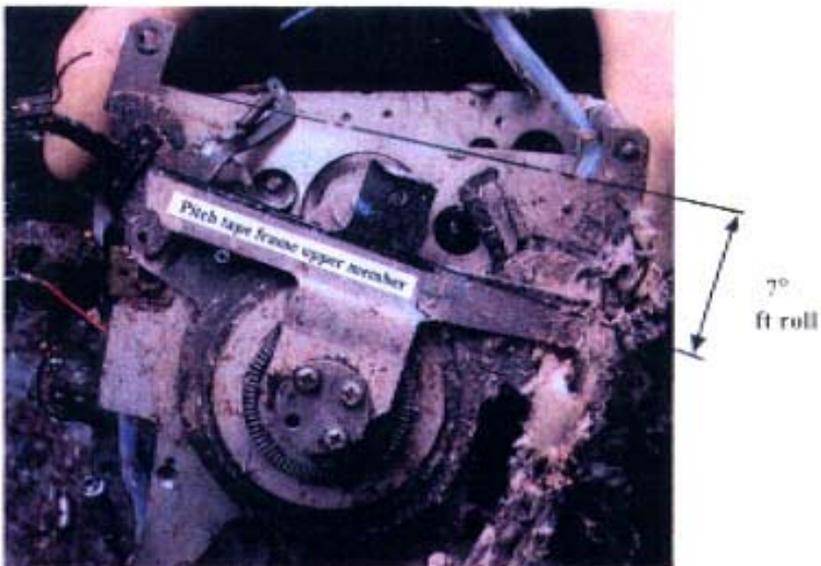
Figure 2

**ASSESSMENT OF INDICATED ROLL ANGLE  
ALLOWING FOR DISTORTION**

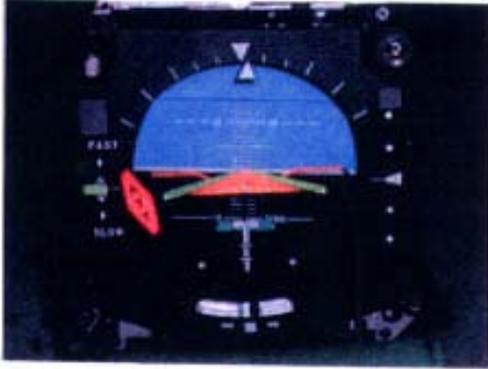
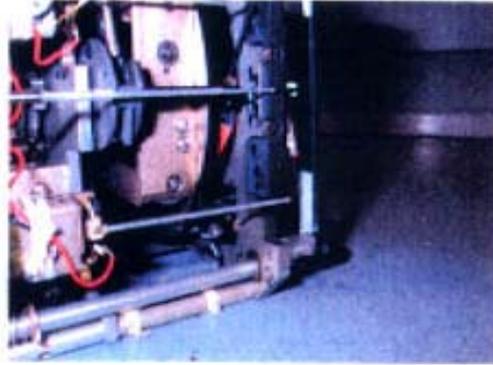
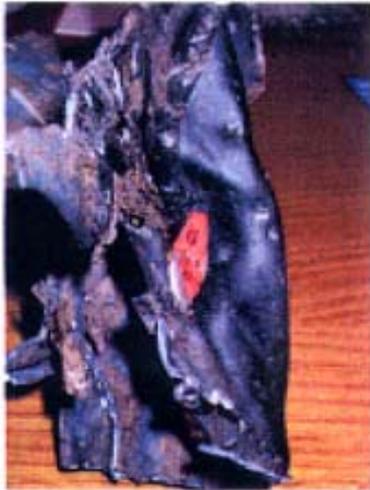
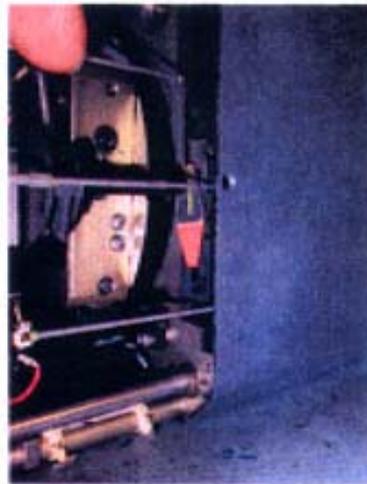
Appendix M  
Figures 3 - 6

GYRO flag in view seen from front and rear

GYRO flag as-found, seen from the front, crimped between the folds of the FDI case sidewall. Angle of flag, in relation to front and top edge of the casing, is similar to the flag out of view position

GYRO flag out of view seen from the rear

ASSESSMENT OF GYRO FLAG POSITION PRIOR TO IMPACT

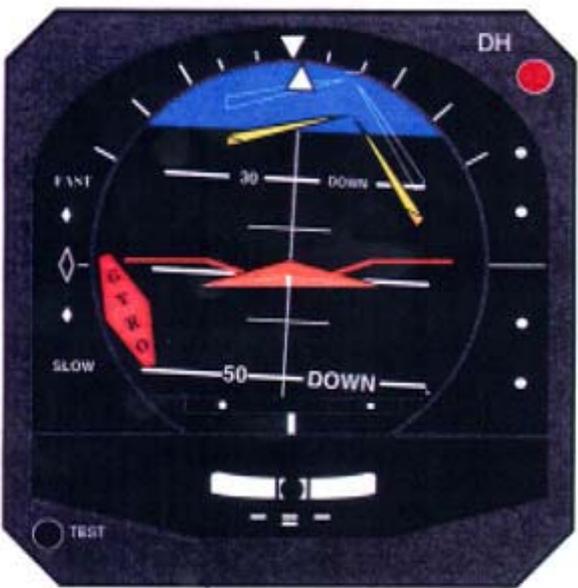
Figure 1

DIAGRAM OF ESTIMATED FDI PRESENTATION AT MOMENT OF IMPACT

Yellow command bars drawn at maximum normal fly UP (15°) and RIGHT (20°) position, roll attitude indicating approx. 2.5° LEFT roll  
(White command bars represent as-found position, derived from FDI strip examination)

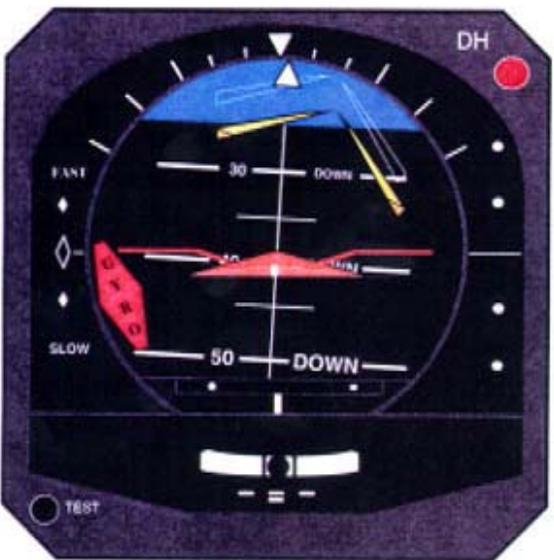
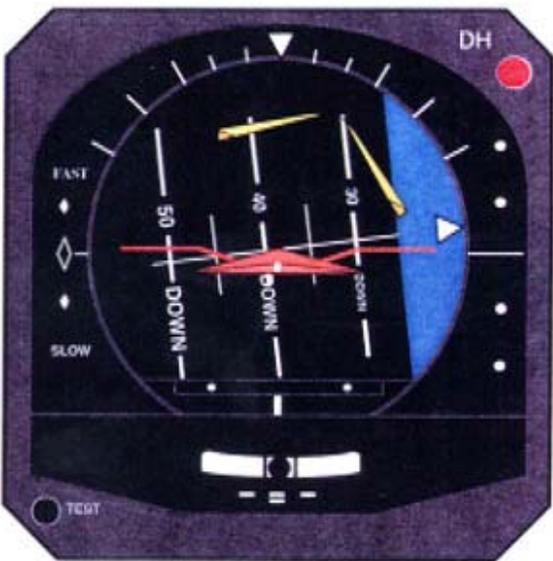
Appendix P

### DIAGRAM OF ESTIMATED FDI PRESENTATIONS AT MOMENT OF IMPACT
