Hard landing, BAe 146-200, G-JEAJ

BAe 146-200, G-JEAJ

AAIB Bulletin No: 10/2000 **Ref: EW/C2000/6/2** **Category: 1.1**

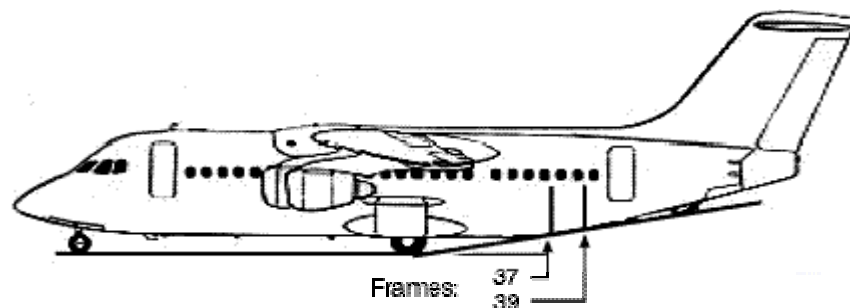
It was apparent that light scrape 1.57 metres long and approximately 0.27 metres wide had occurred on the underside of the rear fuselage. The damaged area extended from just ahead of Frame 37 to the forward face of Frame 39. Frame 37 was close to the aft edge of the baggage door on the left side of the fuselage, with the rear pressure bulkhead being joined to the fuselage skin at Frame 45. Additionally, there had been a light strike on the tail bumper, which is attached to the air conditioning equipment bay door aft of the rear pressure bulkhead. The area of damage is indicated on the sketch below.

Apart from the loss of paint, the skin had suffered light abrasion but had not been penetrated. Some dimpling had occurred in the areas between the stringers and frames in the centre of the panel. After removing the floor panels in the baggage area the dimpled areas of skin could be inspected. No cracking had occurred and the frames and stringers were undamaged. The subsequent inspection at the operator's maintenance base revealed no additional damage, and the aircraft was returned to service following replacement of the skin panel.

The commander concluded that, whilst he may have retarded the throttles slightly early in the flare, the sink rate had developed probably due to a downdraft from adjacent buildings or the variable wind direction. Whilst he recollected applying some power, it was insufficient to arrest the sink rate

and the aircraft touched down early in a nose high landing attitude leading to the fuselage scraping the ground.
