Pitch-up moment, Fokker F28 Mark 0100, G-BYDN, 3 November 2000 at 1945 hrs

Fokker F28 Mark 0100, G-BYDN, 3 November 2000 at 1945 hrs

AAIB Bulletin No: 8/2001 Ref: EW/C2000/11/02 Category: 1.1

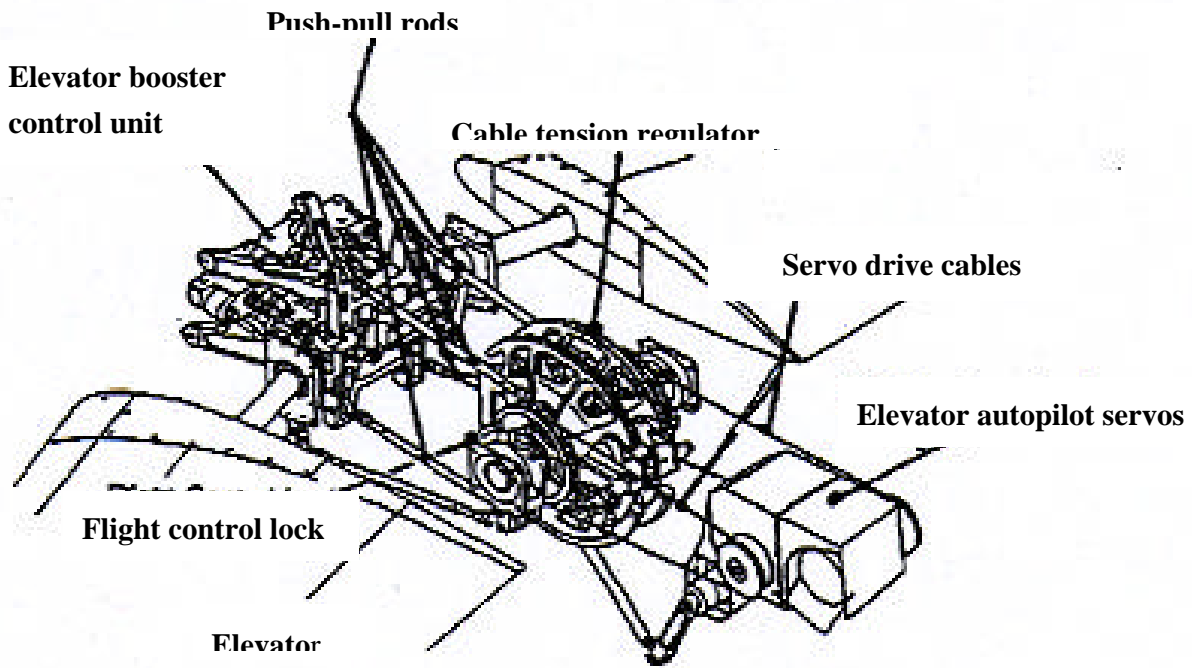
Figure 4. Elevator controls in bullet fairing

Following the incident the aircraft was examined by the operator's usual maintenance organisation. The elevator servo cables, which run between the servo motor cable drums and the elevator cable tension regulators, were found to be slack. Other, minor defects were also found; these included slightly reduced elevator up travel, lack of lubrication on the right hand tension regulator cross-head shaft and excessive friction on the manual trim wheel. No circuit breakers had tripped during the incident.

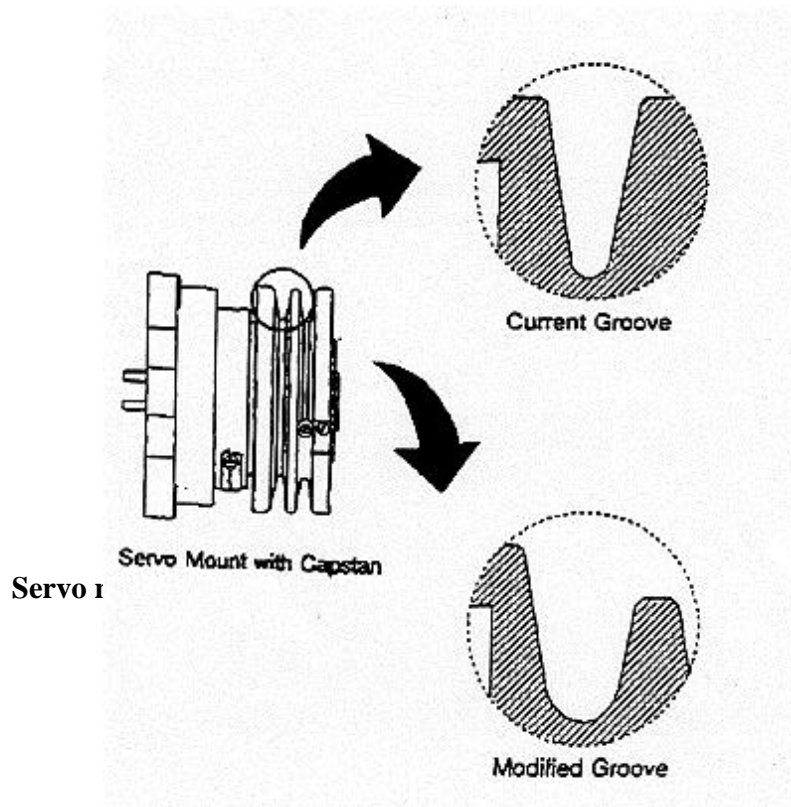
Figure 5. Modification to servo motor capstan cable grooves as per Service Bulletins SBF100-22-039 and SBF100-22-047

The aircraft manufacturer had received reports of a number of events that occurred in the early 1990's which involved high elevator forces following a manual disconnection of the autopilot. Investigation revealed that under certain conditions of temperature and humidity, ice could accumulate in the elevator servo cable groove such that it impeded the movement of the cable in the groove. Deflection of the elevator caused the ice to break away, thus restoring normal control forces. A temporary solution was the issue of Service Letter No 134. This advised operators to apply silicon grease to the servo cable capstan at intervals of 250 flying hours.

In 1994 a Service Bulletin, SBF100-22-039, was issued which introduced a modified servo mount capstan. The cable grooves were of a different profile, wider and with lower flanges, as shown in Figure 5. Whilst ice could still form, the breakout forces were reduced. The SB was eventually incorporated on the aircraft production line, but remained optional for existing operators. G-BYDN did not have the SB embodied although one of the two other aircraft in the operator's fleet did. Following the incident the operator stated its intention to modify its aircraft with a superseding Service Bulletin, SBF100-22-047, (see below) as soon as parts became available. Pending parts availability the instructions contained in Service Letter No 134 would be carried out.

Fokker Services BV should issue an All Operators Letter or similar, drawing attention to the possibility of ice accretion on the elevator servo capstan in cold humid conditions. Operators should be advised to comply with Fokker SB 100-22-039 (or relevant superseding Service Bulletin) at the earliest practicable opportunity. This introduces a revised capstan groove with less possibility of jamming. Pending the availability of parts, operators should additionally be urged to implement the intent of Service Letter No 134, which calls for greasing of the elevator servo cables at intervals of 250 flying hours.

In order to reduce the potential for elevator control restriction due to ice accretion on the elevator servo capstans of Fokker F100 aircraft, the Dutch Civil Aviation Authority confer mandatory status on Fokker Service Bulletin SB F100-22-039 (or relevant superseding Service Bulletin), that introduces a revised capstan groove.
