## Uncontained engine failure, Fokker F27 Mk 500 Friendship, G-CEFX

# Fokker F27 Mk 500 Friendship, G-CEXF

<b>Aircraft Accident Report No: 4/2004 (EW/C2001/6/5)</b> .....	<b>3</b>
<b>Synopsis</b> .....	<b>4</b>
<b>1. Factual Information</b> .....	<b>6</b>
1.1 History of the flight.....	6

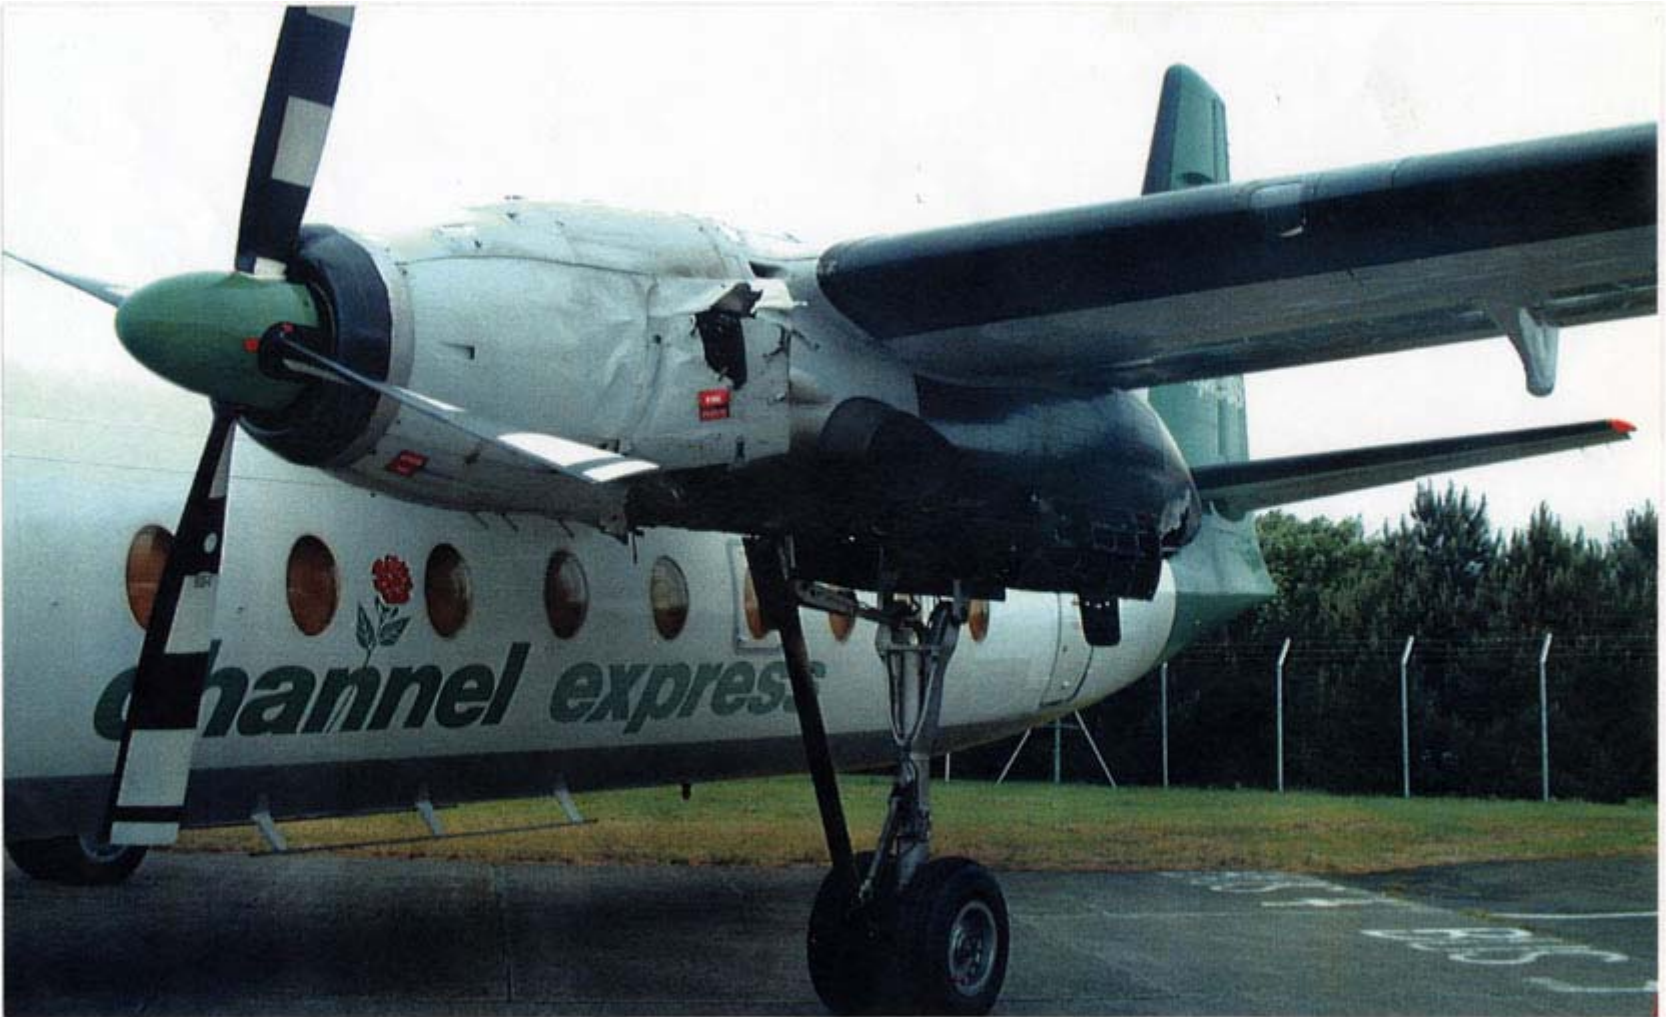
**Figure 1 General view of left nacelle showing external damage**

Aircraft damage consisted of severe disruption and fire damage to the No 1 powerplant, landing gear doors and engine nacelle, and minor damage to the left Main Landing Gear (MLG) and propeller, Figure 1.

Examination of the aircraft at Jersey Airport revealed all damage to be confined to the left engine and its nacelle, left propeller and left main landing gear (MLG). The left engine hinged cowls had remained in place but exhibited two major exit holes, one each in the outboard and lower cowls, in line generally with the plane of rotation the HPT. Severe distortion was present to one of the steel struts of the engine support frame adjacent to the lower left attachment at the firewall, where the

The left engine cowl doors had remained in place but ragged holes had been punched in the outboard and lower doors in the region of the HPT and it was evident that this had been caused by impact from engine debris. There was evidence of only slight fire damage to the inside of these doors but major fire damage was present to the lower section of the nacelle from the firewall to its aftmost point. In many areas, holes had been burnt through the nacelle skins.

GENERAL VIEW OF LEFT NACELLE SHOWING EXTERNAL DAMAGE

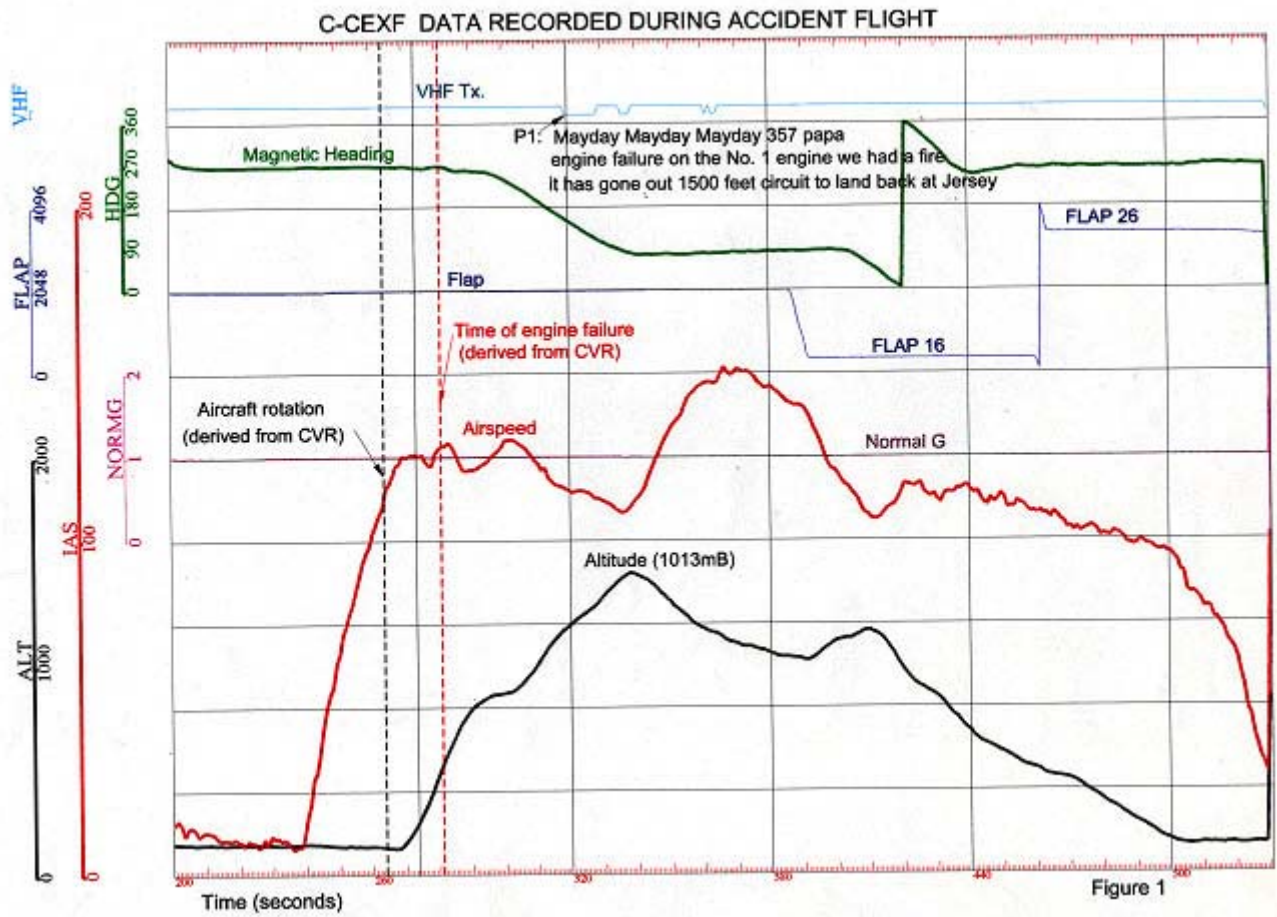
Figure 6 G-CEXF data recorded during accident flight

The CVR and FDR recordings were time correlated using the VHF transmissions from the aircraft. From this it was possible to identify the point at which the engine failed on the FDR time history and a plot of the recorded FDR data is at Figure 6. From this it was determined that the engine failure occurred 17 seconds after takeoff, by which time the aircraft was approximately 400 feet above the runway (670 feet amsl). The absence of recorded aircraft attitude prevented any analysis of the aircraft's behaviour when the engine failed or during the subsequent circuit and landing.

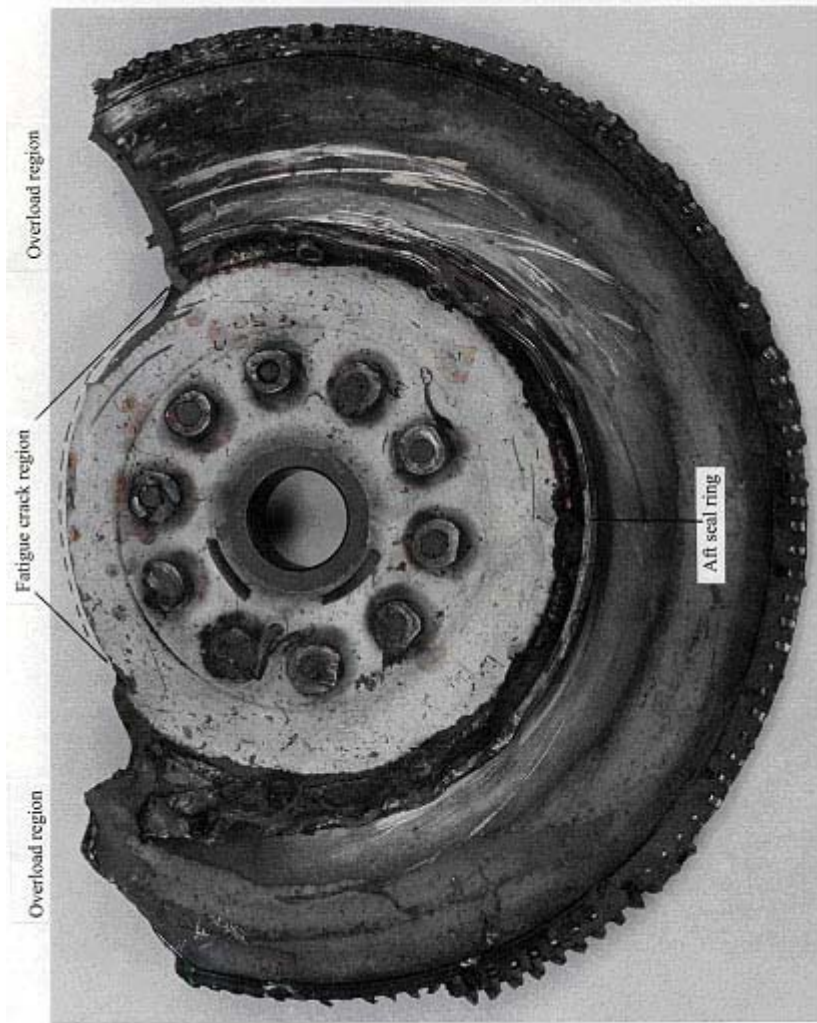
Figure 7 Major segment of HPT disc

The disc portion recovered measured some 15 x 11.5 inches overall and weighed 7.973 kg (17.57 lb), Figure 7. The main part of the disc fracture was circumferential, following the inner radius between the disc aft seal arm and the diaphragm around approximately 40% of the circumference. There was an approximately radial fracture at one end, and a secondary circumferential fracture at the other, which also led to an approximately radial fracture. The face of the main circumferential fracture was mostly flat, and generally banded with a series of light-coloured conchoidal markings. The fracture face had not suffered any appreciable impact damage and only minimal degradation by oxidation. The secondary fracture was also generally flat and similarly marked, Figure 8.

MAJOR SEGMENT OF HPT DISC (view on rear face)

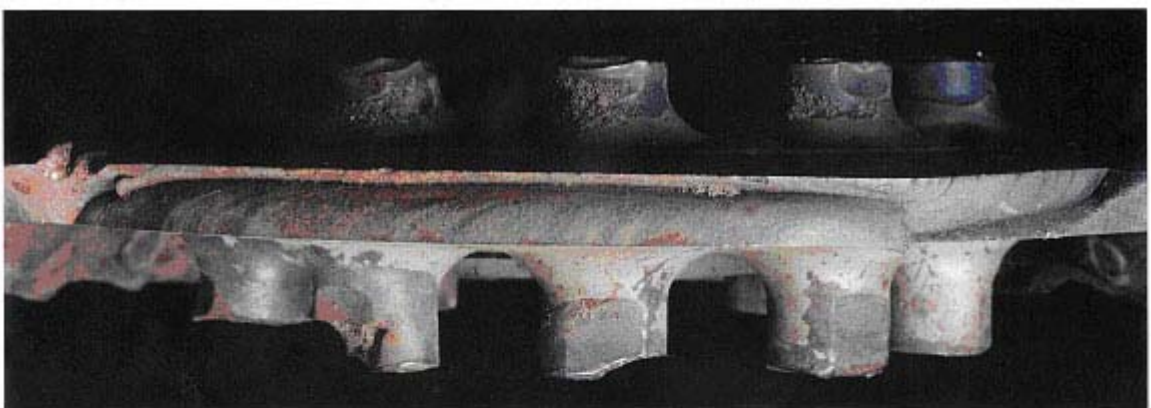
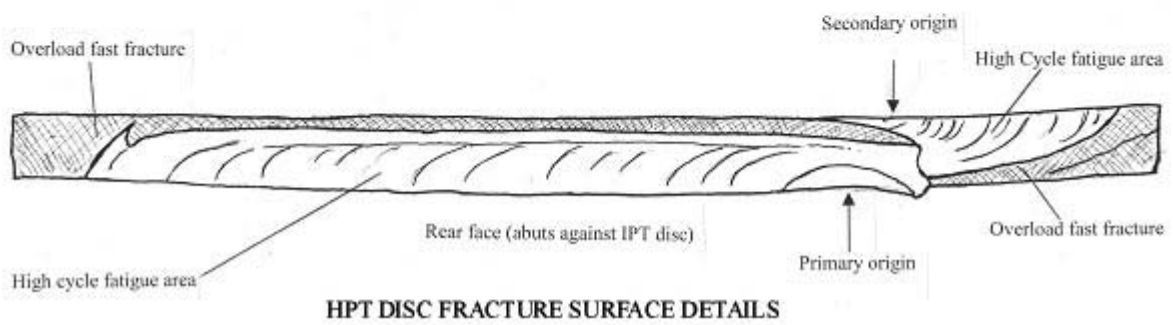
Figure 8 HPT disc fracture surface details

The main fatigue fracture surface exhibited between 35 to 50 (or possibly more) lighter coloured narrow bands, with darker regions between. It was concluded that each light region was an arrest band that represented a divider between separate periods of vibration that had been sufficient to cause crack growth in HCF during the propagation stage. It was not possible to correlate the arrest bands to flight cycles. On the strikingly similar fracture faces on the HPT from another HPT disc failure on G-OJEM (see paragraph 1.16), some indistinct striation features were evident in the HCF areas between the bands, but the available detail was insufficient to allow an accurate striation count over the fracture surface. The best estimate of striation densities, in that event, was in the order of 20,000 per millimetre, and HCF load reversal cycles involved in the propagation of the crack was estimated to be in the order of one to five million.

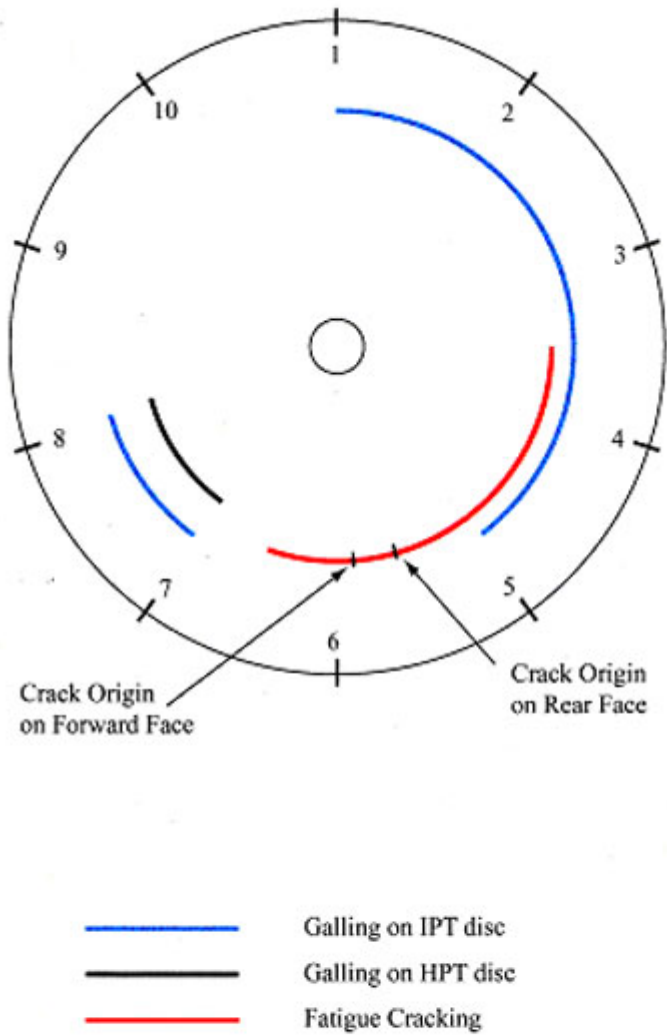
Figure 12 Relative damage locations HPT / IPT seal arm abutment faces / Fatigue Cracking

In the case of G-CEXF, evidence was found of fretting/galling on the HPT to IPT disc seal arm abutment faces, and the location of this damage relative to the fatigue crack is illustrated in Appendix C-3. The seal arm face on the IPT disc showed generally light galling, judged not to be of significance in a loss of dimension context, but this was visibly more severe over the arc between

bosses 1 to 5. Light galling was also present between bosses 7 and 8 on both the HPT and IPT discs, although the loss of the smaller disc segment precluded examination of the seal arm face between, approximately, boss locations 3 and 6. Expert examination by tribologists from the manufacturer indicated that such wear could be consistent with the results of a 'rolling contact' type of mechanism, (see paragraph 1.18.3.6). The taper bolt hole location bosses were examined to determine if any obvious wear was evident on the contact surfaces. All these contact surfaces on the forward side of the disc were free from any evidence of wear. On the rear side of the disc, five of the bosses surfaces were damaged, and this precluded comment on their pre-failure condition. Optical binocular microscopic examination of the remaining four found them to be free of evidence of significant wear, although some patchy black, thin deposits were seen on several. The thickness of the material was assessed as being less than  $0.1 \times 10^{-3}$  inches; analysis of this material found it to be consist of oxides of the disc material. However, residual machining marks were still clearly discernable on the boss faces, indicating that there had been little or no relative motion between the discs.

Relative Damage locations HPT / IPT seal arm abutment faces / Fatigue cracking
