Grinding sound on takeoff, Boeing 727-230F, OO-DHY

Boeing 727-230F, OO-DHY

AAIB Bulletin No: 12/2003	Ref: EW/C2002/11/04	Category: 1.1
INCIDENT		
Aircraft Type and Registration:	Boeing 727-230F, OO-DHY	
No & Type of Engines:	3 Pratt & Whitney JT8D-15 turbofan engines	
Year of Manufacture:	1975	
Date & Time (UTC):	19 November 2002 at 0328 hrs	
Location:	East Midlands Airport, Derby	
Type of Flight:	Public Transport (Cargo)	
Persons on Board:	Crew - 3	Passengers - None
Injuries:	Crew - None	Passengers - N/A
Nature of Damage:	Damage to No 1 engine	
Commander's Licence:	Airline Transport Pilot's Licence	
Commander's Age:	53 years	
Commander's Flying Experience:	14,800 hours (of which 750 were on type)	
	Last 90 days - 90 hours	
	Last 28 days - 32 hours	
Information Source:	AAIB Field Investigation

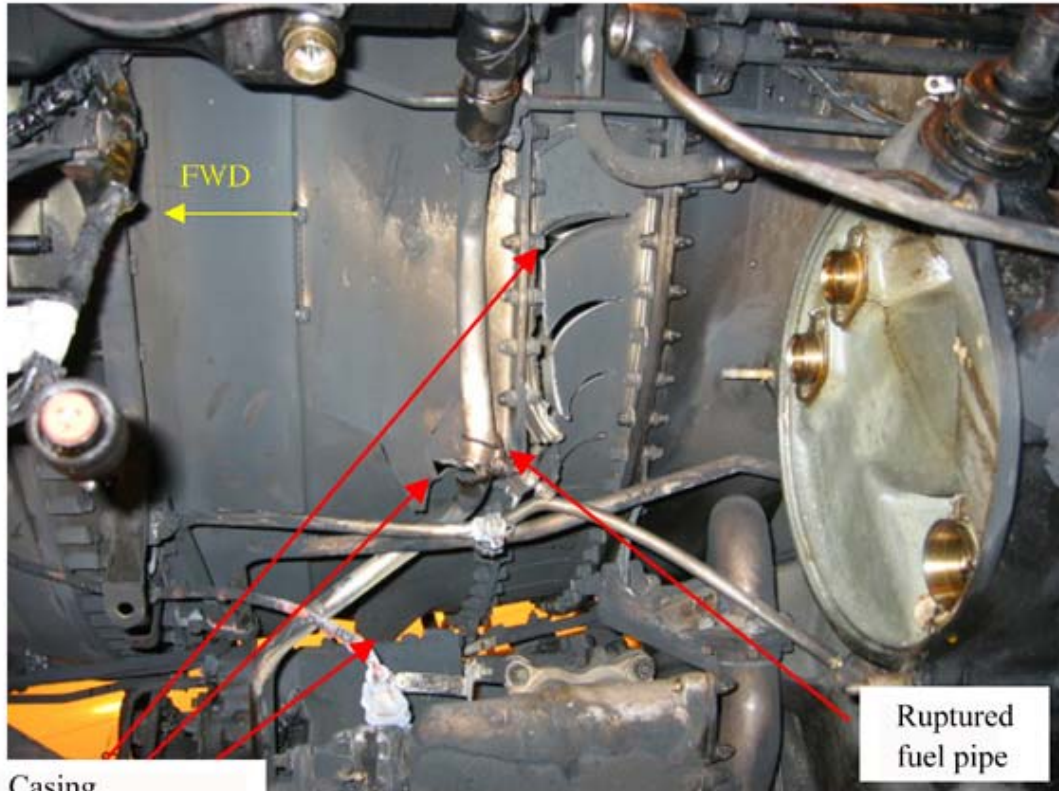
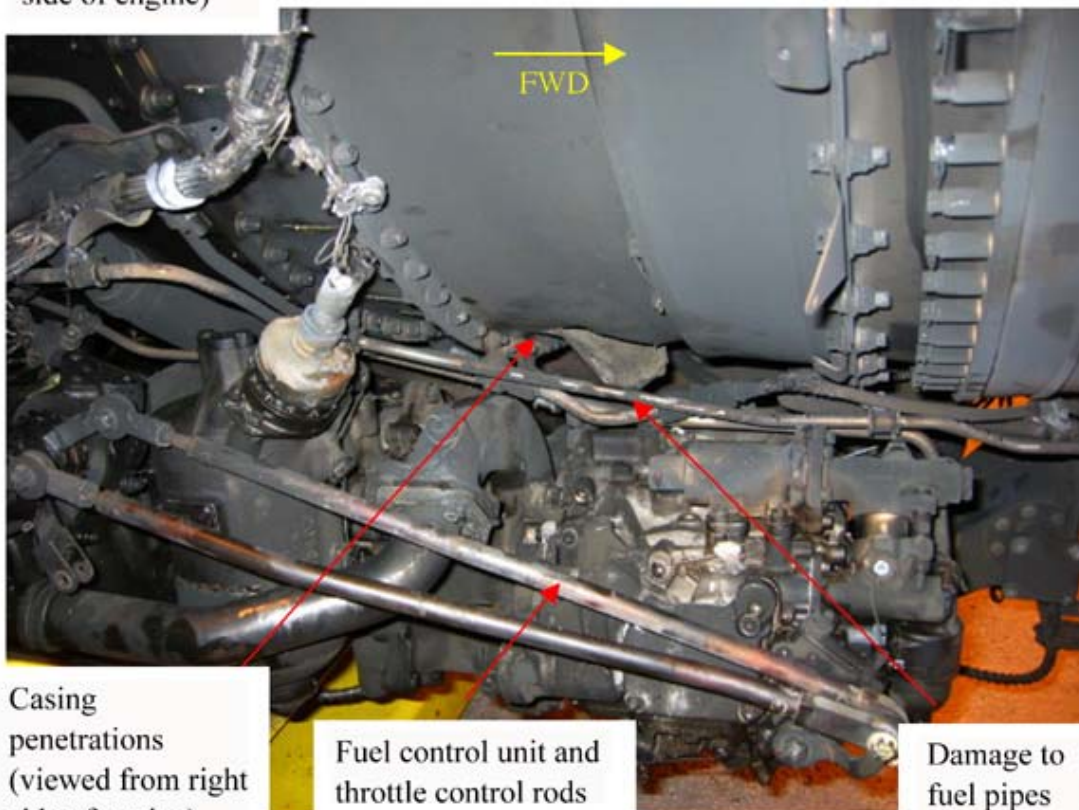
Figure 1 External Engine damage

No damage was evident externally, however, on opening the No 1 engine cowling there was evidence of significant fire damage centred around the underside of the engine. The fire has resulted in sooting and an oily residue around the outside of the engine casing and damage to wiring. The fuel control unit input rods showed signs of heat damage to the bearings. There was also evidence of penetration from inside the engine casing in the area of the discharge vanes in approximately the 5 o'clock position (viewed from the front). A small piece of debris was found within the cowling. Further examination revealed two penetrations of the engine casing around the 5 and 7 o'clock positions with damage to the oil tank and a ruptured fuel pipe (see Figure 1). Furthermore, some liberated material had penetrated and passed through the core of the engine, with some solidified metal spatter visible in the tail pipe. Visual examination of the LP compressor first stage showed moderate damage to both leading and trailing edges of the stator and rotors.

Casing penetrations (viewed from left side of engine)

The penetration marks on the fan case were consistent with fan blade release kinematics. The initial blade tip impact was in the plane of rotation and the impact of the blade root was aft of the plane of rotation. Both impacts tore the containment case. It is probable that no significant material exited through these penetrations as only one piece of blade strap material was recovered from inside the cowling. There was no evidence of cowl penetration.

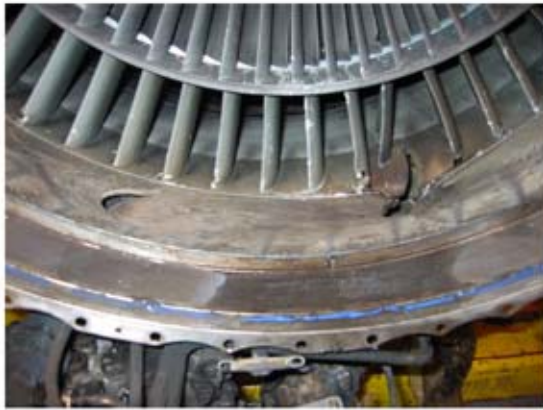
A boroscope examination and partial engine strip revealed that a second stage LP compressor fan blade had detached. A portion (approximately 2/3 span) of the blade had been retained within the casing. The blade had fractured at the root attachment that consisted of two clevis-type straps. The attachment pin was intact and still in place (see Figure 2).

Second stage assembly removed - casing penetrations at 5-7 o'clock positions

The fan discharge vanes were severely damaged in the area of the case rupture and also in the 1 to 3 o'clock position. This appeared to have been caused by the liberated blade being dragged around just prior to final release or just after release. It is likely that the blade tip material exited via this route. There was also some damage to the core inlet guide vanes.

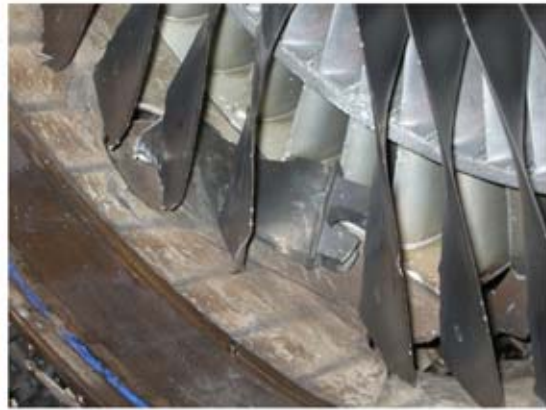
Second stage fan assembly - 'as found' position of detached blade

Visual examination of the blade root fracture surfaces revealed extensive post failure rubbing damage. Where the surfaces had not been destroyed there was evidence indicating ductile overload failure. One of the fractures had a stepped appearance unlike the other three and is therefore considered to be a possible initiation site for the failure, however, post-failure damage had destroyed any corroborative evidence. There was also some twist in the root section indicating that the forces on the blade were sufficient to deform it during the failure. It was also probable that the forward part of the root had failed first, with the rear failing in overload during the twisting.

It is recommended that the FAA, in conjunction with Pratt & Whitney review the inspection and re-inspection period for the LP compressor second stage fan blades as detailed in ASB 5729 and mandated in AD 87-14-01.

It is recommended that the FAA, in conjunction with Pratt & Whitney, mandate SB 5866 that provides a more durable second stage fan blade root attachment and a higher life second stage disk.

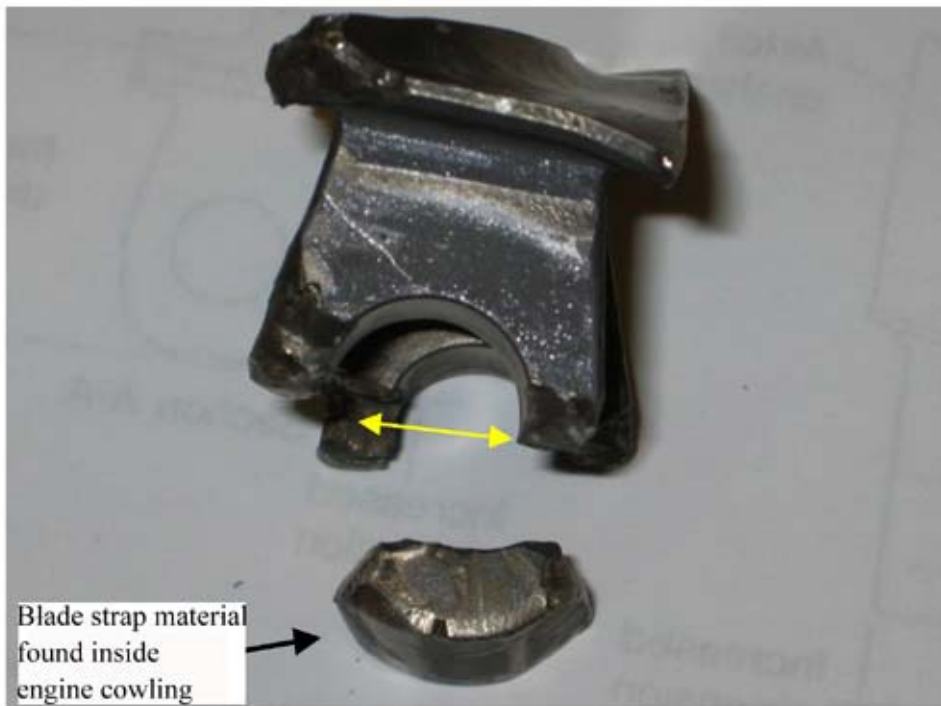
Blade strap material found inside engine cowling
