Nose gear cylinder failure while taxiing, Boeing 747-367, AP-BFV

Boeing 747-367, AP-BFV

AAIB Bulletin No: 11/2004	Ref: EW/C2002/12/01	Category: 1.1
Aircraft Type and Registration:	Boeing 747-367, AP-BFV	
No & Type of Engines:	4 RB211-524C2 turbofan engines	
Year of Manufacture:	1986	
Date & Time (UTC):	7 December 2002 at 2040 hrs	
Location:	London Heathrow Airport, Middlesex	
Type of Flight:	Public Transport	
Persons on Board:	Crew -15	Passengers - 457
Injuries:	Crew - None	Passengers - None
Nature of Damage:	Failure of the nose landing gear oleo outer cylinder	
Commander's Licence:	Airline Transport Pilot's Licence	
Commander's Age:	Not relevant	
Commander's Flying Experience:	Not relevant	
Information Source:	AAIB Field Investigation

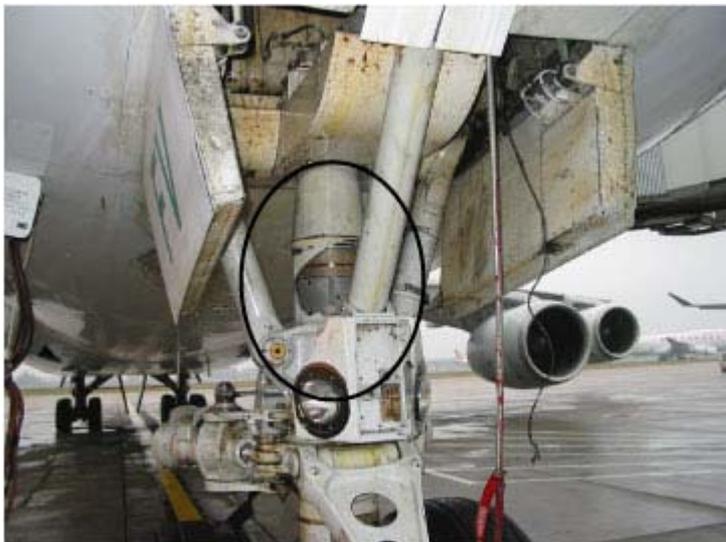
Figure 2

The nose landing gear outer cylinder had suffered a complete circumferential fracture resulting in a large section of the cylinder material being ejected onto the taxiway (see Figures 2, 3 and 4). The nose landing gear was removed from the aircraft and the upper section of the outer cylinder was dispatched to the aircraft manufacturer for a detailed metallurgical examination.

Nose landing gear showing the area of failure

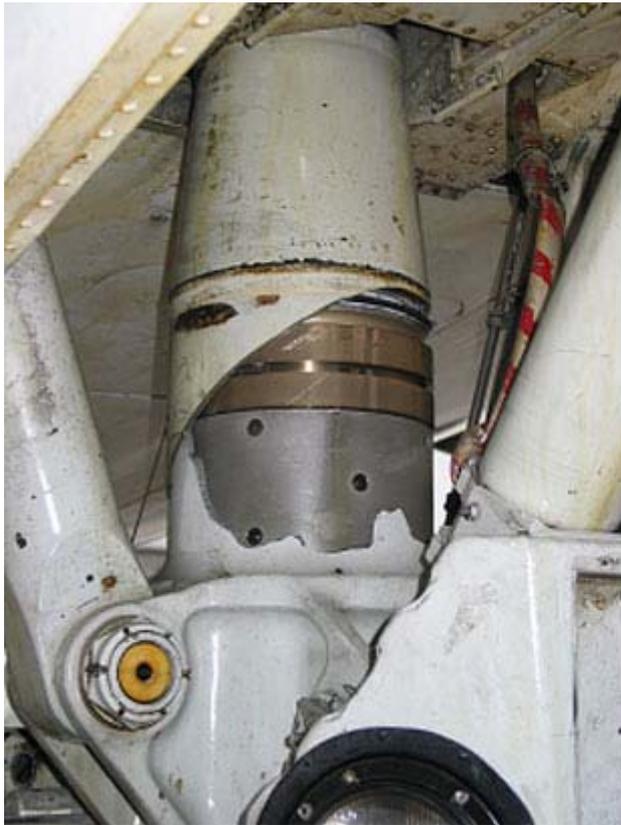
Figure 3

Nose landing gear outer cylinder showing the area from which the ejected section of cylinder material originated

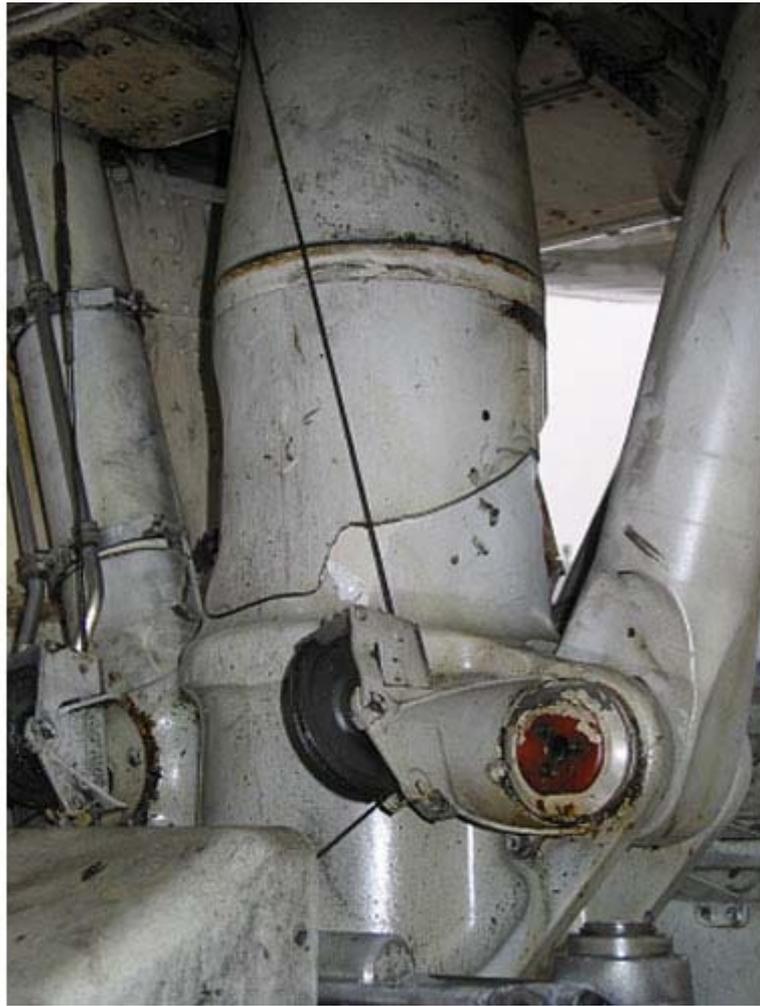
Figure 4

Nose landing gear outer cylinder showing the circumferential failure

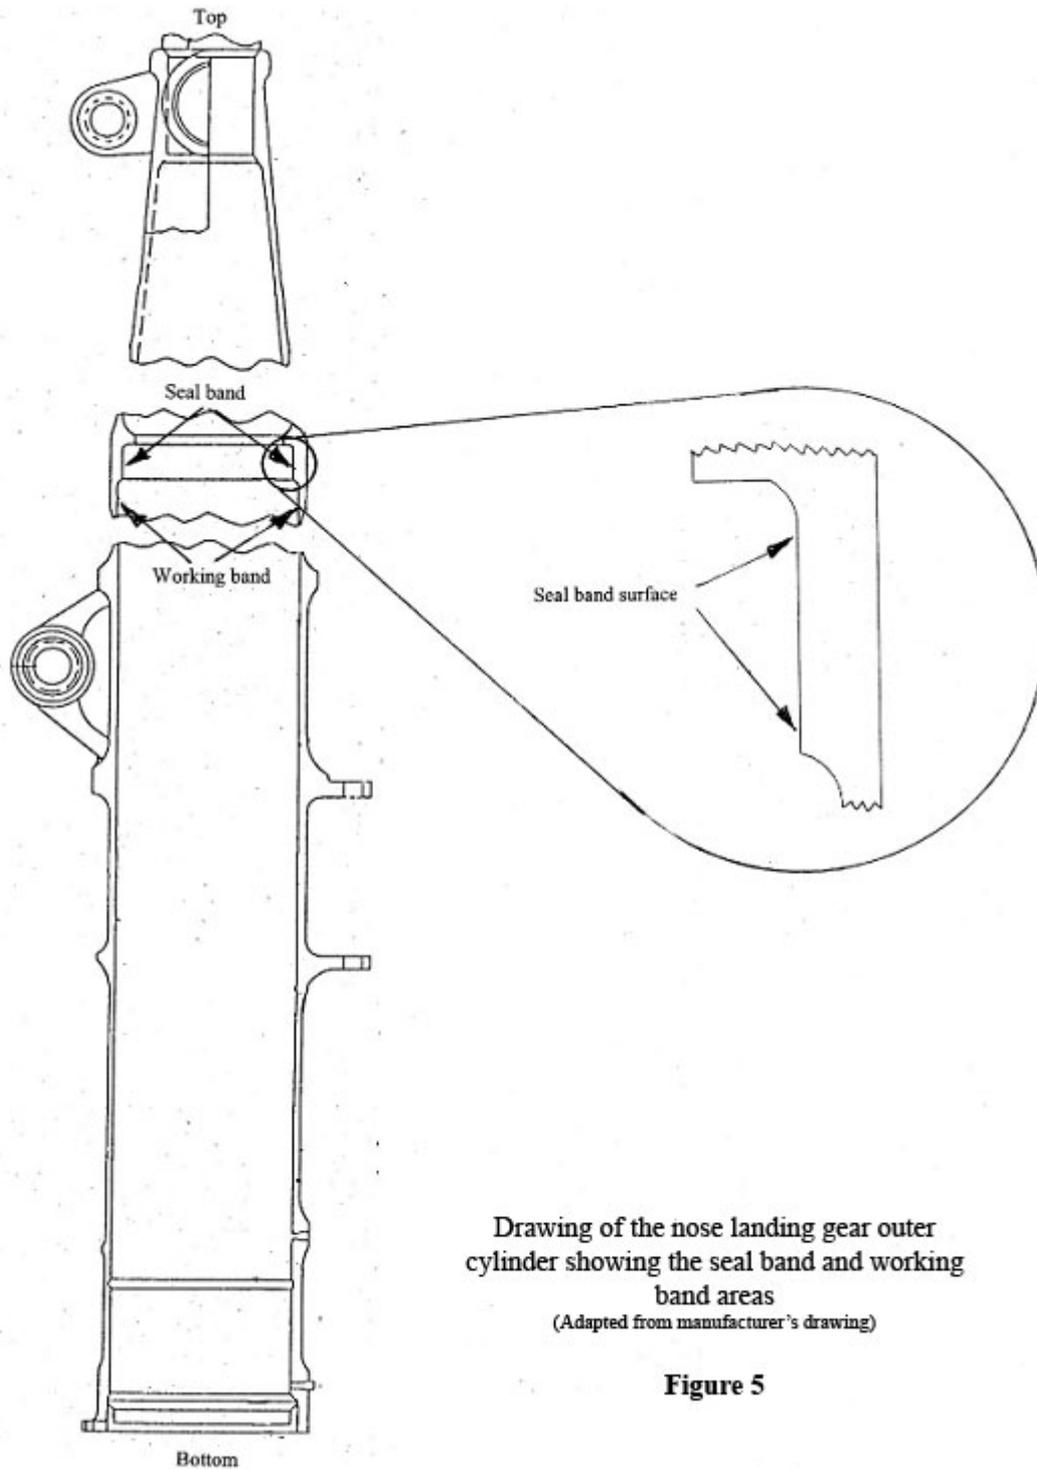
The metallurgical examination concluded that the fracture of the landing gear outer cylinder had occurred as the result of fatigue that had initiated at the base of a groove at the upper edge of the internal diameter (ID) seal band (see Figure 5 and Figure 6) and propagated through approximately half of the cylinder wall thickness prior to the final failure. The groove, square shaped in cross section and of an appearance that it had been made by a rotating cutting wheel, was machined into 70% of the internal circumference. The depth of the groove varied around the circumference. The deepest section was in the middle of the affected area where significant thinning of the outer cylinder wall thickness had introduced a critical stress concentration area. The groove was not part of the design, manufacturing or overhaul specifications.

Drawing of the nose landing gear outer cylinder showing the seal band and working band areas

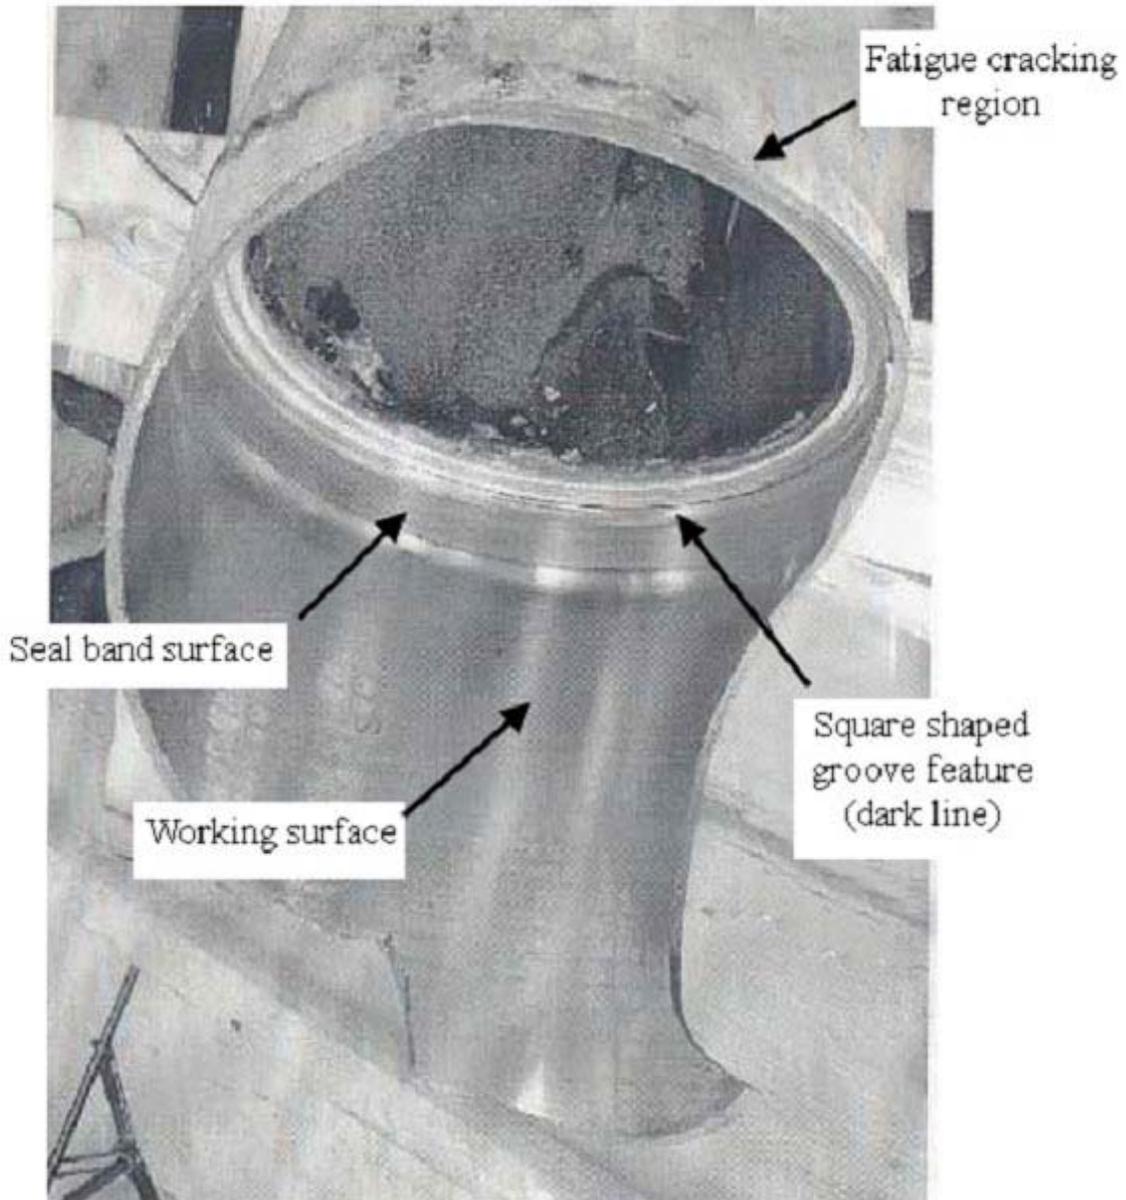
Figure 6

Upper section of the nose landing gear outer cylinder showing the area of the failure
(Photograph courtesy of Boeing Materials Technology)

The examination revealed a number of other deviations from the design, manufacturing and overhaul specifications in the area of the fatigue initiation. A blended depression was present at the transition between the seal band ID and the working surface ID that had resulted in localised outer cylinder wall thinning to a dimension below the minimum requirement. Some of the ID surfaces in the area of the fracture had been blended after nickel plating of the seal band surface. These areas showed no evidence of having been subsequently shot peened as required. Shot peening creates residual compressive stresses in the surface material which inhibits the development of fatigue cracks. A lack of shot peening left the material more prone to fatigue crack development.

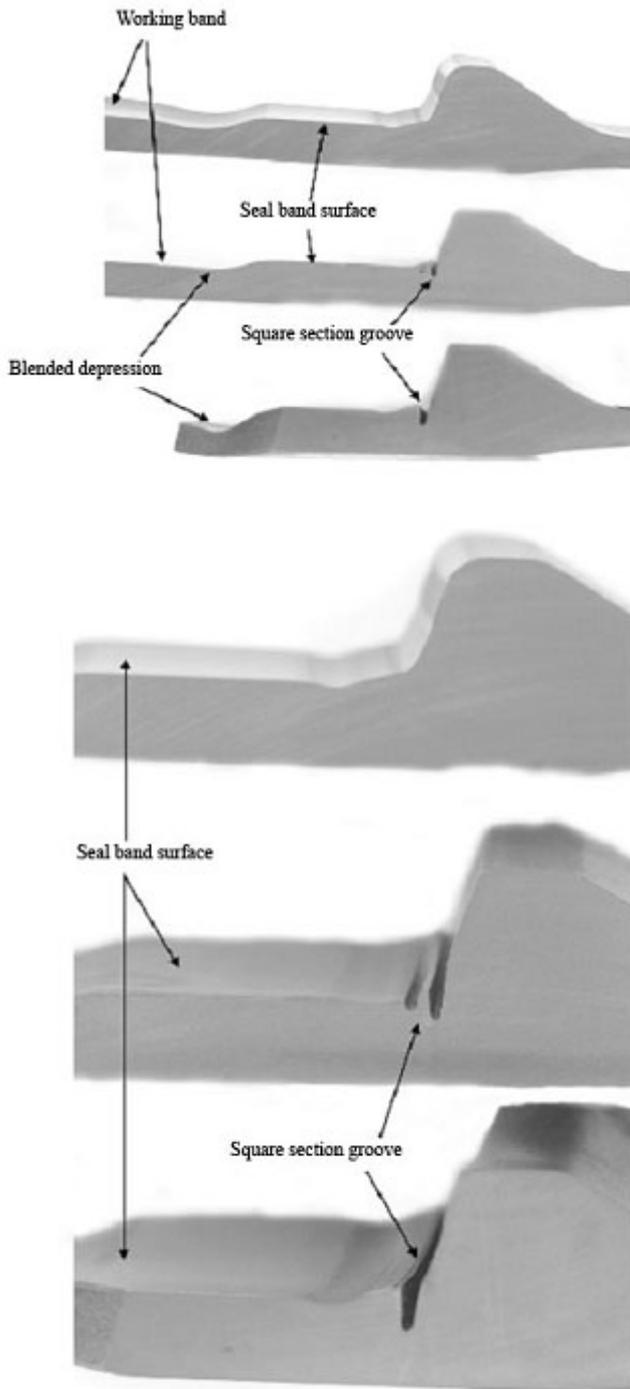
Figure 7

The manufacturer subsequently cut three vertical sections (see Figure 7) from the seal band area of the outer cylinder showing the internal profile and the square shaped groove in the area immediately above the seal band.

Two sets of photographs of the 3 vertical sections cut from the seal band area of the nose landing gear outer cylinder
(Photographs courtesy of Boeing Materials Technology)

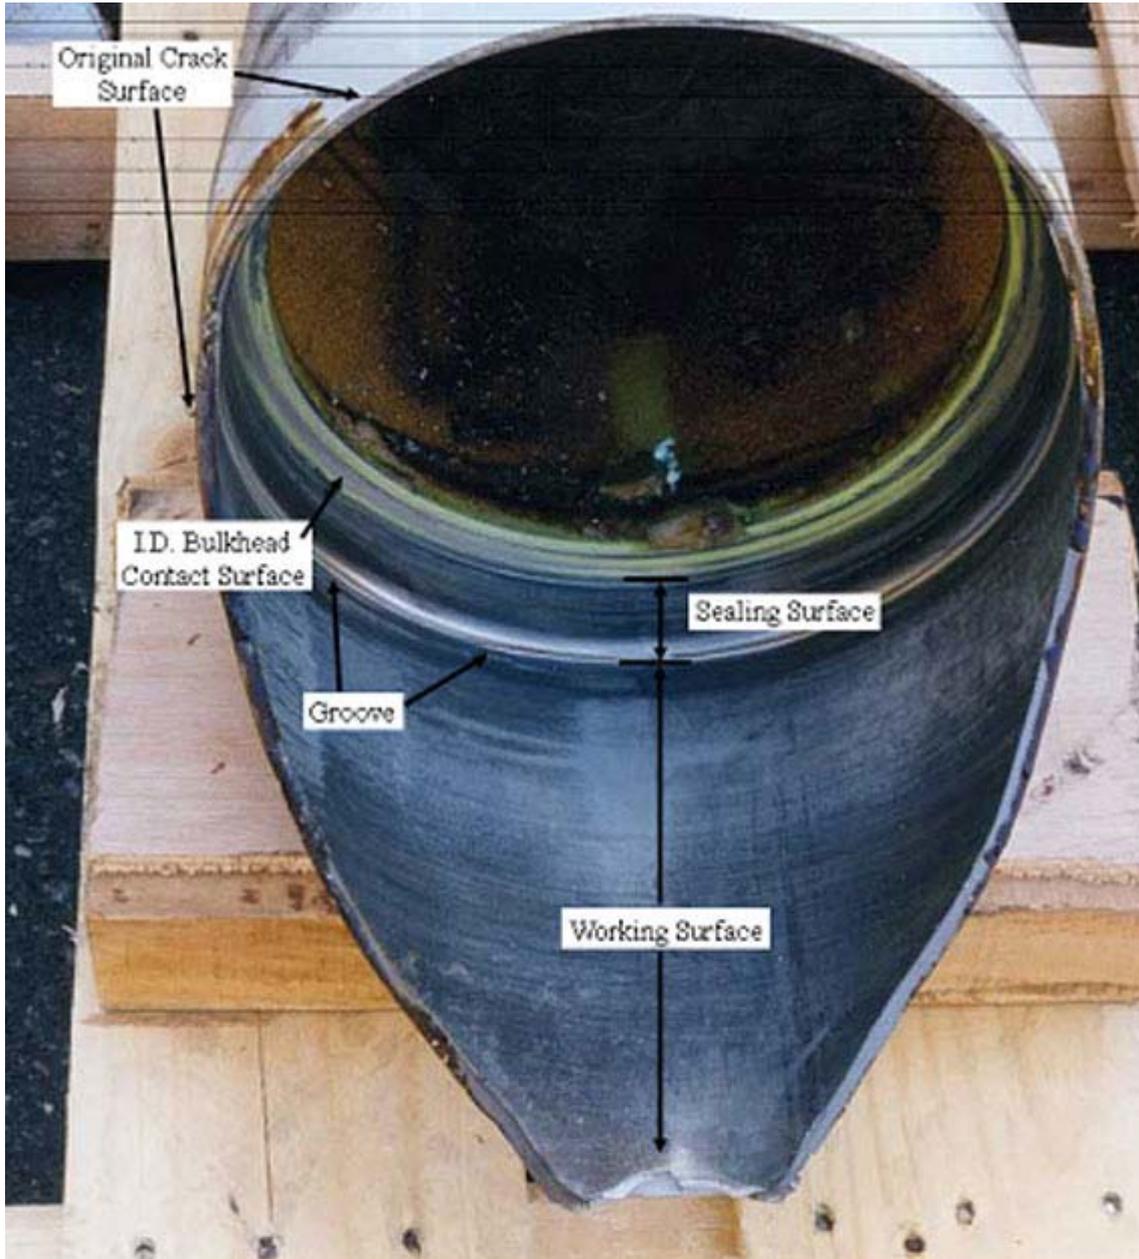
Figure 8

In June 1998 the nose landing gear outer cylinder fitted to a Boeing 747-300 failed while the aircraft was being towed. The outer cylinder had been overhauled/reworked in 1996 and at the time of the accident had completed 689 cycles since the overhaul. The type and location of the failure was very similar to that which is the subject of this investigation (see Figure 7) and the overhaul/rework had been carried out at the same Repair Station.

A metallurgical examination carried out by the aircraft manufacturer concluded that the fracture of the landing gear outer cylinder had occurred as the result of fatigue. The fatigue had been initiated at multiple sites at the base of an irregular circumferential groove just below the lower edge of the ID seal band (see Figures 5, 8 and 9). This had propagated through approximately 40% of the cylinder wall thickness prior to the final failure. The groove had resulted in a significant thinning of the outer cylinder wall thickness. During the examination it was also noted that there was an intermittent 'V- shaped' circumferential groove just above the seal band and that the bulkhead contact surface had been reworked to an angle of 109° instead of 90° as specified in the CMM.

Nose landing gear outer cylinder that was involved in the 1998 incident showing the area of failure
(Photograph courtesy of Boeing Materials Technology)

Following the failure of the nose landing gear outer cylinder in 1998 the Repair Station instigated a number of significant changes to their overhaul/rework practices and procedures and an inspection of all suspect outer cylinders that had been overhauled/reworked in their facility. This inspection required a unique Non Destructive Testing (NDT) technique to be developed to allow inspection of outer cylinders fitted on aircraft without removal or disassembly of the nose landing gear. A total of 35 outer cylinders were inspected using this NDT technique resulting in the rejection of 22 units because of incorrect internal tolerances detected during the inspection.

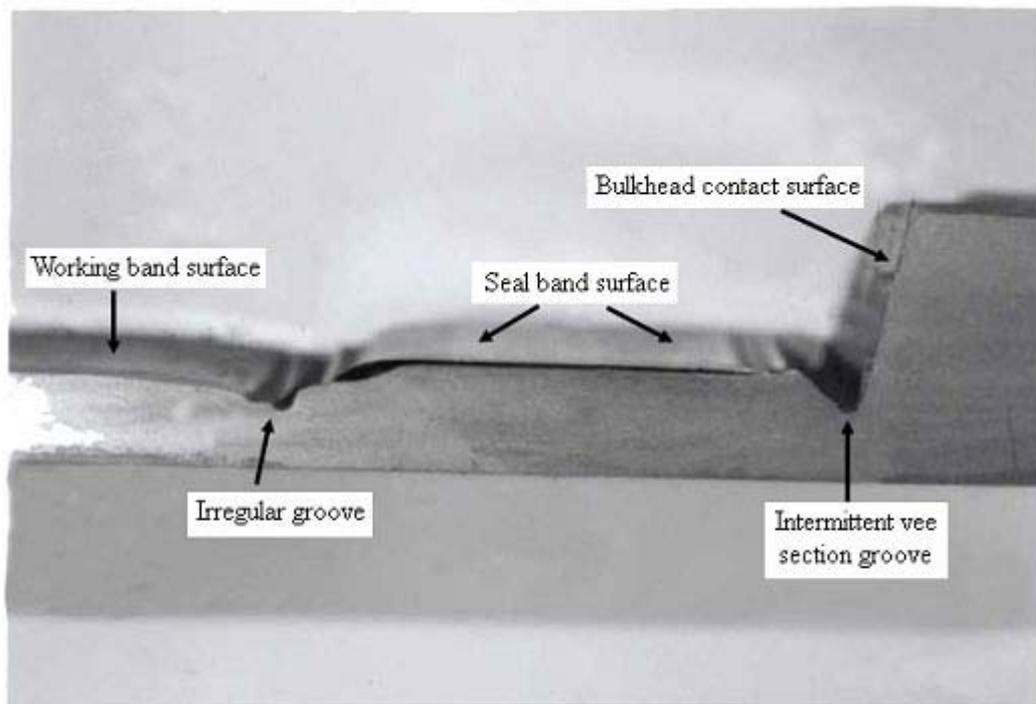
Figure 9

A vertical section cut from the seal band area of the nose landing gear outer cylinder involved in the 1998 incident
(Photograph courtesy of Boeing Materials Technology)
