Uncommanded yaw, Boeing 737-81Q, G-XLAD

Boeing 737-81Q, G-XLAD

AAIB Bulletin No: 5/2004	Ref: EW/C2002/12/04	Category: 1.1
Aircraft Type and Registration:	Boeing 737-81Q, G-XLAD	
No & Type of Engines:	2 CFM56-7B26 turbofan engines	
Year of Manufacture:	2000	
Date & Time (UTC):	23 December 2002 at 0030 hrs	
Location:	Gatwick Airport, West Sussex	
Persons on Board:	Crew - 8	Passengers - None
Injuries:	Crew - None	Passengers - N/A
Nature of Damage:	None	
Commander's Licence:	Airline Transport Pilot's Licence	
Commander's Age:	37 years	
Commander's Flying Experience:	4,980 (of which 2,950 were on type)	
	Last 90 days - 216 hours	
	Last 28 days - 85 hours	
Information Source:	AAIB Field Investigation

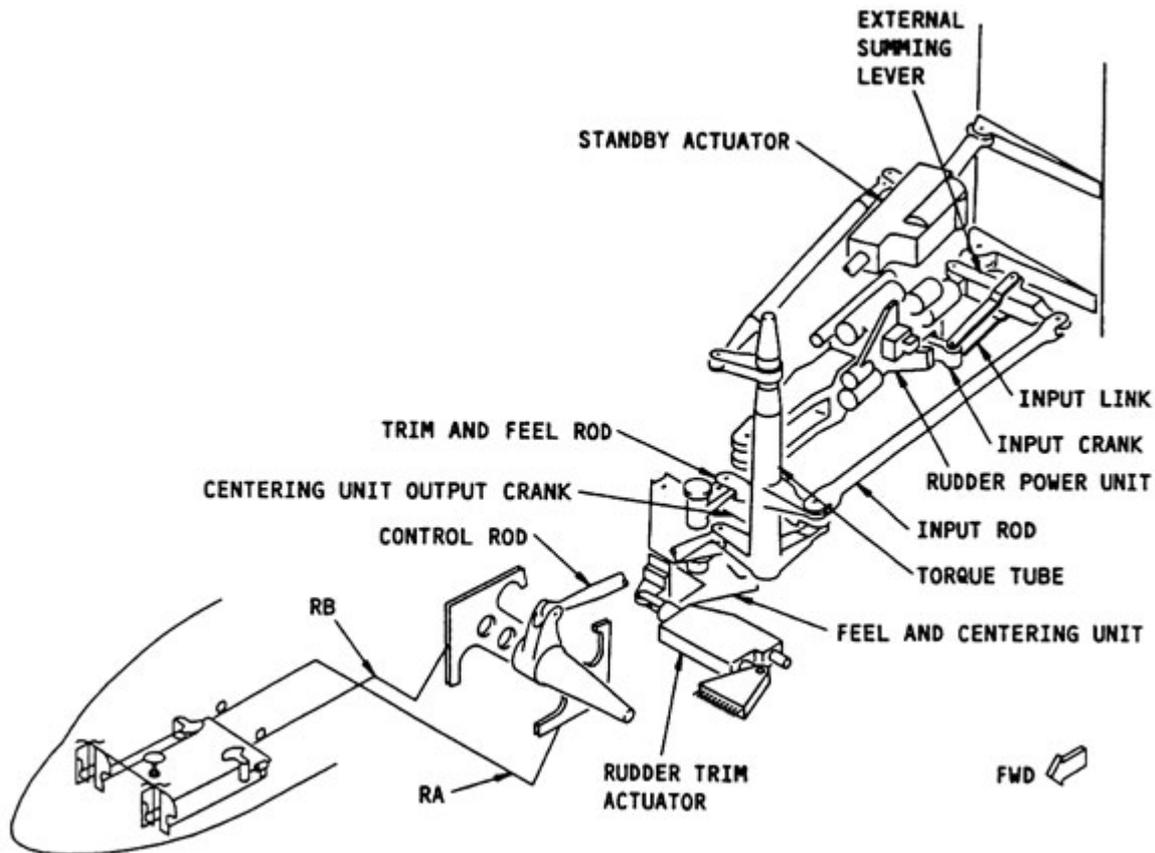
Figure 1: B737-800 Rudder control system

Figure 1 shows the main elements of the 737-800 rudder control system, which is similar to earlier 737 models. The pilot inputs are made through two pairs of conventional rudder pedals, connected in series through forward quadrants and a single cable loop to an aft quadrant. This aft quadrant is connected to a control rod, which is directly connected to the rudder torque tube. The rudder feel and centering unit, which is biased by the electrically-powered rudder trim actuator, is also connected to the rudder torque tube and this torque tube is directly linked to provide mechanical inputs to the rudder hydraulic actuator and to the standby rudder actuator.

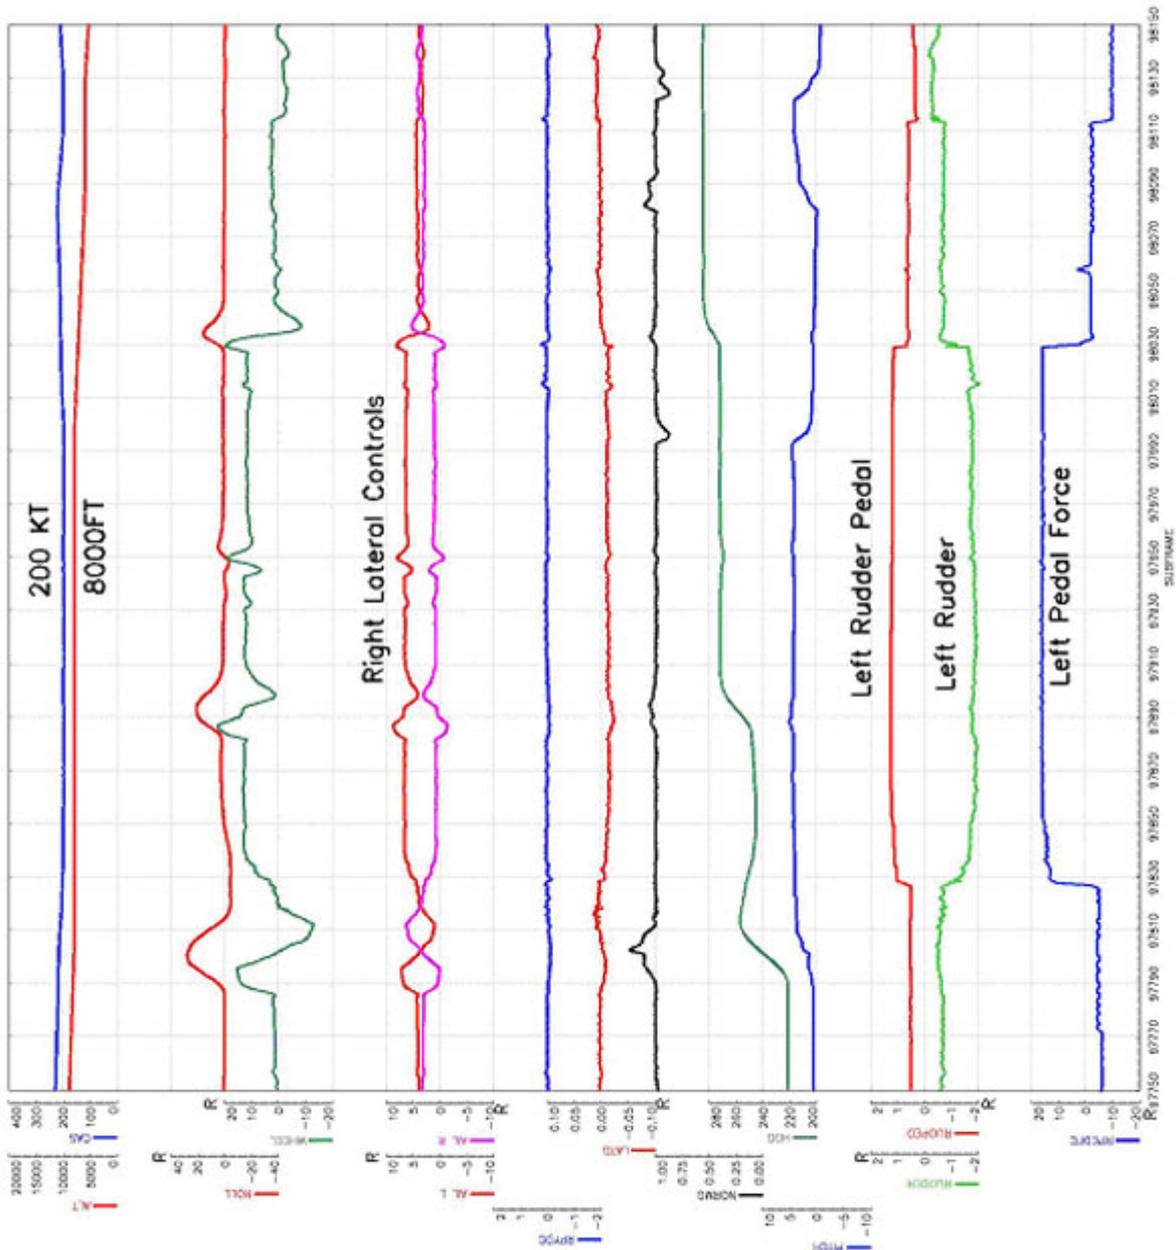
Figure 2: Salient FDR Parameters Incident to B737-81Q en-route to Gatwick on 22 December 2002

2, when the aircraft was at about 8,000 feet and 200 kt. It can be seen that at an FDR time of about 97830 seconds the rudder pedal was deflected to the left by about 1° (from its initial position of 1° to the left), and remained essentially unchanged from this value for about 3 minutes, even during the turn to the right at time 97890 seconds. Throughout this period the indicated rudder pedal force to the left was about 16 lb. It can also be seen that throughout this period the ailerons were deflected to the right, suggesting that the aircraft was in a slight but prolonged side slip. This is an unusual manoeuvre for a large commercial aircraft, especially with the autopilot engaged.

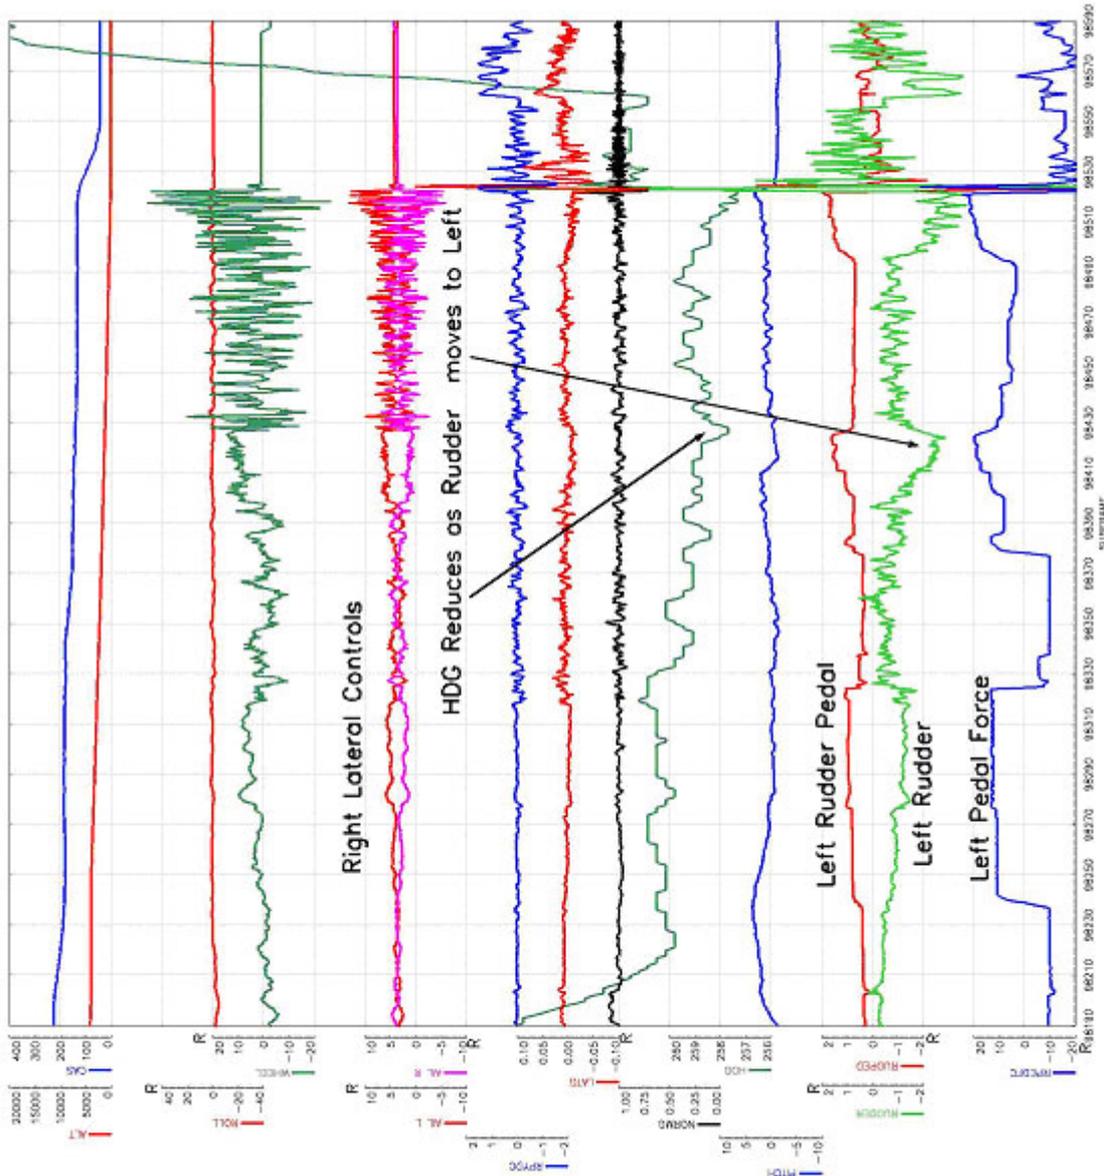
Figure 3: Salient FDR Parameters during Landing at Gatwick Incident to B737-81Q en-route to Gatwick on 22 December 2002

The same parameters are displayed in Figure 3 for the landing at Gatwick. Here it can be seen that there were a number of reversals of both the rudder inputs and forces during the approach (eg at FDR time 98323 seconds and at 98378 seconds). However, these force levels are within the breakout and friction bands and result in very small rudder movements.

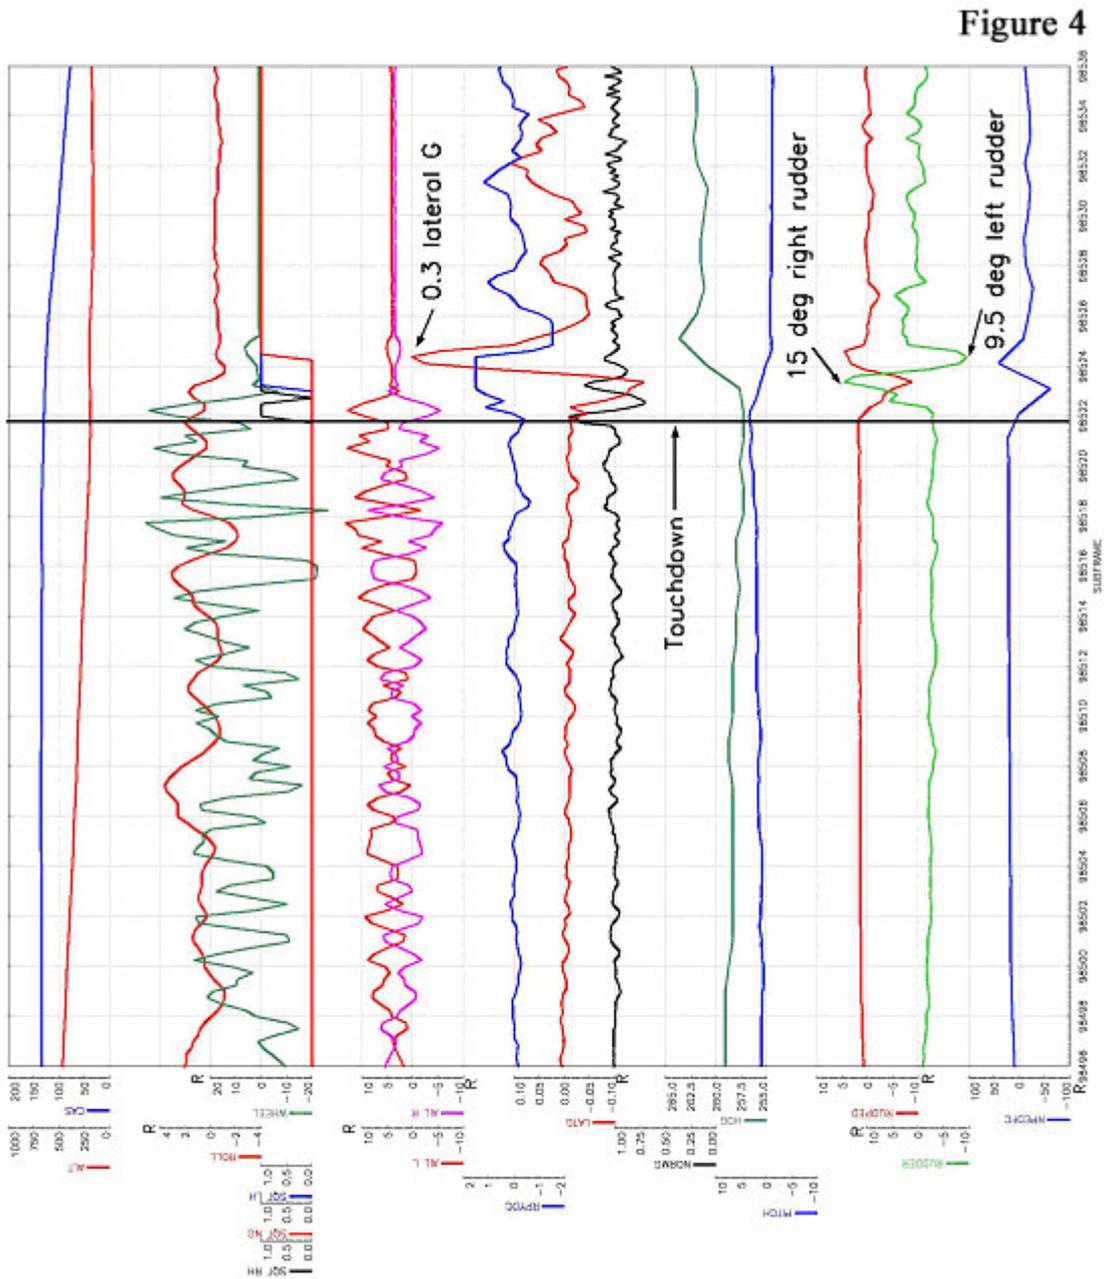
Figure 4: Salient Parameters from 500 Feet to Touchdown Incident to B737-81Q en-route to Gatwick on 22 December

Figure 4 shows the recorded data from 500 feet on the approach to touchdown. During this period the maximum control wheel usage was about 50° which was similar to that used on previous landings. The aircraft appears to have landed with about 2° of right bank. The magnetic heading on the approach was an average of about 258°. About 15° of right rudder was applied just after touchdown (FDR time 98522 secs) and the aircraft appears to have responded with the heading increasing from 257° to 263°. A left rudder input was then applied at FDR time 98524 secs which resulted in a lateral acceleration to the left of about 0.3 'g'. The magnetic heading then remained at about 261° for the remainder of the roll-out. The FDR data does not show any evidence of yaw divergence or use of full lateral controls during the final approach.
