Roll control difficulties, McDonnell Douglas MD-11F, N583FE, January 15, 2003

McDonnell Douglas MD-11F, N583FE

AAIB Bulletin No: 8/2003 Ref: EW/C2003/01/03 Category: 1.1

Aircraft Type and Registration: McDonnell Douglas MD-11F,
N583FE

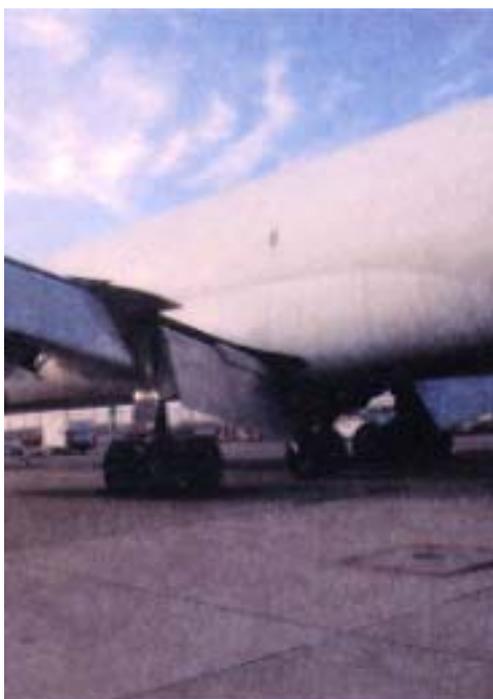
The inboard flap vane is an aerofoil section fitted to the leading edge of the inboard trailing edge flap. It is supported at three positions on spring loaded tracks, which extend the vane as the flap moves away from its retracted position. Examination of the aircraft showed that the outboard half of the vane on the left inboard flap was missing, together with its attachment fittings at the outboard and centre positions. The inboard section of the vane was still attached to the flap and both the inboard and centre vane tracks showed significant distortion. Retraction of the flaps during taxiing had resulted in damage to the flap shroud structure and the No 2 hydraulic system.

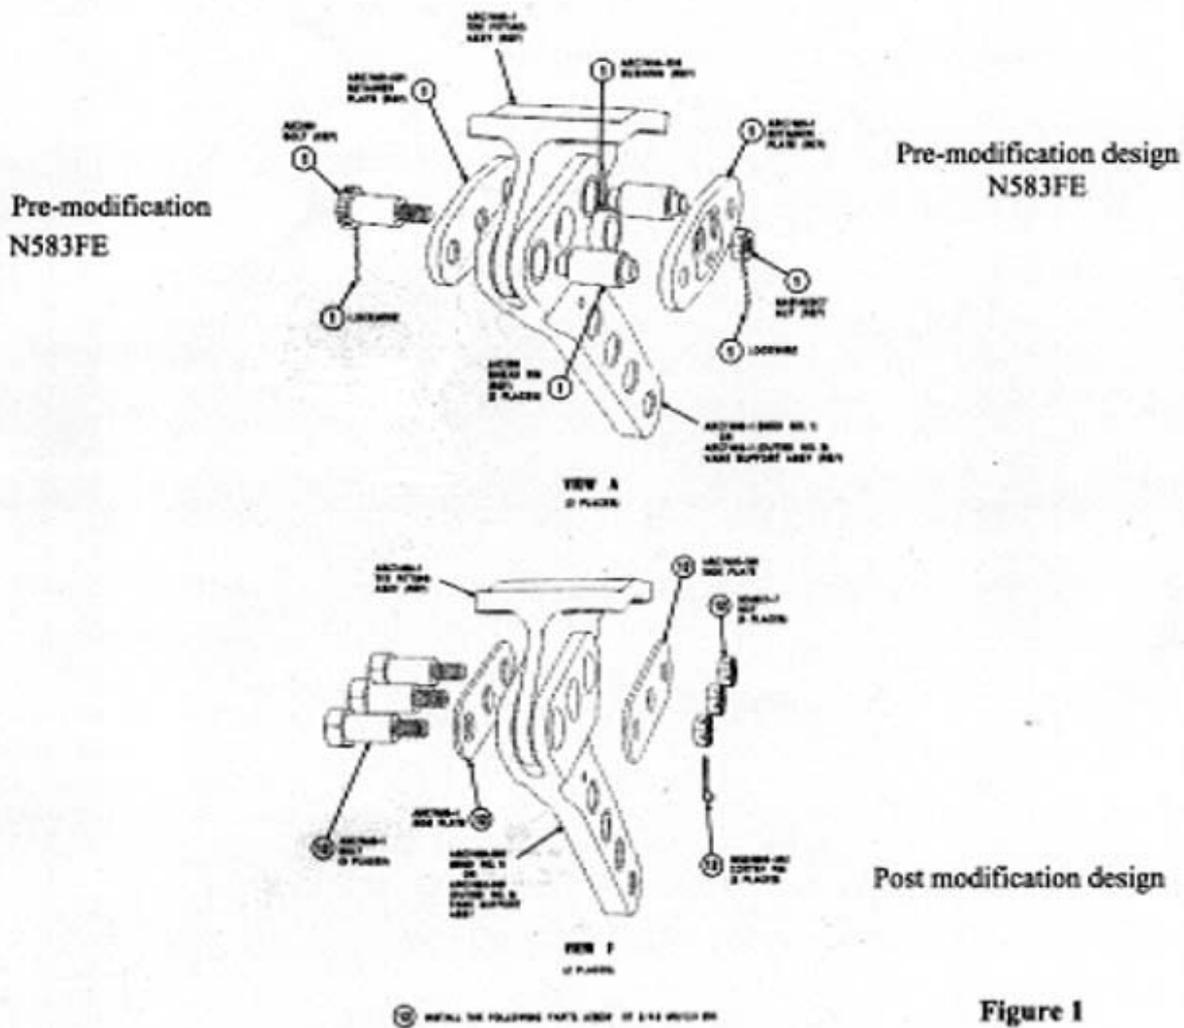
Figure 1 is reproduced with acknowledgements from the manufacturer's Service Bulletin MD11-57-034 and shows details of both the pre and post modification design of the vane attachment to the inboard flap. The vane outboard attachment was of the pre-modification design

After dismantling, a locking (retainer) plate and nut, each with part of the broken locking wire attached, were found inside the flap, in a pocket for the vane outboard track. No other attachment parts were found, and for these parts to have been retained in the flap it was necessary for them to have detached whilst the flap was retracted. Subsequent operation of the flap would have allowed the remaining attachment items to fall from the aircraft.

Analysis of the fractured lock wire was conducted using a Scanning Electron Microscope (SEM). The material of the lock wire was consistent with the required MS20995C32 specification and ASTM A580 material, which is an annealed and passivated corrosion resistant steel. The standard of workmanship employed in locking the wire appeared adequate. The two strands of the wire had fractured in a brittle manner, consistent with a fatigue process, and there was evidence of a notch or groove in the wire at one of the two fractures, which were co-located. It is possible that the wire had been accidentally nicked. The position of the fracture was such that it was likely that the wire would have made rubbing contact with a corner of the nut, and this may also have accounted for the nick and subsequent fracture.

There was normally no maintenance requirement to disturb the outboard attachment area of this vane and, during checks, only routine visual inspections would have been conducted. In March of 2002, a Special Inspection to check for cracks in the flap vane 'Tee' fittings (see Figure 1) would have required this area to be dismantled. The last major work input associated with this area was during a 'C' check, carried out in July 2002, when this area was inspected but not disturbed.

In 1996, the aircraft manufacturer issued Service Bulletin MD11-57-034, in response to a report of the in-flight loss of an inboard flap vane, during the approach to land. This event was attributed to flap vane attachment points becoming disconnected due to either broken or missing lockwire. The Service Bulletin introduced at the inboard and outboard positions as an optional modification, three bolts/nuts locked with cotter pins, in place of the one bolt/nut locked with safety wire and two location pins.

The operator conducted a fleet inspection of its MD-11 aircraft, and found two further cases where the lock wire was broken although the detail parts had not become disassembled. The operator plans to modify all its MD-11s as described in Service Bulletin MD11-57-034 within the next 18 months.
