Tailstrike on landing, BAe 146-200, G-MANS

BAe 146-200, G-MANS

AAIB Bulletin No: 3/2004	Ref: EW/C2003/03/03	Category: 1.1
INCIDENT		
Aircraft Type and Registration:	BAe 146-200, G-MANS	
No & Type of Engines:	4 Lycoming ALF 502R-2 turbofan engines	
Year of Manufacture:	1987	
Date & Time (UTC):	30 March 2003 at 1757 hrs	
Location:	Brussels Airport, Belgium	
Type of Flight:	Public Transport	
Persons on Board:	Crew - 5	Passengers - 43
Injuries:	Crew - None	Passengers - None
Nature of Damage:	Damage to tail bumper	
Commander's Licence:	Airline Transport Pilot's Licence	
Commander's Age:	33 years	
Commander's Flying Experience:	3,680 hours (of which 480 were on type)	
	Last 90 days - 90 hours	
	Last 28 days - 24 hours	
Information Source:	AAIB Field Investigation

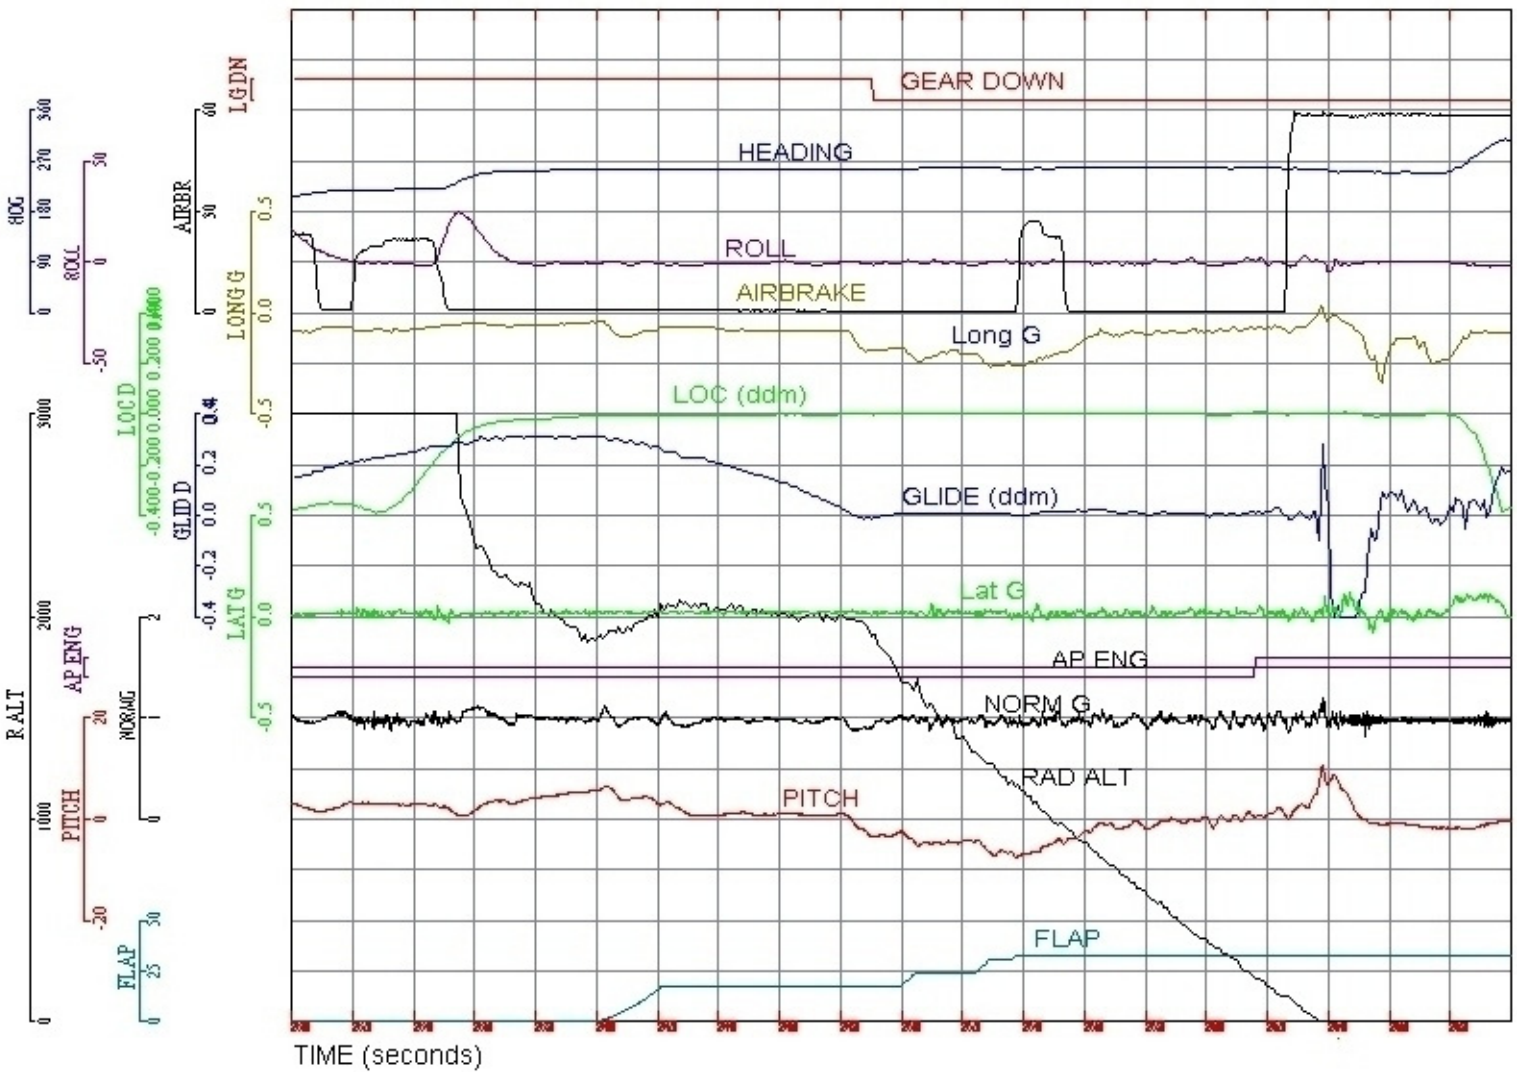
Figure 1

A plot of relevant data recorded during the approach and landing is at Figure 1.

The absence of altitude, airspeed and engine parameters severely restricted the usefulness of the recorded data. The data that was recorded showed that the aircraft had captured the glideslope at 2,000 feet agl. As soon as the aircraft started to descend with the glideslope the landing gear was lowered. At 1,170 feet agl, after the final stage of flap had been selected, a little less than half of the available airbrake was deployed for a period of 16 seconds; the airbrakes were then restowed.

The autopilot was disengaged at 215 feet agl, 22 seconds before touchdown. At 125 feet agl the airbrake was deployed to 55° and remained in that position until the aircraft had landed. After the airbrake had been deployed the recorded pitch attitude increased, as did the rate of descent which, by 70 feet agl, had developed to about 900 fpm. In the final second before touchdown the pitch attitude increased rapidly and the rate of descent was reduced to about 300 fpm.

At touchdown the recorded pitch attitude was 10.6° nose up. Immediately after touchdown the pitch attitude was reduced to 7° as the aircraft began to roll to the left, reaching a maximum of 4.5° left wing down over the next four seconds.
