Collision with air bridge, Airbus A320-231, G-JOEM

Event Date: 2004-03-17 at 1540 UTC

Investigative Body: Aircraft Accident Investigation Board (AAIB), United Kingdom

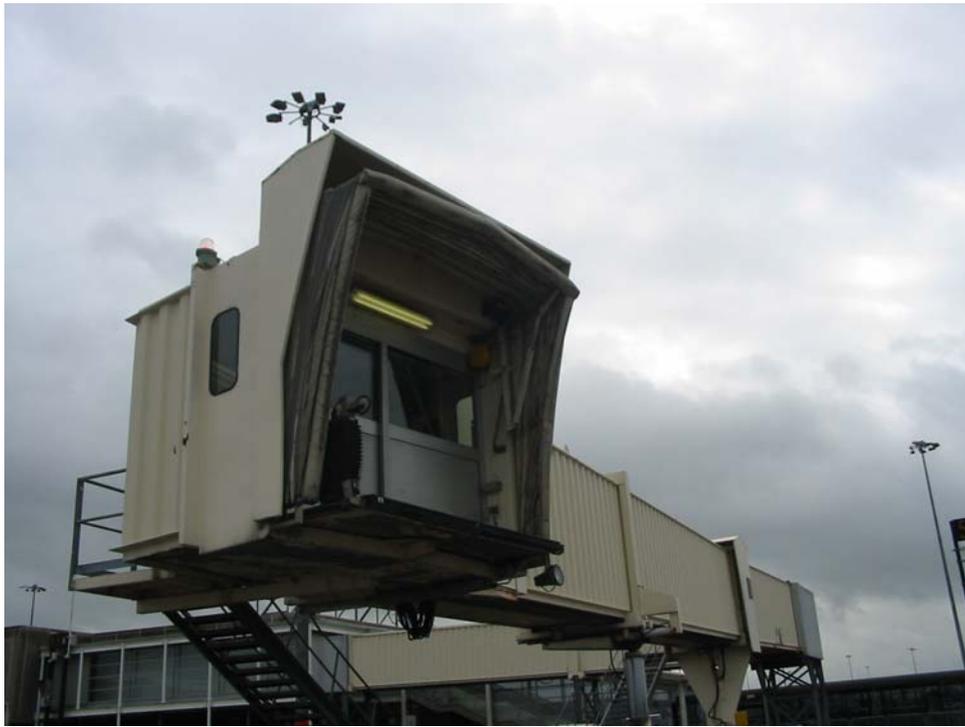
Figure 1

Passengers were boarding the aircraft through the forward left cabin door, via an airbridge (see Figure 1). When approximately two-thirds of the passengers had embarked, the cabin crew noticed that the bottom of the door, which opens outwards and forwards, was in contact with the floor of the airbridge. The crew contacted their handling agent and one of their staff attended the aircraft.

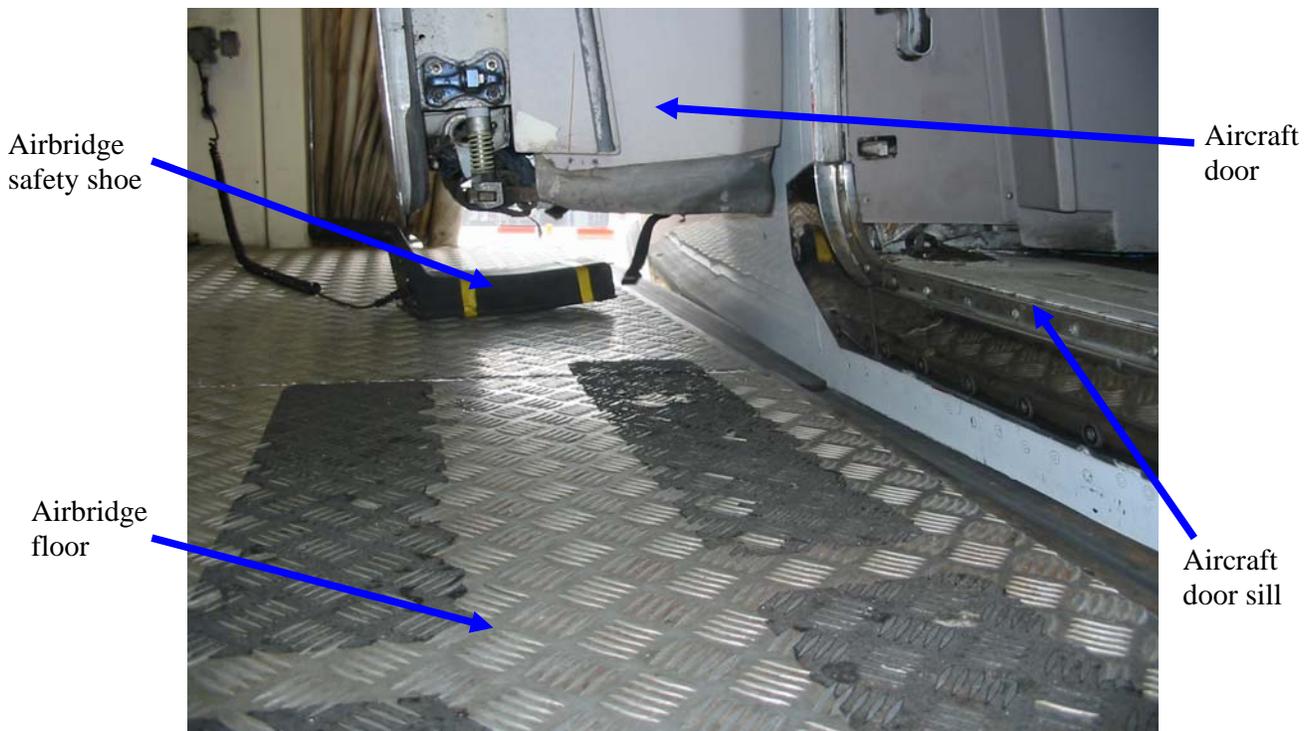
Figure 2

On arrival at the airbridge the ground agent noticed that the airbridge 'autolevel' alarm had activated. This indicated that there was an autolevel malfunction or that the 'travel timer' had tripped, or both. (Note: The autolevel circuit includes an adjustable timer that permits the airbridge's vertical travel motor to operate continuously for a maximum of six seconds.) She also saw that the autolevel 'safety shoe' (see Figure 2) was not in place on the airbridge floor beneath the aircraft door. The safety shoe is designed to create a 'signal' that triggers the airbridge to descend when the bottom of the aircraft door touches the shoe, thus preventing contact between the door and the airbridge.

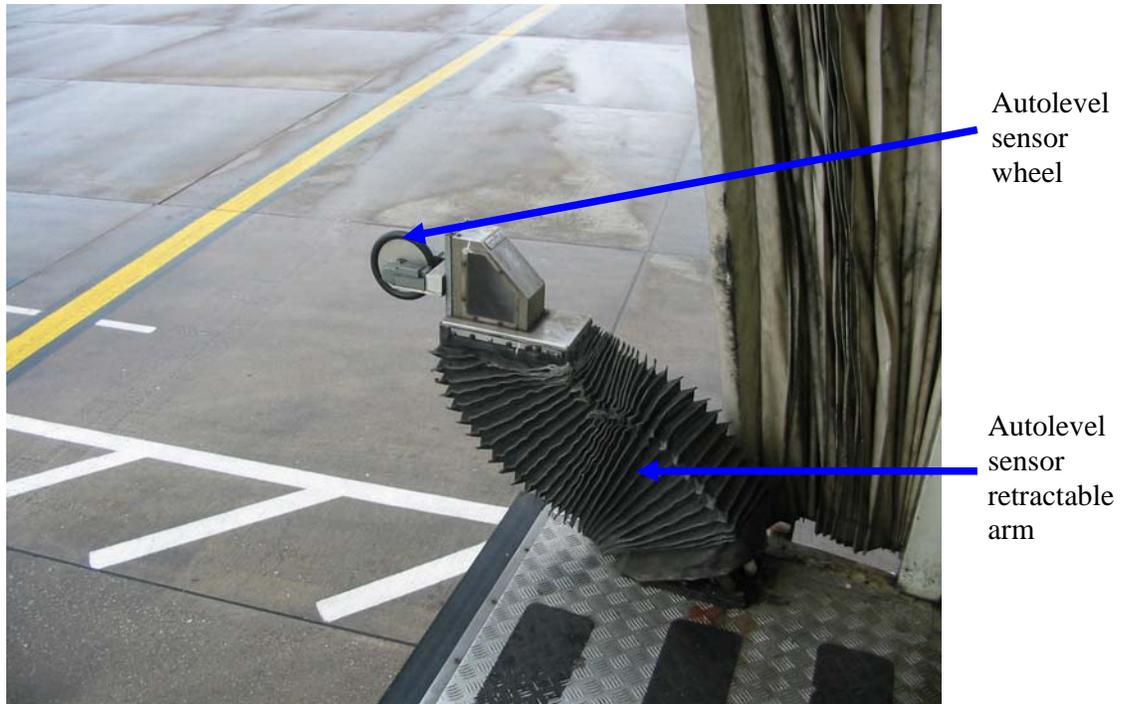
Figure 3

Examination of the autolevel sensor on the airbridge (see Figure 3) showed that the wheel had rotated to its full extent and jammed, indicating that the aircraft had descended relative to the floor of the airbridge. Once the wheel had been freed, the autolevel system was tested and found to operate correctly.

The autolevel system sensor wheel had rotated to its fully 'down' position and jammed, suggesting a protracted movement of the aircraft in that direction. The autolevel alarm had activated and this indicated that there was a malfunction in the autolevel system or that there had been continuous 'levelling' of the airbridge for a maximum of six seconds. Following this alarm, the correct procedure would have been for an operator to operate the airbridge manually. Why the airbridge moved up slightly after the autolevel reset button had been pressed, as reported, is not clear. Nor was it apparent which of the two causes had triggered the alarm.

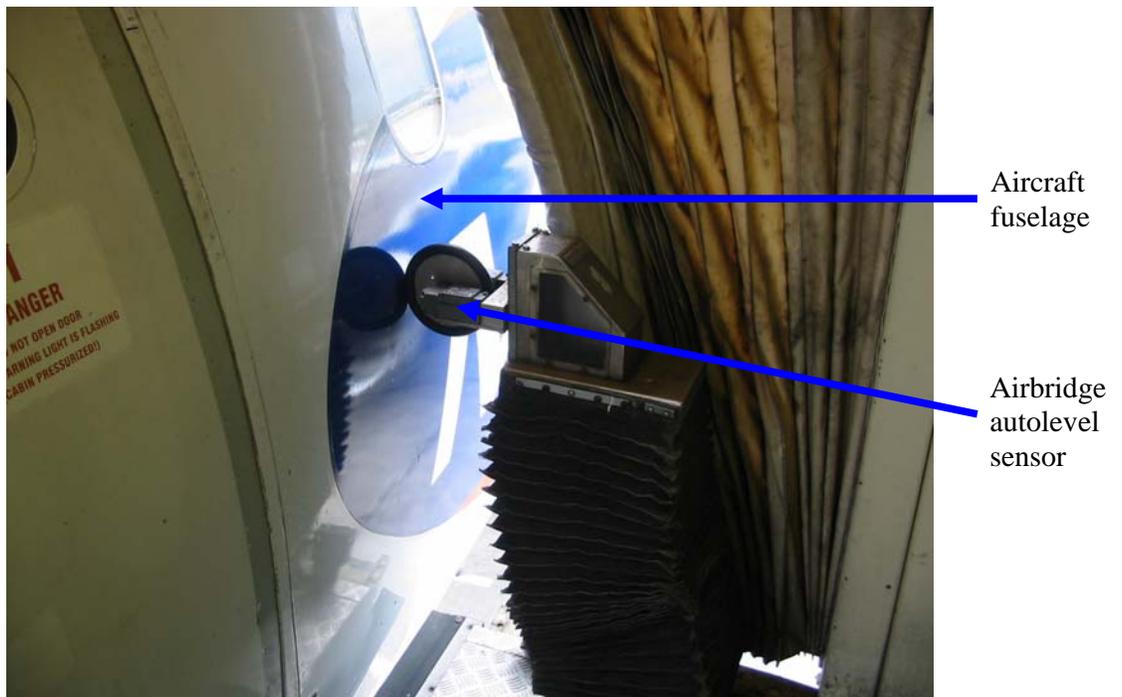
Figure 4

the end of a retractable arm located on the airbridge head floor. The wheel rests against the aircraft fuselage and rotates as the aircraft rises or falls with respect to the airbridge (see Figure 4). The autolevel circuit also contains an adjustable timer, which permits the vertical travel motor to operate continuously for a maximum of six seconds. At the end of this time all power to the system is removed, an audible alarm sounds and a warning light is energised at the control panel.
