Apparent fuel leak, Boeing 777-236, G-YMME

S2/2004 - Boeing 777-236, G-YMME

AAIB Bulletin No: S2/2004	Ref: EW/C2004/06/01	Category: 1.1
Aircraft Type and Registration:	Boeing 777-236, G-YMME	
Serial Number:	30306	
No & Type of Engines:	2 Rolls-Royce Trent 895-17 turbofan engines	
Year of Manufacture:	2000	
Date & Time (UTC):	10 June 2004 at 1907 hrs	
Location:	London Heathrow Airport	
Type of Flight:	Public Transport (Passenger)	
Persons on Board:	Crew - 15	Passengers - 151
Injuries:	Crew -None	Passengers - None
Nature of Damage:	None	
Commander's Licence:	Airline Transport Pilot's Licence	
Commander's Age:	50 years	
Commander's Flying Experience:	14,607 hours (of which 2,256 were on type) Last 90 days - 178 hours Last 28 days - 64 hours	
Information Source:	AAIB Field Investigation

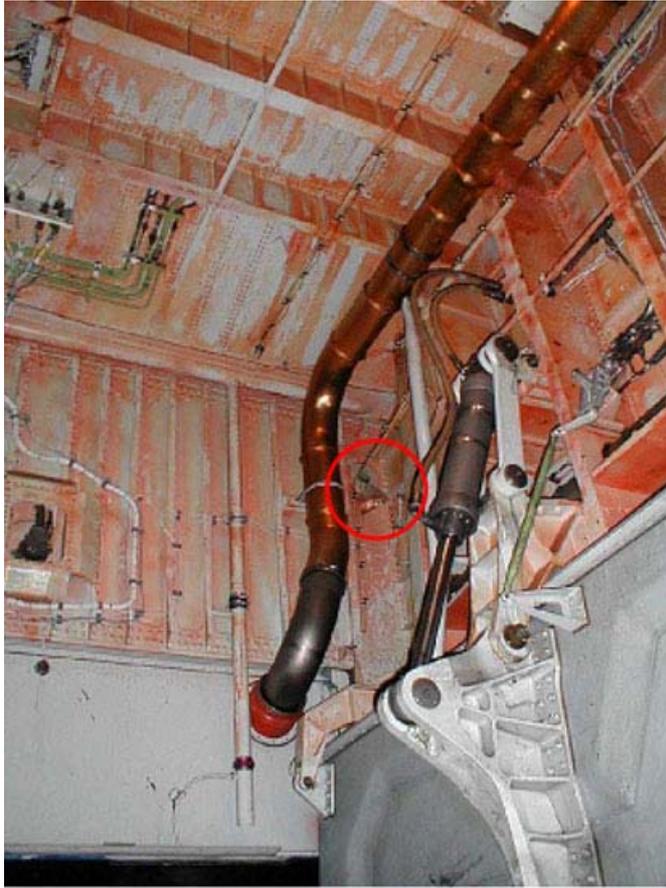
An engineer inspected the aircraft after it arrived at the stand. He noticed a few drips of fuel on the left main landing gear but none on the ground. After opening the left main gear door he detected a distinct smell of fuel. An inspection inside the gear bay revealed that the centre fuel tank purge door was not in place. The purge door was hanging on a lanyard inside the fuel tank and a plastic bag was attached to the purge door opening. The bag contained fuel and it also contained the screws that would normally hold the purge door in place (see Figures 1 and 2).

Figure 1 - View inside left main gear bay looking forward at the rear spar of the centre fuel tank. Purge door opening circled in red.

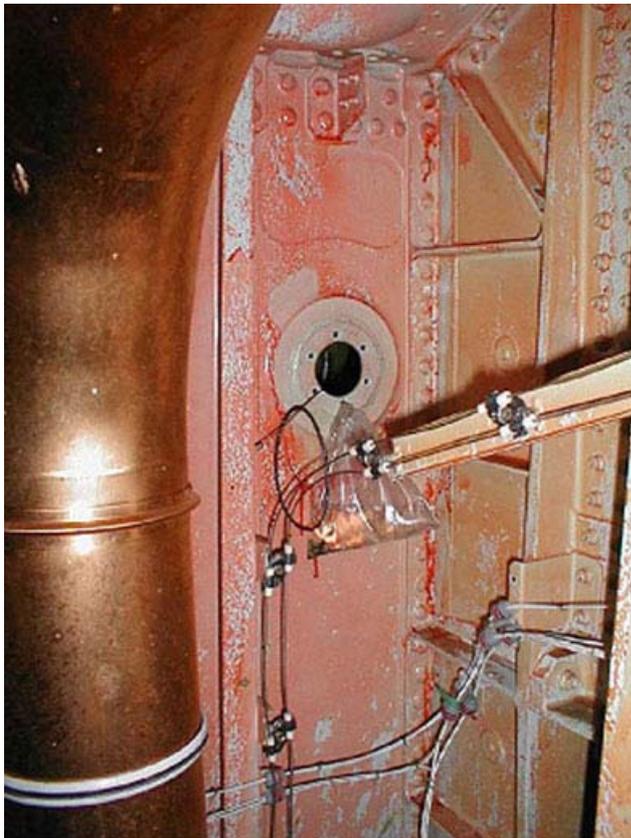
Figure 2 - Purge door opening. Fuel and retaining screws inside plastic bag. Purge door is hanging on lanyard inside the fuel tank. The O-ring seal was removed from the purge door by maintenance staff following the incident.

The Boeing 777-200 ER has a centre fuel tank that occupies the centre wing box and the inboard sections of the wings. It has a capacity of 98,800 litres or approximately 80 tonnes of jet fuel. Before start-up G-YMME had approximately 43 tonnes of fuel in the centre tank which would have reached a level slightly below the purge door opening. The aircraft's pitch attitude during climb-out would have been sufficient for the fuel to start flowing through the purge door opening.

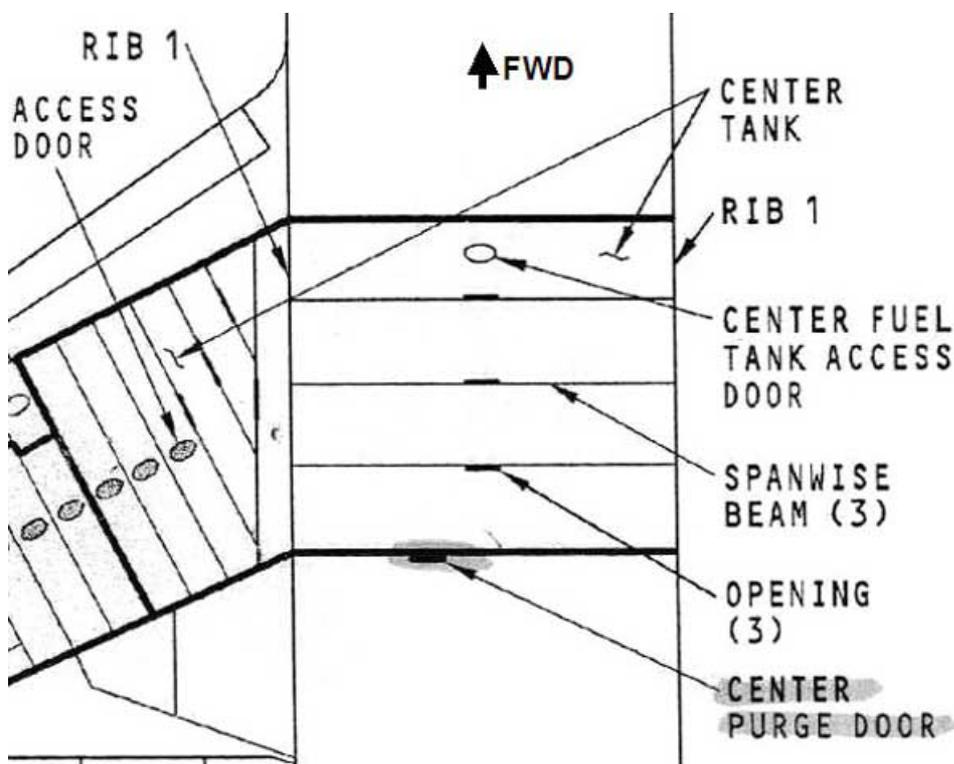
The centre fuel tank was drained and purged to permit safe access inside the tank to carry out the inspections. The purge procedure in the Aircraft Maintenance Manual (AMM) called for the removal of the centre tank access door on the belly of the aircraft and the three inboard access doors under each wing (see Figure 3). The AMM contained a stand-alone procedure detailing removal of the purge door which is on the rear spar of the centre tank (and accessible within the left main landing gear bay) but this was not referenced in the purge procedure. The maintenance organisation had raised routine job cards for removal of the centre tank access door and removal of one inboard access door on each wing. No routine job card had been raised for removal of the purge door. In the event that the purge door needed to be removed, standard procedure required that a defect card be raised calling for the purge door to be refitted. No such defect card was raised during the 2C check.
