## Collision between Boeing 767-204, G-SATR and Boeing 737-37Q, G-ODSK, while taxiing.

**Event Date:** 2004-11-04 at 1620 UTC

**Investigative Body:** Aircraft Accident Investigation Board (AAIB), United Kingdom

**ACCIDENT**

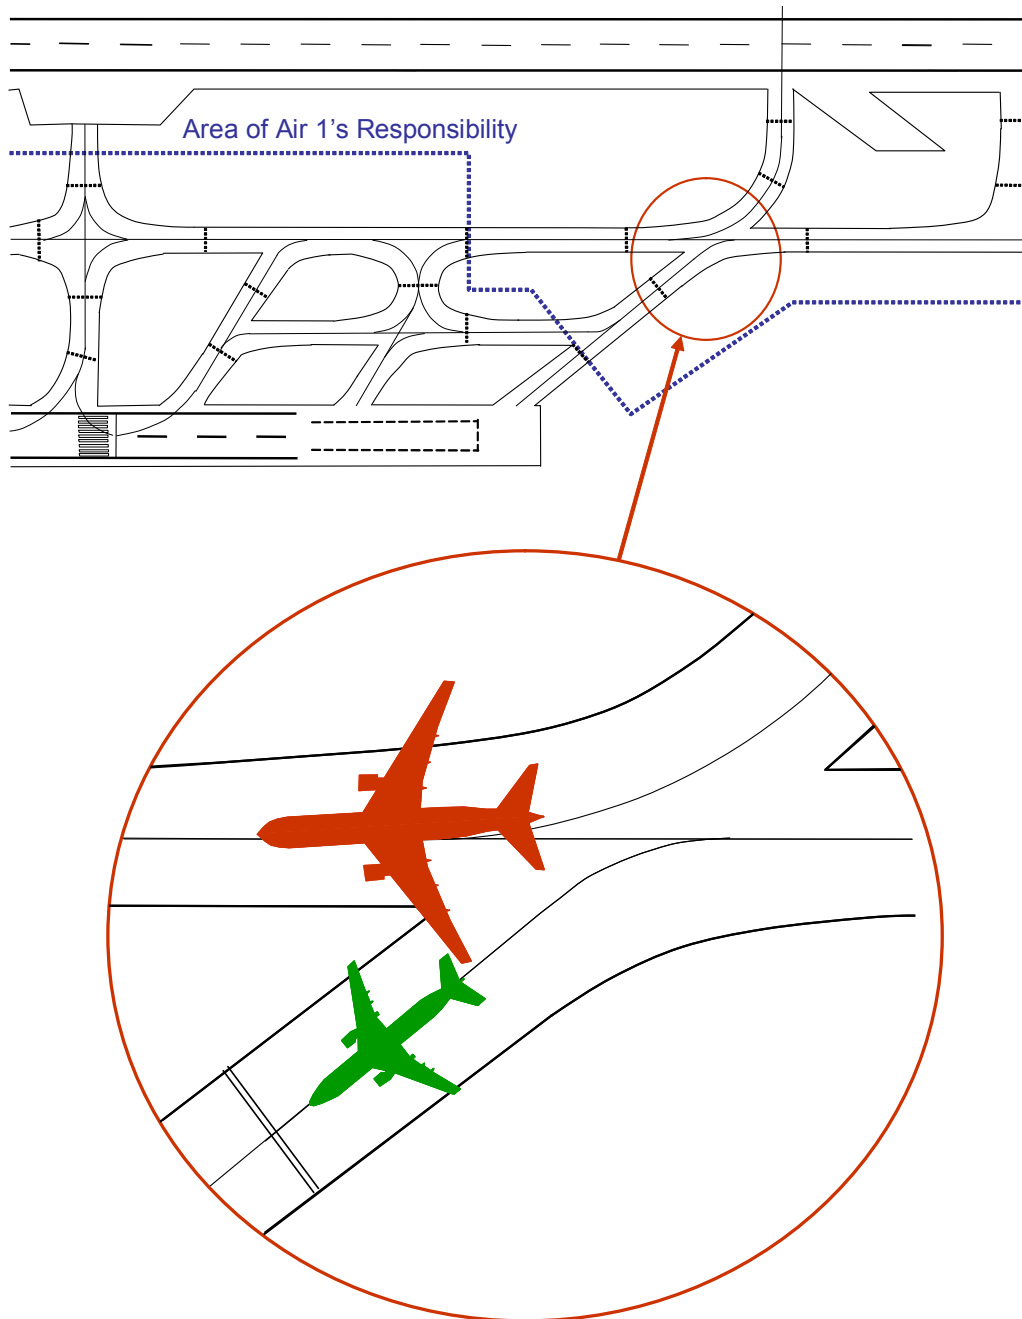
**Figure 2**

South Side Taxiways and Geometry of Collision

Analysis of the SMR and the nature of the damage to both aircraft indicated that the B767 was on or very close to the marked taxiway centre line during the turn and at the point of collision. The aircraft would therefore have begun to turn away from the B737 when it was still some distance from it. As the turn continued, the B737 would have moved into the commander’s left side window, giving him the impression that his aircraft was moving away from the B737 when the wingtip was still, in fact, moving towards it. As the tail of G-ODSK moved further aft, the task of monitoring it and looking ahead and to the right to follow the taxiway would have become increasingly difficult, with the commander having to monitor two points separated by about 150°. It is not certain that the pilot was physiologically equipped to assess the separation between a wing tip which he could not see and which was behind him, and the tail of
