Unstabilized approach, Boeing 747-2D7B, N523MC

Micro-summary: This Boeing 747-2D7B descended significantly beneath the glide slope.

Investigative Body: Aircraft Accident Investigation Board (AAIB), United Kingdom

INCIDENT

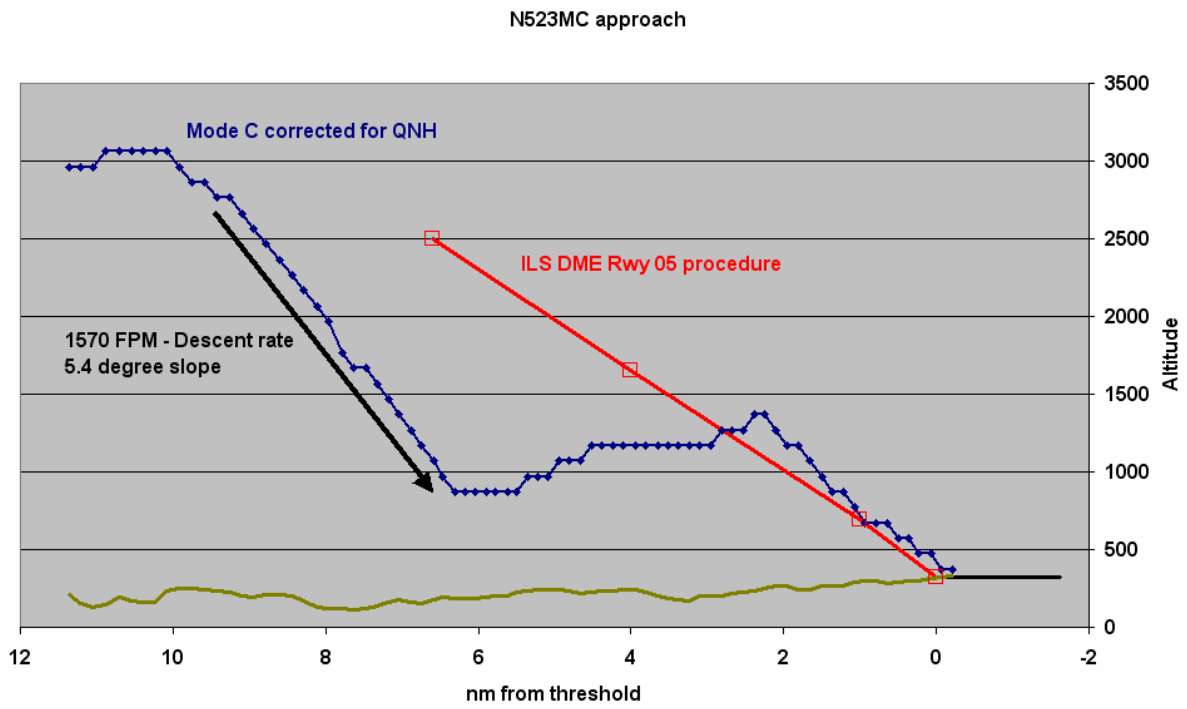
The radar recording, based on Stansted Radar was evaluated by the AAIB. This indicated that the descent from 3,000 feet amsl was at an average descent angle of 5.4°. The rate of descent was fairly constant at 1,570 feet per minute until the level off at approximately 900 feet amsl; Stansted Airfield elevation is 348 feet amsl. Figure 1 shows the recorded descent path of the aircraft relative to the normal glideslope together with the range from touchdown and the ground elevation.

Figure 1 N523MC Approach and normal glideslope
