## Loss of two ADIRUS, Airbus A320-200, I-BIKE

**Micro-summary:** This airplane experienced the loss of two ADIRUS, resulting in the partial loss of flight info to the crew and a number of system inconveniences, all compounded by a go-around.

**Investigative Body:** Aircraft Accident Investigation Board (AAIB), United Kingdom

**INCIDENT**

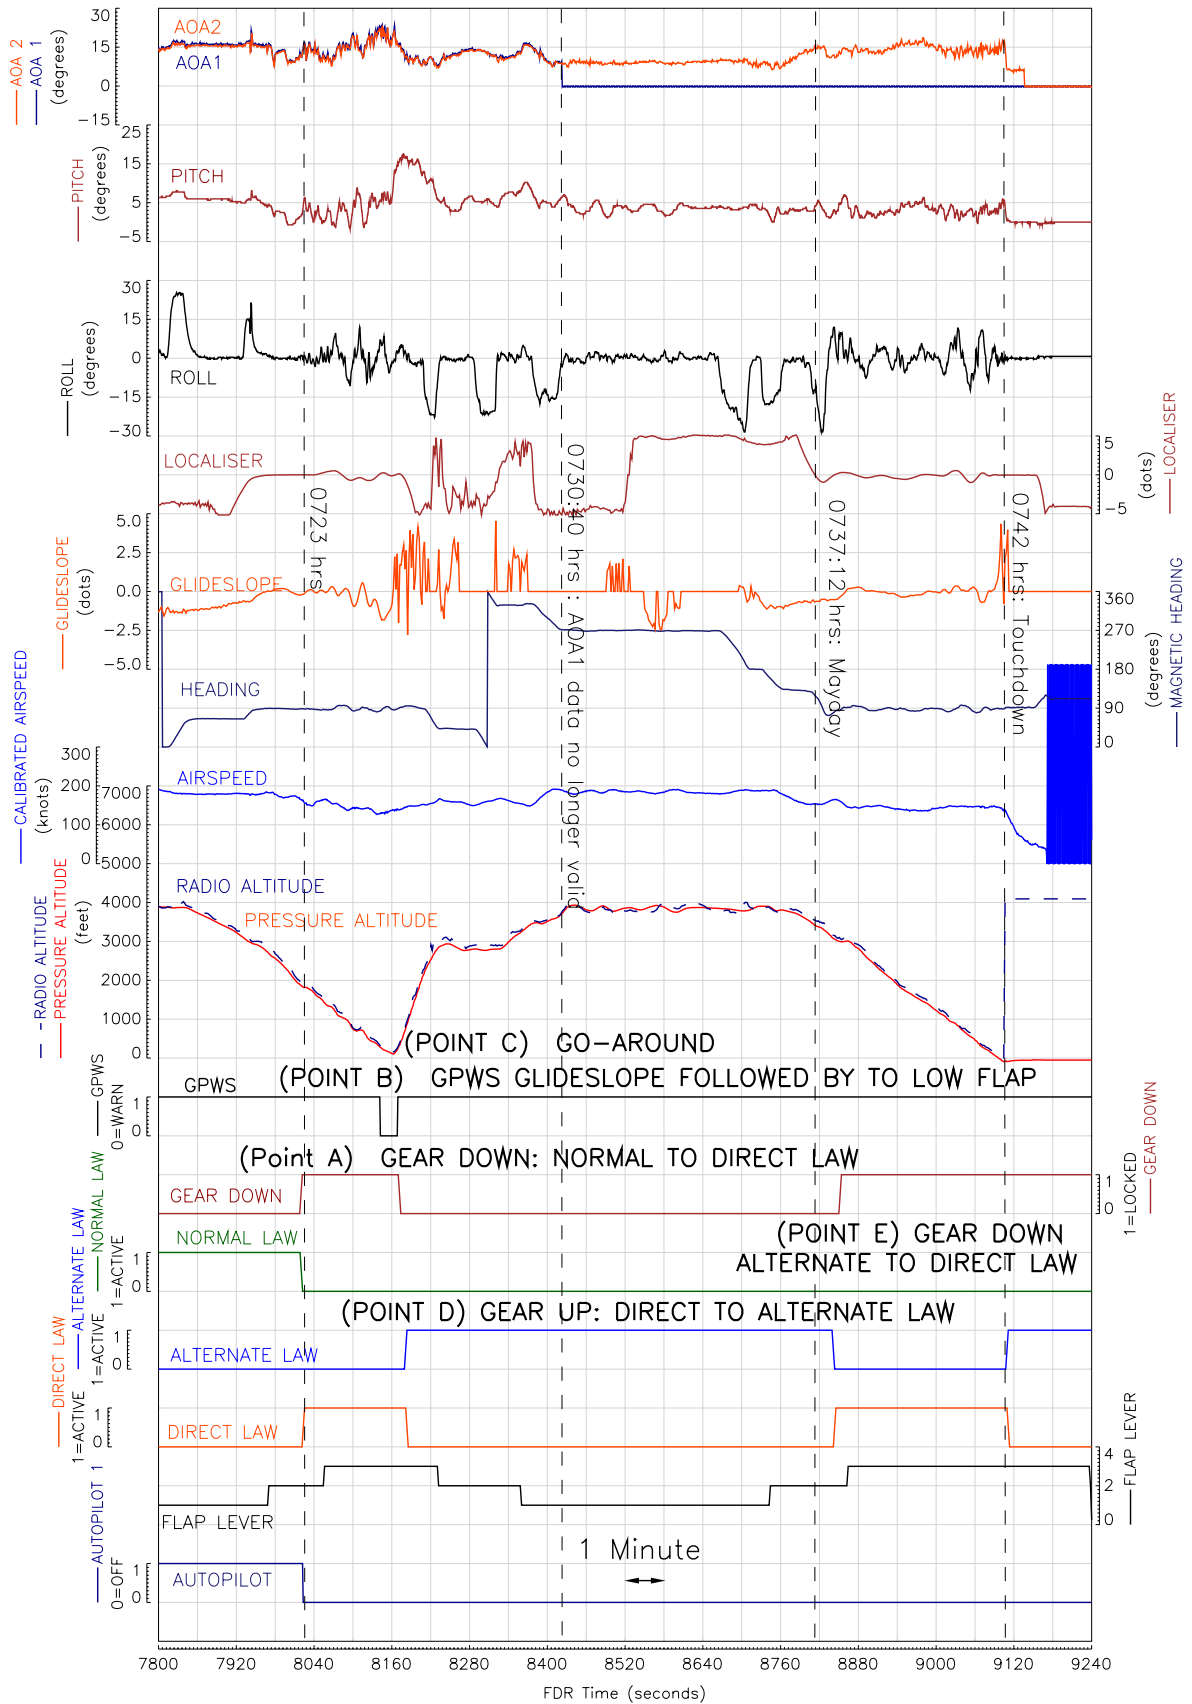
At about 0724 hrs, the flap lever was set to position three. Shortly after this time the aircraft started to deviate from the glideslope and localiser. The aircraft altitude continued decreasing and, by about 300 ft radio altitude and when at an airspeed of 130 kt, the aircraft had deviated some 1.3 'dots' below the glideslope. Almost coincident with this, the CVR recorded an EGPWS "glideslope" warning (see Figure 1 Point B). The deviation below the glideslope continued to increase and a second EGPWS "glideslope" warning was recorded by the time the aircraft was at some 1.84 'dots' below the glideslope.

As the crew continued their approach, ATC advised that they would receive a late clearance to land. When the aircraft was at about 250 ft radio altitude an EGPWS "too low flap" warning was recorded on the CVR. The commander then decided to go-around in order to attempt to restore the NAV IR 1 fault condition but, before he could do so, ATC instructed the aircraft to go-around as the preceding aircraft had not yet cleared the runway. The commander acknowledged this instruction and called "GOING AROUND, REQUEST A HOLDING PATTERN OVERHEAD CHILTERN OR OCKAM TO RESOLVE A LITTLE FAILURE" but ATC were not advised of the specific nature of the failure. The thrust levers were set to the takeoff/go-around (TOGA) detent and, having descended to a minimum radio altitude of 159 ft, the aircraft then started to climb, Figure, 1 Point C. The landing gear lever was selected up, Figure 1, Point D, and the landing gear retracted normally. At this point, the EGPWS warning ceased.

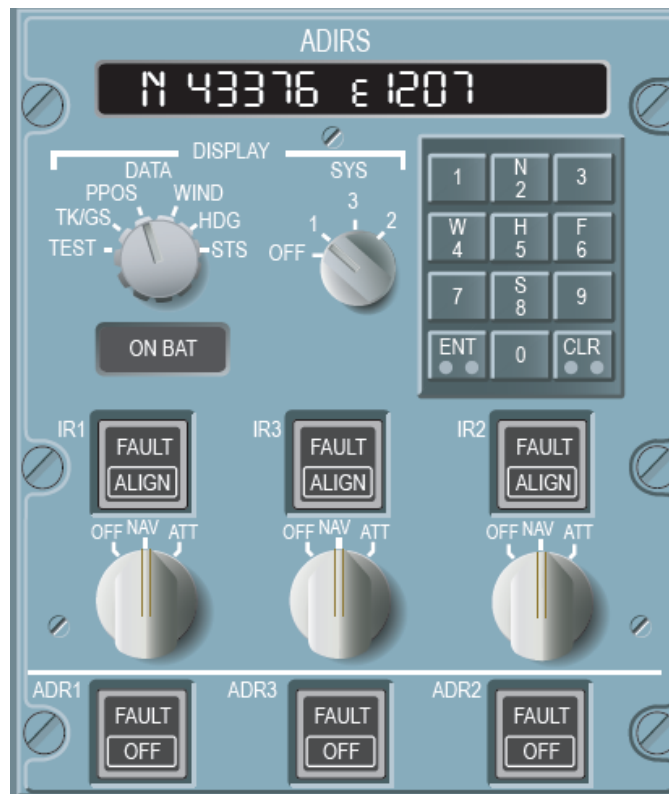
Figure 2

The ADIRS is controlled via the ADIRS control panel on the overhead panel, Figure 2. In normal operation, the rotary selector mode switches are set to the NAV position. In this configuration, the No 1 and 2 ADIRUs supply data to the commander's and co-pilot's EFIS displays respectively, with No 3 ADIRU available as a standby. Following loss of the ADR and/or IR function of either the No 1 or 2 ADIRU, rotary selector switches on the SWITCHING panel on the centre pedestal, Figure 3, enable air data and/or inertial data from the No 3 ADIRU to be selected to replace the data from the failed unit.

According to the Flight Crew Operating Manual, a failure of the IR section of the ADIRU is indicated by a steady amber FAULT light on the corresponding IR push button on the ADIRS control panel, with

an associated caution message on one of the ECAM displays. A flashing amber light indicates that the affected system has lost the ability to navigate, but attitude and heading information may be recovered by setting the mode rotary selector switch to the ATT position and performing an alignment procedure. An ADR failure is indicated by a steady amber FAULT light on the corresponding ADR push button and an associated ECAM caution message. In the event of an ADR failure in an ADIRU, the air data output may be switched off by pressing the appropriate ADR push button switch on the ADIRS control panel.
