Rejected takeoff, Boeing 767-3YOER, ZS-PBI, London Gatwick Airport

Micro-summary: A rejected takeoff by this Boeing 767 led to a landing gear fire.

Event Date: 2005-07-11 at 1951 UTC

Investigative Body: Aircraft Accident Investigation Board (AAIB), United Kingdom

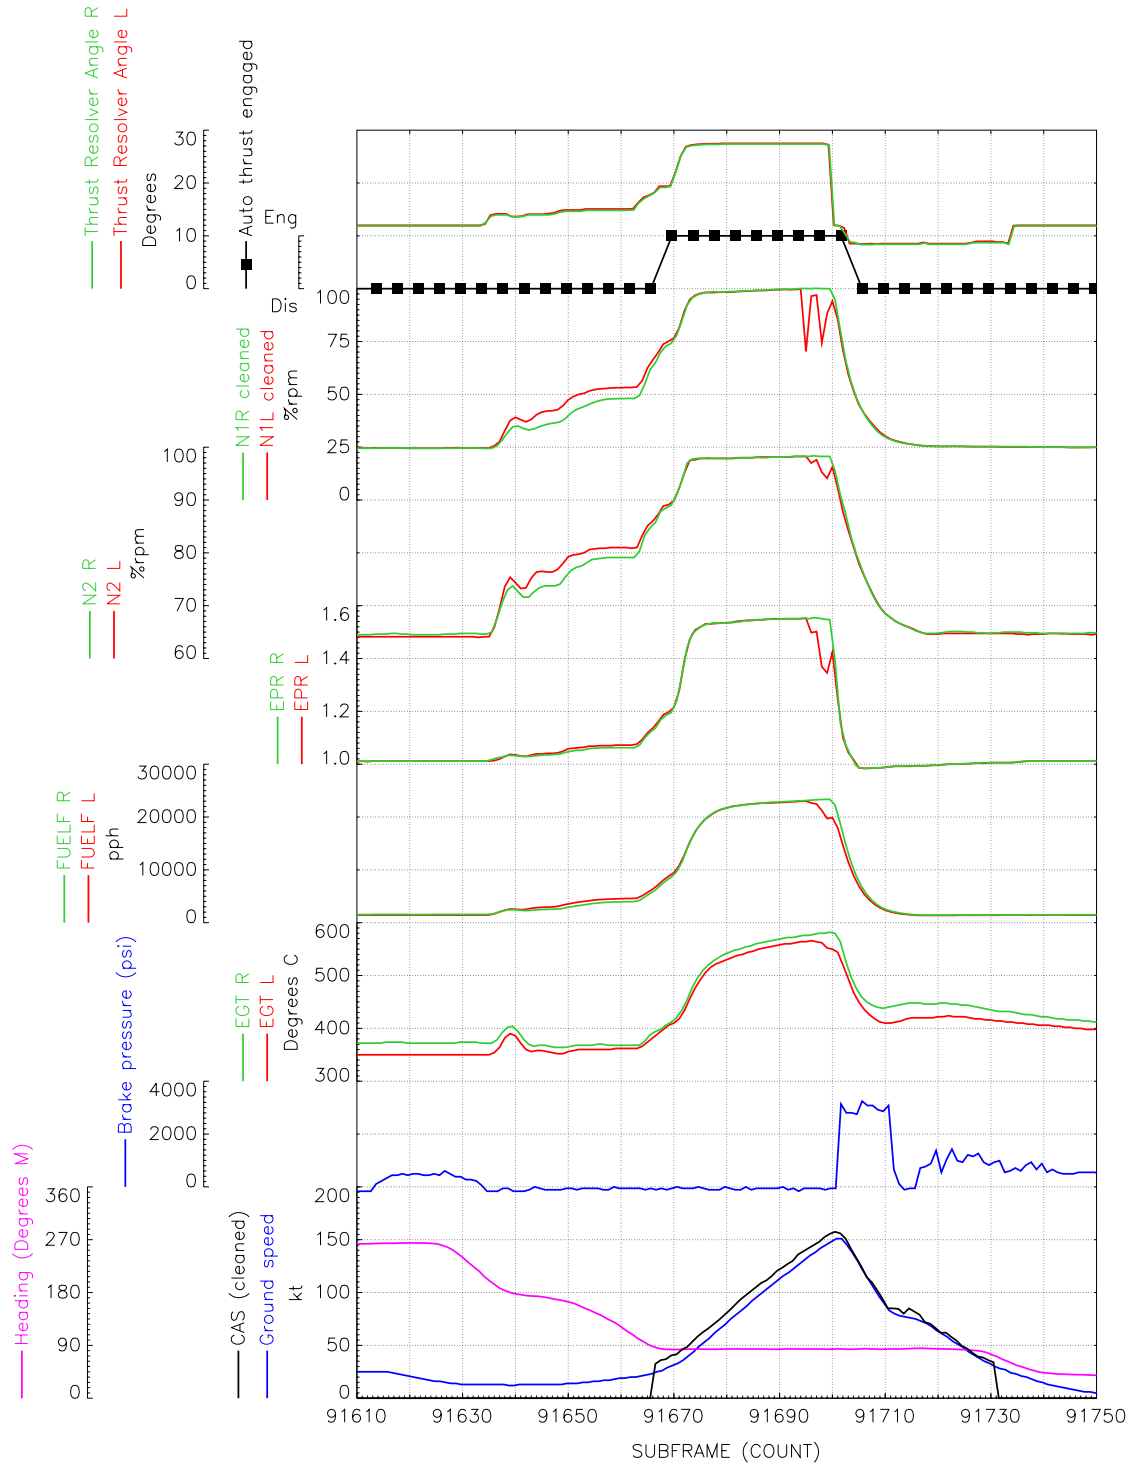
At 1942 hrs the brakes were released and the engine power was increased. The aircraft taxied with a ground speed of between 7 kt, in turns, and 25 kt, on straight sections of the taxiway. At 1950 hrs the aircraft was slowed to 12 kt and turned from the taxiway adjacent to the runway onto Runway 08R. The aircraft accelerated from half way through the turn, reaching 30 kt by the time the heading stabilised on the runway heading of 83°M. At this point the auto thrust was engaged, in takeoff mode, and the aircraft continued to accelerate, with the engine parameters matched throughout the acceleration period. The N_2 values reached a maximum of just under 98%, five seconds after turning on to the runway. The rise in N_1 and EPR started to stabilise shortly afterwards, although both continued to climb slightly throughout the takeoff run, and the EGTs continued to climb as the aircraft speed increased smoothly. Approximately 27 seconds after turning on to the runway, the N_1 of the left engine recorded a sharp drop from the previous 100% reading to a value of just over 70%. In the next second this recovered to 97% but the N_2 , EPR and fuel flow values showed a drop. Over the next four seconds the N_1 remained erratic and

Figure 1
Recorded engine parameters during the rejected takeoff.

the N_2 , EPR and fuel flow values decreased, at which point the thrust levers were retarded and the brakes were applied.

a replacement engine installed. The suspect engine was sent for examination to an overhaul organisation in Singapore, where the subsequent examination did not show any physical anomaly within the engine. However, it appeared from the recorded data that the engine behaviour had probably been caused by an intermittently erroneous LP rotor speed (N_1) signal. Such a signal fault would cause the FADEC to schedule fuel flow in an unusual manner, with a rapidly decreasing fuel flow when the indicated N_1 increased, followed by a corresponding reduction in fuel flow when the N_1 signal returned to a more normal level.
