Collision with passenger terminal, Fokker 50, OO-VLQ

Investigative Body: Aircraft Accident Investigation Board (AAIB), United Kingdom

ACCIDENT

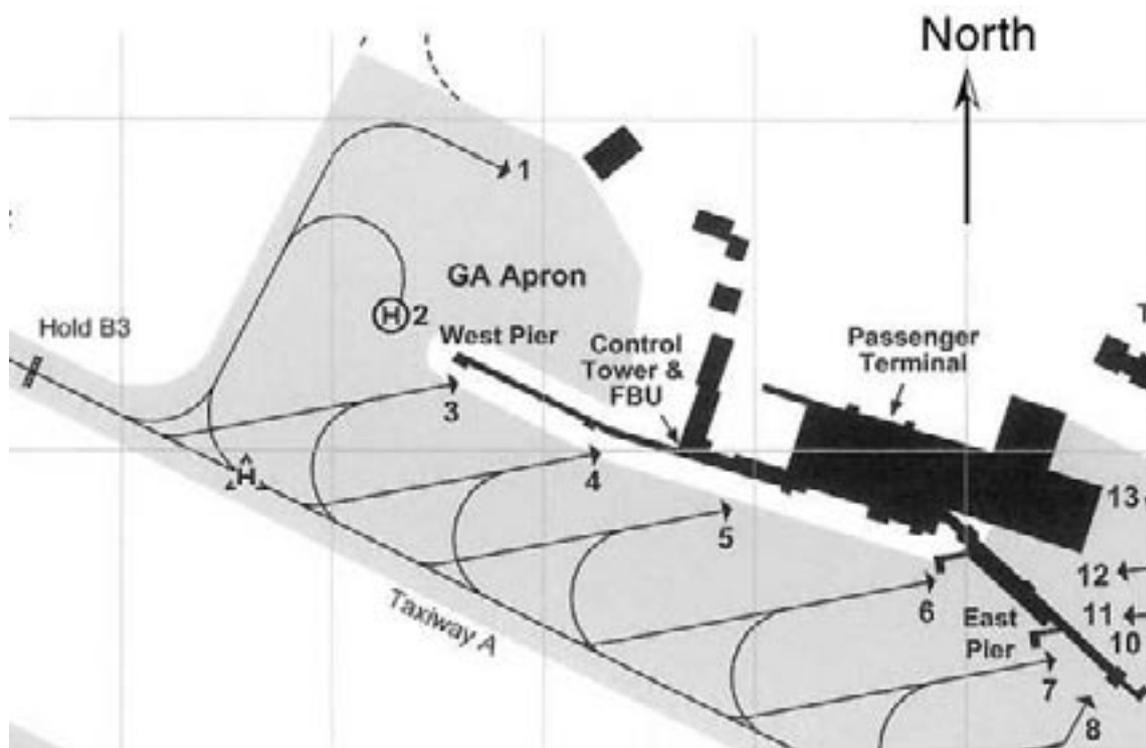
The aircraft dispatcher was standing at the end of the West Pier to wait for the aircraft to come onto Stand 3 (see Figure 2 for a plan of the stands). As the aircraft was being brought along the edge of adjacent Stand 2, he was not unduly alarmed by the approaching aircraft as he thought the marshaller was going to turn the aircraft quite late in order to line it up with the line on Stand 3, as this was common practise. When the aircraft was

Extract from Cardiff Airport AIP chart
