Hard landing, ATR 72-212A, D-ANFH, September 17, 2005

Investigative Body: Aircraft Accident Investigation Board (AAIB), United Kingdom

ACCIDENT

Synopsis

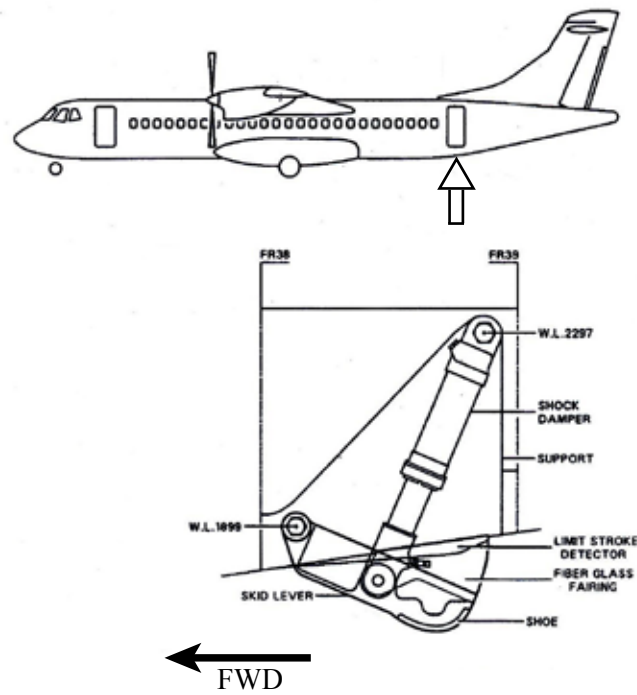
ATR 72 Tail skid detail

The aircraft was equipped with a tail skid, located between Frames 38 and 39, which comprised a skid lever, hinged at its forward end, and an oleo-pneumatic strut (shock damper) attached to its aft end. A steel shoe was attached to the underside of the lever; this had been painted red in order to provide readily visible evidence of skid contact. It was evident that both the shoe and front edge of the skid lever had suffered severe abrasion, with no trace of red paint remaining on the shoe. According to the aircraft Maintenance Manual, the installation was designed to:

The shock damper had a stroke of 112 mm and, when fully compressed, the forward edge of the skid lever was virtually parallel to, and slightly proud of, the fuselage skin. Two small fins are attached to the fuselage, one each side of the skid; these serve as 'limit strike detectors' and, on D-ANFH had been worn away. Figure 1 shows the damage to the fuselage and skid, together with a diagram of the skid components.

There was no doubt that the damage to the aircraft was consistent with the fuselage making contact with the runway, heavy enough to cause the tail skid damper to compress to its full limit of travel. The loss of material from the skid's shoe allowed the fuselage structure to contact the runway surface and be abraded. This was as a direct result of an excessive pitch attitude during the landing.

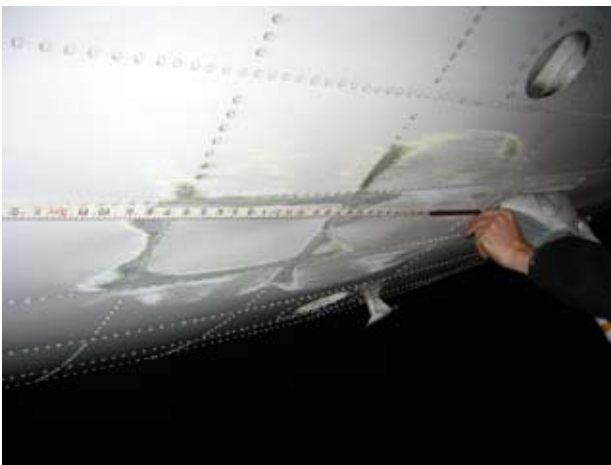
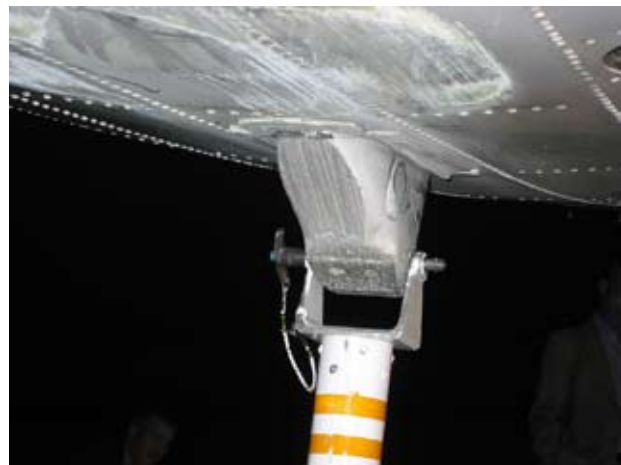
Figure 1

The aircraft's fuselage skin directly beneath the rear cabin door had been abraded, as a result of runway contact, over a length of approximately 0.9 m and

a width of some 0.5 m. This had affected fuselage Frame Nos 36 to 38, with the skin having worn through to the extent that the flanges of Frames 36 and 37 were exposed. The damage was symmetrical about the aircraft centre line, indicating that the aircraft was in a wings level attitude at the time it initially touched down.

Abrasion damage on fuselage underside

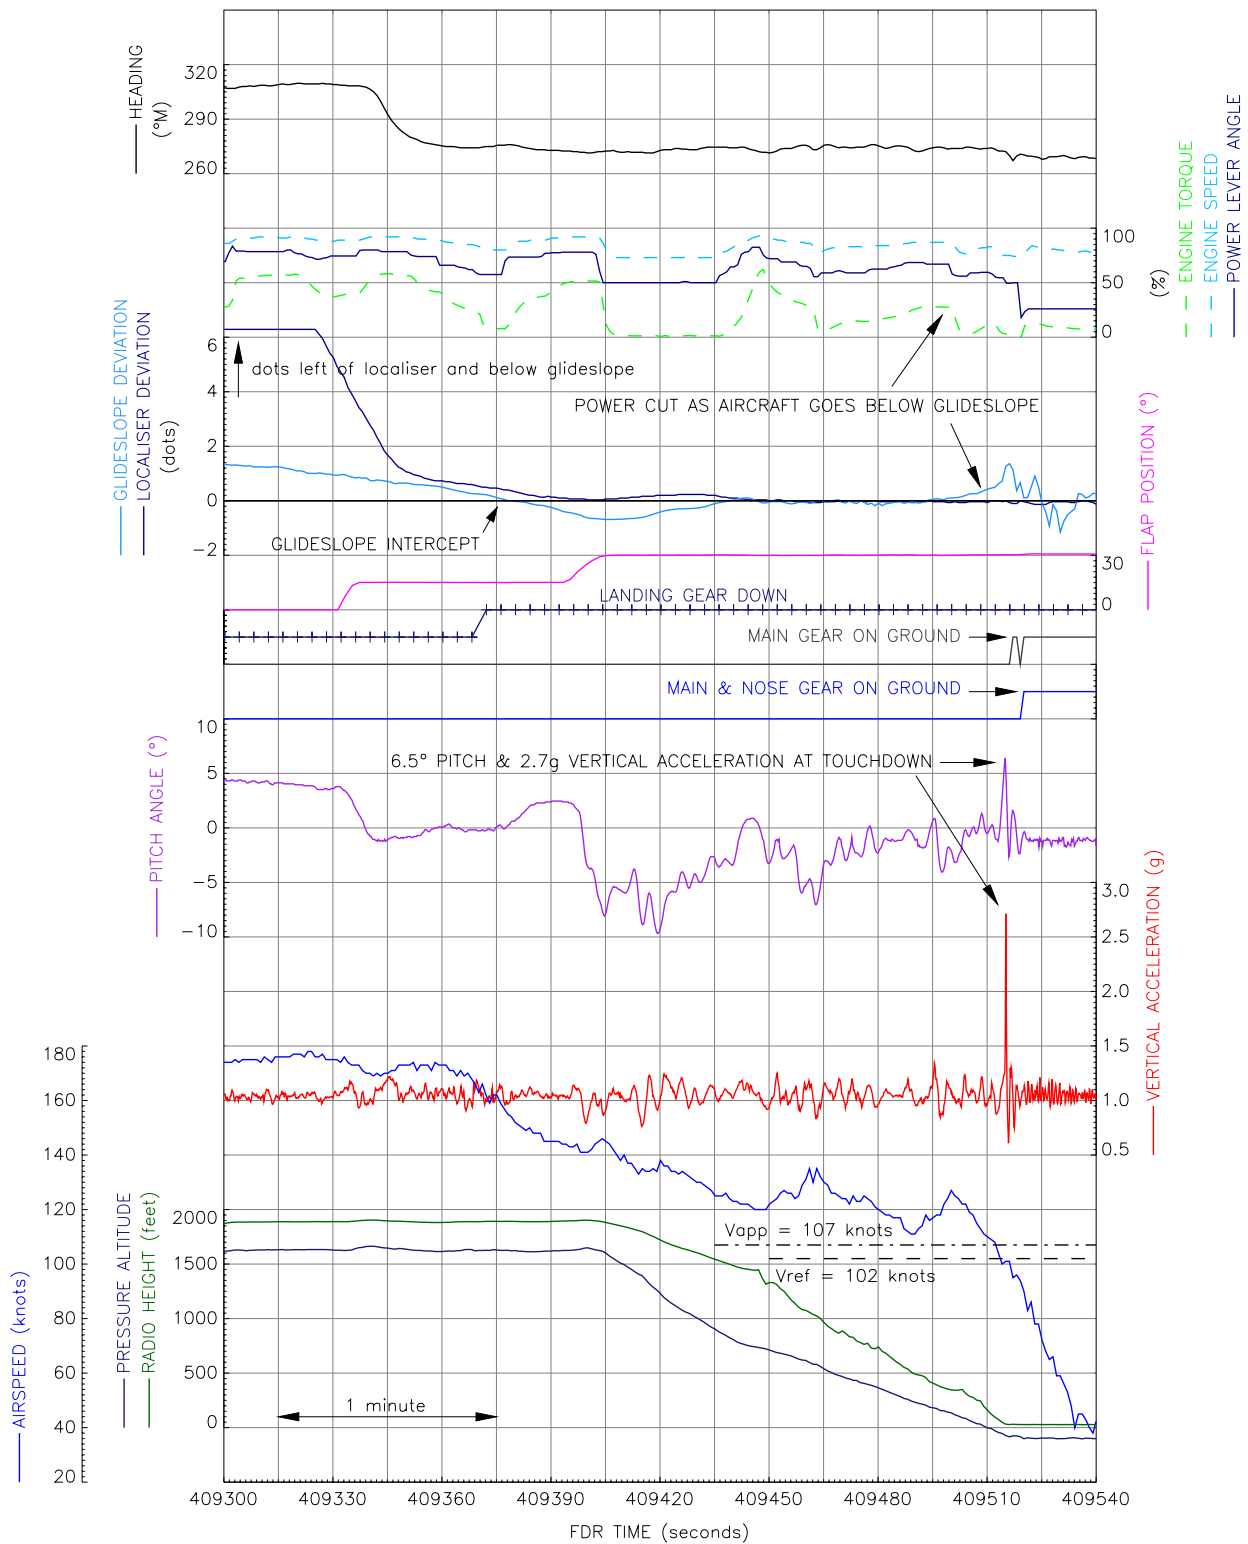
Figure 2
 Salient FDR Parameters – Approach and Landing
 (Accident to D-ANFH on 17 September 2005)

A time-history of the relevant parameters from the FDR during the approach and landing is shown at Figure 2. The data presented starts just over three and a half minutes before the touchdown with the aircraft in level flight at an altitude of approximately 1,800 ft, whilst flying at an airspeed of 175 kt and with the flaps and landing gear up. Some 30 seconds later, Flap 15 was selected and the aircraft turned to the left through 34°, to 275°M, on to an intercept with the Runway 27 localiser. Height and speed remained unchanged.

The aircraft remained on the glideslope, during which time the airspeed increased to 135 kt, then reduced to 110 kt, before increasing again to 118 kt, with corresponding changes in pitch and power, until it was at a height of approximately 500 ft, some 15 seconds before touchdown. The aircraft was then manoeuvred below the glideslope, with an initial 5° decrease in pitch attitude to -4°. This caused the airspeed to increase to 124 kt and, as the aircraft was pitched up to 0°, the torque on both engines reduced from 29% to 3%, then increased to 12%, following which the airspeed reduced to 107 kt (V_{APP}).

The flare began two seconds before the main wheels touched down, and the aircraft's pitch attitude increased to the maximum (recorded) value of +6.5°. At this time, the engine torque reduced from 12% to 3%. The recorded airspeed and vertical acceleration at touchdown were 100 kt ($V_{REF} - 2$) and 2.7g, respectively, with the main then nose gear squat switches signifying ground 'contact', over one second later.
