Nacelle collision with ground, Boeing 747-41R, G-VWOW

Micro-summary: While landing in a stiff crosswind, this Boeing 747's #1 engine nacelle touched the ground.

Investigative Body: Aircraft Accident Investigation Board (AAIB), United Kingdom

INCIDENT

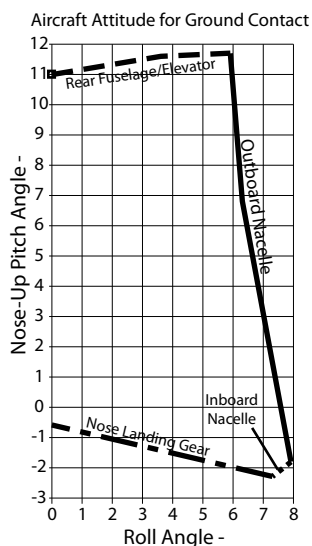
Figure 1

At the time of the examination, with the aircraft lightly loaded (no payload, 18,100 kg of fuel) and supported on its landing gear, the ground clearance of the outboard nacelles averaged 75 inches (1.9 m). Information from the 747-400 Flight Crew Training Manual indicated that, with the engine type fitted to G-VWOW, nacelle ground contact would occur with the combination of aircraft pitch and roll angles shown in Figure 1. The graph

related to a situation with relevant main landing gears in ground contact, with shock struts compressed, and the aircraft pitched about the body gear and rolled about a wing gear. It applied to a 'Normal Landing' situation and it was clear that changes in wing bending due to factors such as inertial loading and lift reduction on spoiler deployment could lead to significant variation in the roll angle at which nacelle ground contact would occur. The nacelle profile differs somewhat for the two other engine types that can be fitted to the B747-400 and it was noted that with one of these types the roll angle required for outboard nacelle ground contact at a given pitch angle can be up to 1° lower than shown in Figure 1.

small additional left control wheel input, coincident with speedbrake deployment, preceded a further roll excursion to the left. The pitch/roll angle combination recorded by the FDR did not reach the predicted attitude limits for nacelle ground contact but these would be affected by changes in wing bending. It was likely that this further roll excursion led to the engine pod contacting the ground. The commander commented that he did not detect this roll developing as he was concentrating on attempting to raise the thrust levers rapidly, as per the flight crew training manual, and he found some difficulty in doing so. It was also relatively dark outside and, together with rain on the windshield, this may have masked his perception of the changing attitude. He was also relatively inexperienced in the left hand seat on this aircraft, and the view over the reverse slope of the flightdeck coaming, compared to that from the right hand seat, may have hampered early recognition of an abnormal bank angle.

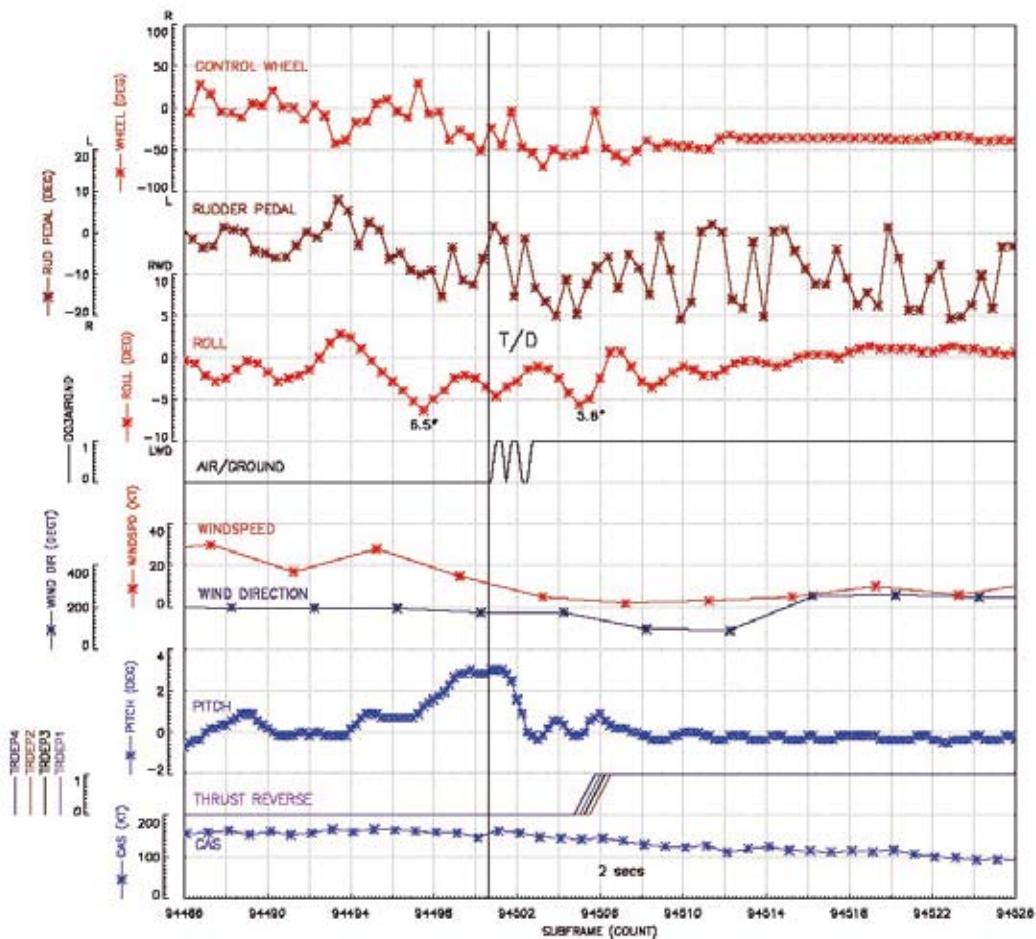
Figure 2
Relevant Flight Data Parameters

Data from the Flight Data Recorder (FDR) and Quick Access Recorder (QAR) were successfully recovered. A time history of relevant FDR parameters for the final approach and landing roll is shown in Figure 2. It can be seen that, up to about 6 seconds before touchdown, the recorded wind direction was generally from the south (actual direction about 200°), with a windspeed that varied from about 15 to 30 kt. Right rudder pedal was applied about 6 seconds before touchdown. The recorded QAR windspeed reduced to about 8 kt just before touchdown. These wind parameters were derived from inertial navigation system data. The aircraft appears

to have touched down with a small amount of left bank (about 2°) at about 147 kt. After touchdown, there was a rocking motion in roll with a period of about 4 seconds. The bank angle was generally about 2° to the left with an amplitude of about ±2°. After touchdown, left (into wind) control wheel was applied. About 5 seconds after touchdown, the bank angle reached a value of about 5.6° to the left. This coincided with the selection of the thrust reversers. It can also be seen that the control wheel was reduced to the neutral position when this bank angle was achieved, and that the bank angle returned to about zero. Thereafter, into wind (left) control wheel was applied for the remainder of the landing roll.
