## Late gear and flap selection, Boeing 767-200, N653US

**Micro-summary:** This Boeing 767-200 landed safely, but only after late gear and flap selection.

**Investigative Body:** Aircraft Accident Investigation Board (AAIB), United Kingdom

**INCIDENT**

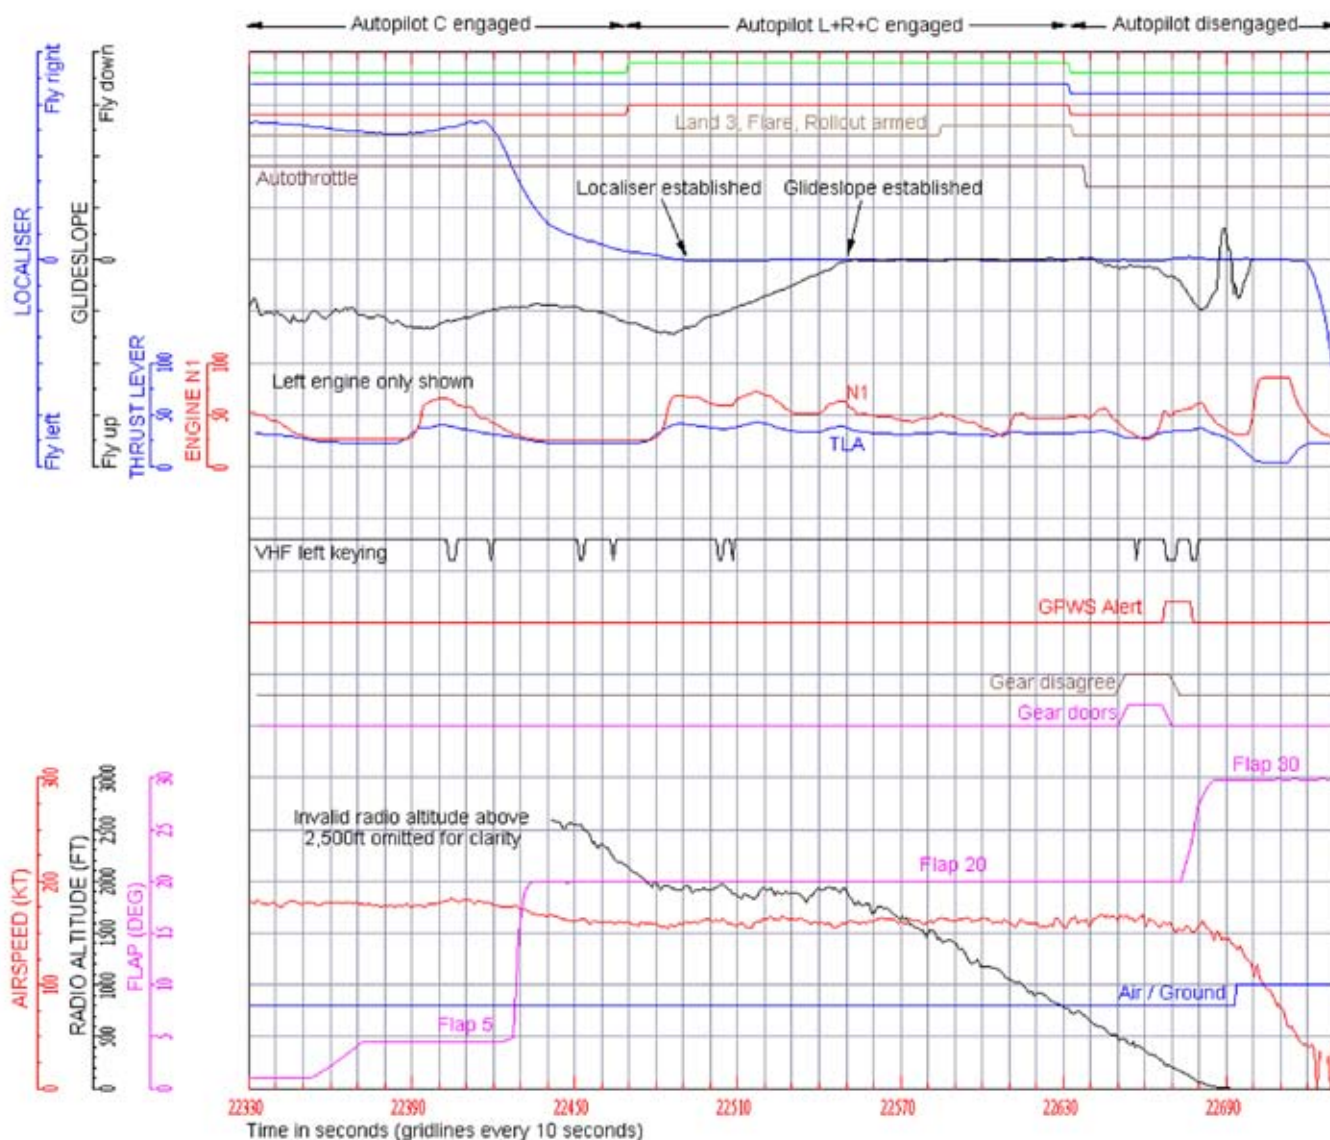
**Figure 1**  
Selected parameters

The flight data recorder was downloaded by the operator and data for the flight was recovered. A plot of selected parameters is included at Figure 1 and an expanded plot incorporating ATC recordings is provided at Figure 2. The significant parameters in the sequence of events are listed below:

- Flap 20 selected at 2,900 ft amsl
- Localiser established at 2,000 ft amsl
- Glideslope established and followed from 2,000 ft amsl
- At 740 ft agl autopilot disconnected
- At 711 ft agl autothrust disconnected
- At approximately 500 ft agl, gear lever moved down (this occurred between 2 and 4 seconds before ATC queried the gear position)
- At 420 ft agl, whilst gear doors were open and gear position disagreed with gear lever position, N653US crew responded to ATC confirming three greens
- At 229 ft agl, GPWS alert began
- Between 225 ft agl and 175 ft agl crew confirmed three gear down and locked. During this transmission the gear doors closed and gear position agreed with lever position (gear down)
- At 170 ft agl, flaps began to extend past 20°

- 5 seconds later at 90 ft agl flaps moved through 25° and GPWS alert stopped
- 7 seconds later, at 16 ft agl, flaps reached 29.7 deg (stopped)
- 9 seconds later, aircraft touched down

The recorded flight data indicated that there was a GPWS mode 4b alert active for a period of eleven seconds.

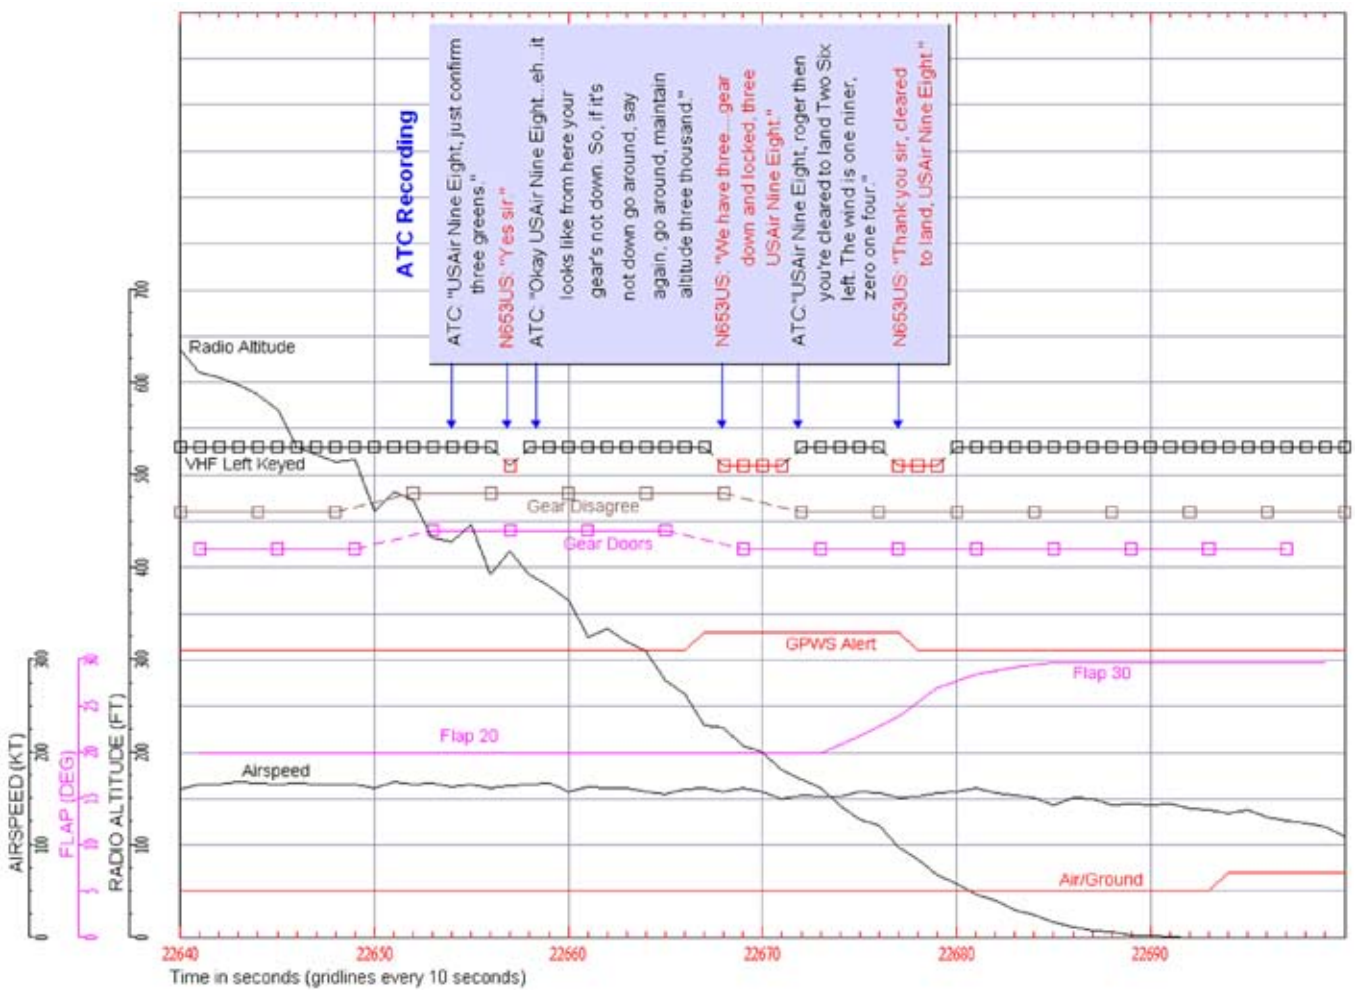
**Figure 2**  
Expanded plot incorporating ATC recordings

The tower controller saw the aircraft on short final approach and noticed that the landing gear was not down. He contacted the aircraft to advise the crew and gave an instruction that if the gear was not down they should go around. The crew replied that the gear was down and the controller then issued a landing clearance. The flap reached 30° shortly before touchdown and an uneventful landing was carried out.
