Struck by baggage belt vehicle, Boeing 737-8AS, EI-DAP, November 26, 2005

Investigative Body: Aircraft Accident Investigation Board (AAIB), United Kingdom

INCIDENT

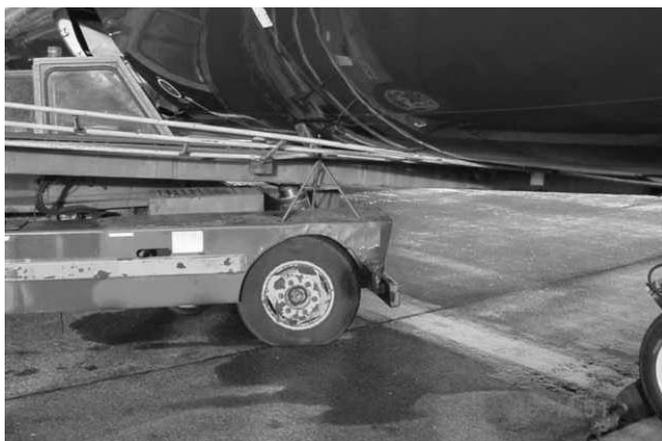
Figure 1

manoeuvred towards the front hold. As the vehicle approached the aircraft the driver put his foot on the brake, however the pedal went all the way to the floor without slowing the vehicle. The driver tried, but failed, to grasp the hand brake and he reacted by steering the vehicle to the right to avoid the open cargo hold. The conveyer belt, which overhangs the front of the vehicle, struck the aircraft bringing the vehicle to a stop (see Figure 1).

Photograph taken shortly after the collision showing the baggage belt vehicle and the aircraft fuselage

It was possible to push the pedal through the full length of travel without resistance. The hydraulic pipe leading to the brake cylinder on the front offside wheel was found fractured which had caused immediate loss of brake fluid pressure and it was concluded that the driver would have had no prior warning of the failure. The independent inspection did not attempt to determine why the pipe had fractured.

The front section of the parking brake cable, which had been replaced in June 2005, was found to be seized. There was therefore no parking or emergency braking available, a defect that would have been noticeable, for example during a daily check. The parking brake system downstream of the seized cable was found to operate satisfactorily.

The incident was caused by a failure in the hydraulic pipe for the brakes. The vehicle had been serviced twice in the 14 months prior to the incident and on two occasions (12 and 14 months prior to the incident) parts of the brake pipe system had been replaced. However, the vehicle became unsafe within six months of its last service. The impending brake pipe failure and the defective parking brake might have been detected had a daily check, or a quarterly service, together with an effective defect reporting system been used.

- a) A full review of: the ground vehicle fleet; the defect reporting system; the maintenance reporting process; the content and the frequency of the servicing schedule and the manning levels in the Motor Transport department.
- b) A review of a range of activities to improve the awareness of prompt and effective use of emergency procedures. This includes the immediate reporting by ground handlers to the aircraft captain of any ground incident.

It is recommended that the Civil Aviation Authority should remind airport operators that their Safety Management Systems should ensure that safe standards of maintenance and use are applied to all vehicles and mobile ground equipment used in the proximity of aircraft.
