Cabin smoke, Airbus A340-642, G-VGOA, December 30, 2005

Investigative Body: Aircraft Accident Investigation Board (AAIB), United Kingdom

INCIDENT

Aircraft Type and Registration:	Airbus A340-642, G-VGOA	
No & Type of Engines:	4 Rolls-Royce Trent 556-61 turbofan engines	
Year of Manufacture:	2001	
Date & Time (UTC):	30 December 2005 at 1528 hrs	
Location:	After takeoff from London Heathrow Airport	
Type of Flight:	Public Transport (Passenger)	
Persons on Board:	Crew - 18	Passengers - 308
Injuries:	Crew - None	Passengers - None
Nature of Damage:	None	
Commander's Licence:	Airline Transport Pilot's Licence	
Commander's Age:	43 years	
Commander's Flying Experience:	11,238 hours (of which 2,092 were on type) Last 90 days - 173 hours Last 28 days - 73 hours	
Information Source:	Aircraft Accident Report Form submitted by the pilot and further enquiries by the AAIB

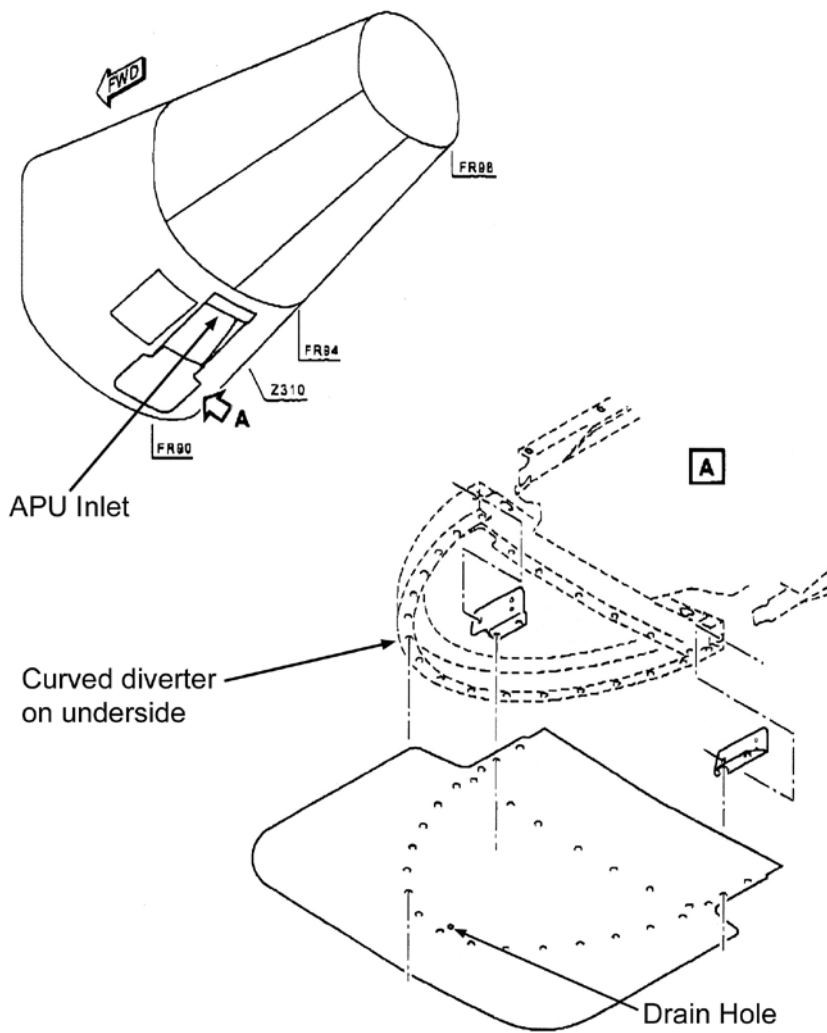
A week later, during a routine inspection of the APU, an engineer noticed a small drain hole (approximately 1/8 inch in diameter) located aft of the curved APU diverter¹ (see Figure 1). He reported that it was very difficult to spot. When he attempted to check if the hole was clear almost a litre of an oil-water mixture drained out. The panel containing the drain hole was removed and the area inside was found to be wet and contaminated. The operator suspected that a build-up of dirt and dried oil had blocked the hole.

1 The curved diverter on the underside of the aircraft, forward of the APU inlet, serves to divert any fluid streaming aft along the fuselage's underside from entering the APU. It does not prevent fluid from the drain hole entering the APU.

Figure 1
Location of drain hole relative to diverter and APU inlet

A build-up of dirt and oil in the drain hole aft of the diverter had caused a blockage which prevented oil

and other fluid contaminants draining overboard. If this blockage were to unblock suddenly, for example due to the vibration during a takeoff, then the released fluid could easily be ingested by a running APU. Once ingested this contaminant could pass into the bleed air duct and subsequently into the cabin air conditioning system. This scenario probably explains the oily smell and mist observed in the cabin during takeoff.

In response to this incident, the operator decided to raise a new maintenance task requiring an inspection of the drain hole at every A check. The aircraft manufacturer was informed of the decision. The reason for the low jettison rate had not been determined by the aircraft manufacturer at the time of writing.
