Ground collision on pushback, Boeing 777-236, G-ZZZC

Investigative Body: Aircraft Accident Investigation Board (AAIB), United Kingdom

ACCIDENT

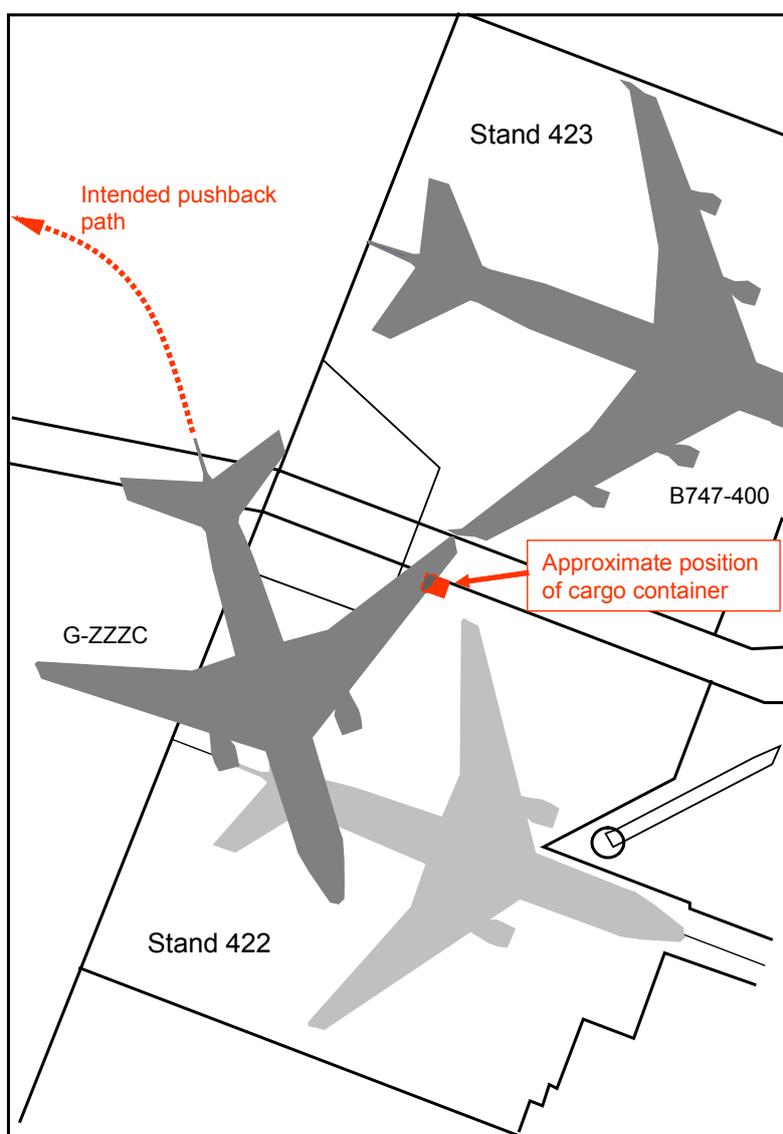
Figure 1

pushed back onto the taxiway centreline in readiness for taxiing out of the 'cul-de-sac' (Figure 1). The specific duties of the observers were to ensure safe clearance of the left wing tip during the initial pushback, and then to ensure clearance of the tail from the blast screen at the 'cul-de-sac' head during the latter stages of the manoeuvre. Any hazard was required to be communicated directly to the TBL driver by the use of approved hand signals, and this requirement meant that the observers were to remain in direct sight of the driver at all times during the pushback.

Aircraft positions at point of collision

As the pushback progressed and the wing of G-ZZZC approached the Boeing 747-400, the wing observer found himself behind the container and may have been momentarily out of the driver's sight. As the wing observer moved around the container he continued to indicate a safe clearance by holding his arms out horizontally but shortly afterwards quickly changed the signal to an arms crossed 'stop' signal and shouted to the TBL driver. The driver saw the signal and stopped the pushback, but not before the left wing tip had struck the right winglet of the parked aircraft.
