Hydraulic accumulator burst on approach, BAe 146-300, G-JEBB

Investigative Body: Aircraft Accident Investigation Board (AAIB), United Kingdom

Aircraft Type and Registration:	BAe 146-300, G-JEBB	
No & Type of Engines:	4 Lycoming ALF502R-5 turbofan engines	
Year of Manufacture:	1991	
Date & Time (UTC):	15 February 2006 at 1330 hrs	
Location:	Approach to Birmingham International Airport	
Type of Flight:	Public Transport (Non revenue)	
Persons on Board:	Crew - 3	Passengers - None
Injuries:	Crew - None	Passengers - N/A
Nature of Damage:	Ruptured hydraulic accumulator and small hole in fuselage pressure hull	
Commander's Licence:	Airline Transport Pilot's Licence	
Commander's Age:	35 years	
Commander's Flying Experience:	4,500 hours (of which 3,000 were on type) Last 90 days - 82 hours Last 28 days - 28 hours	
Information Source:	Aircraft Accident Report Form submitted by the pilot and metallurgical examination commissioned by the AAIB

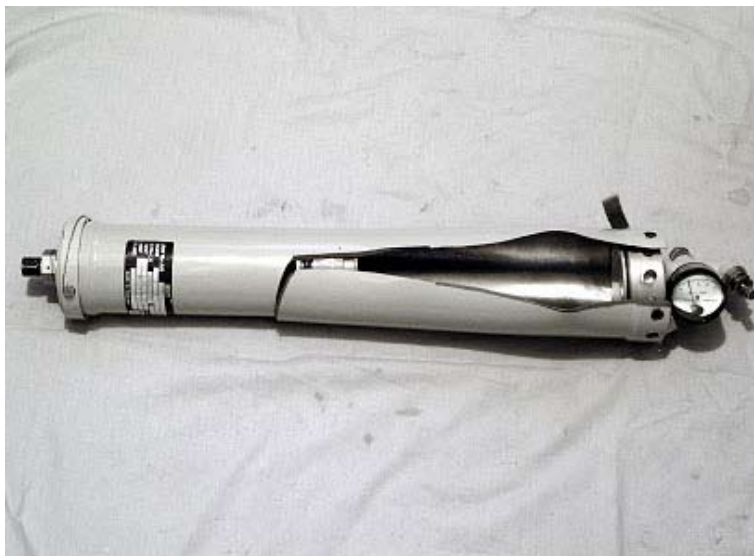
After the shutdown checks were completed it was determined that the yellow system accumulator had burst causing immediate loss of functionality of the yellow hydraulic system. Moreover a metal pin from the accumulator had pierced the fuselage pressure hull.

Figure 1
Accumulator as removed from
the aircraft

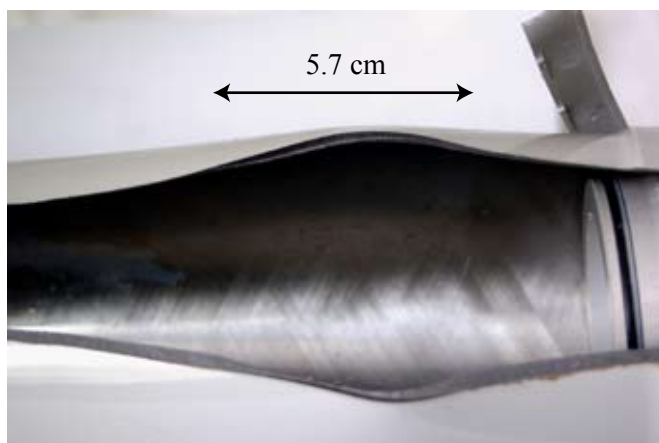
Figure 2

The damaged accumulator was subject to a metallurgical examination which resulted in two inclusions being found in the cylinder wall. These inclusions were thin strands of non-metallic material that were present in the bar stock prior to machining and were located on the outer face of the cylinder wall running longitudinally. The longer inclusion (see Figure 2) was 5.7 cm long and was where the cylinder initially burst. This was immediately followed by failure of the cylinder wall at the second inclusion. Both the inclusions had reduced the wall thickness locally by approximately two thirds and the discontinuities in the cylinder wall had subsequently grown as a result of low cycle, high stress fatigue (see Figure 3).

Photograph showing the location of the primary inclusion

The failure of the hydraulic pressure accumulator was caused by a pre-existing inclusion of non-metallic material, and this defect progressed through low cycle fatigue resulting in the cylinder bursting.

The manufacturer of the accumulator and the manufacturer of the aircraft were promptly informed of the results of the metallurgical examination. They have examined their inspection records and, at the time of writing this report, are putting in place a programme which includes non-destructive crack detection of those components considered to be at risk. They

are also reviewing the inspection and manufacturing processes for the accumulators. In view of this it is not considered necessary for the AAIB to make any safety recommendations.

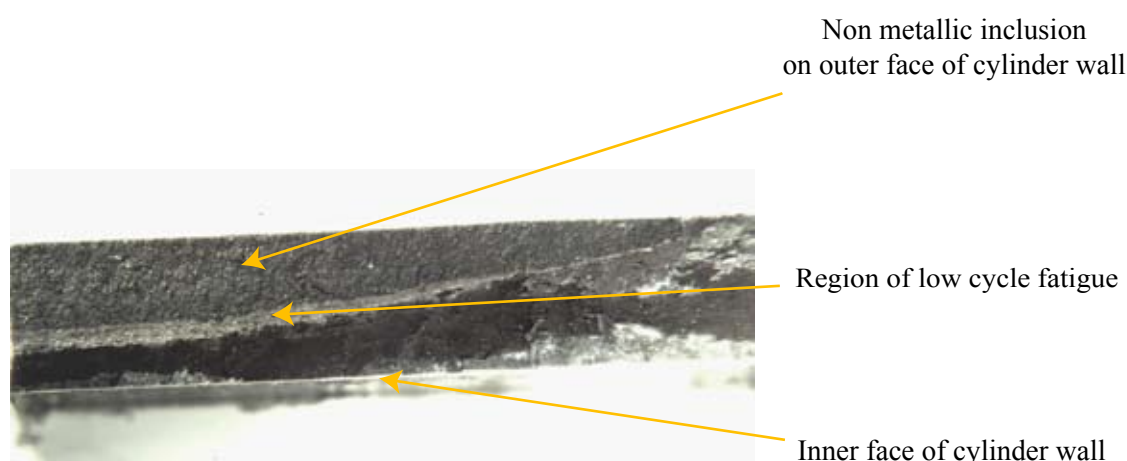
Figure 3

Photograph showing one end of the fracture face for the shorter of the two inclusions

This type of inclusion in the cylinder can arise if insufficient material is machined away at various stages in the production of the cylinder from the solid steel bar stock. Any defects remaining after machining should have been detected by the subsequent magnetic particle inspection and should have resulted in the cylinder component being rejected.
