## Altitude excursion on SRA approach, Boeing 757-2T7, G-MONE, March 17, 2006

**Micro-summary:** This Boeing 757-2T7 descended beneath glide slope on a surveillance radar approach.

**Event Date:** 2006-03-17 at 1945 UTC

**Investigative Body:** Aircraft Accident Investigation Board (AAIB), United Kingdom

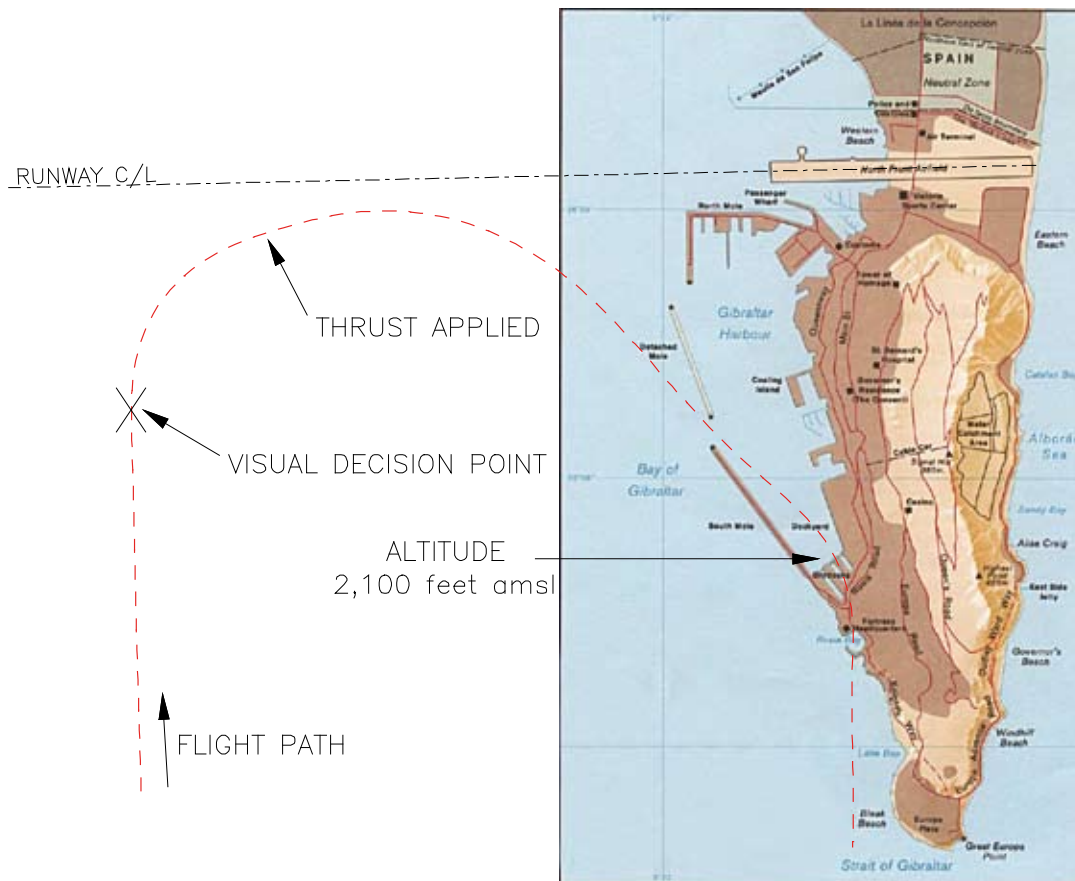
**Figure 1**

The flight path of the aircraft during the incident period was constructed from data recorded on the QAR. This flight path is presented in Figure 1. It commences as G-MONE tracked north on 001°M towards the VDP. At the VDP, the aircraft was at an altitude of approximately 1,000 ft, at a computed airspeed of 133 kt, and was descending at just under 900 ft/min. G-MONE then entered a descending turn to the right, achieving a maximum recorded bank angle of just over 26°.

Thirty seconds after the aircraft commenced the turn, the engine thrust increased for the 'Go-Around'. At this point G-MONE was descending through 650 ft at 134 kt, with a bank angle of 8° to the right and turning through a heading of 077°M. The aircraft descended a further 100 ft to 550 ft before it entered a climb. It then achieved a climb rate of about 3,000 ft/min whilst turning onto a heading of 140°M. It remained on this heading for 12 seconds before turning left onto a heading of 134°M for a further 12 seconds, followed by a turn to the right onto a heading of 180°M. As G-MONE turned onto the heading of 180°M, it was overland and climbing through 2,100 ft.

Reconstructed flight path of G-MONE
