## Aircraft accident report, Mandala Airlines MDL493, Boeing B737-200 Adv PK-RIL, Hasanuddin Airport, Ujungpandang, South Sulawesi, 5 April 1999

KNKT/99.06/02.04.008

AIRCRAFT ACCIDENT REPORT

Boeing B737-200 Adv PK-RIL

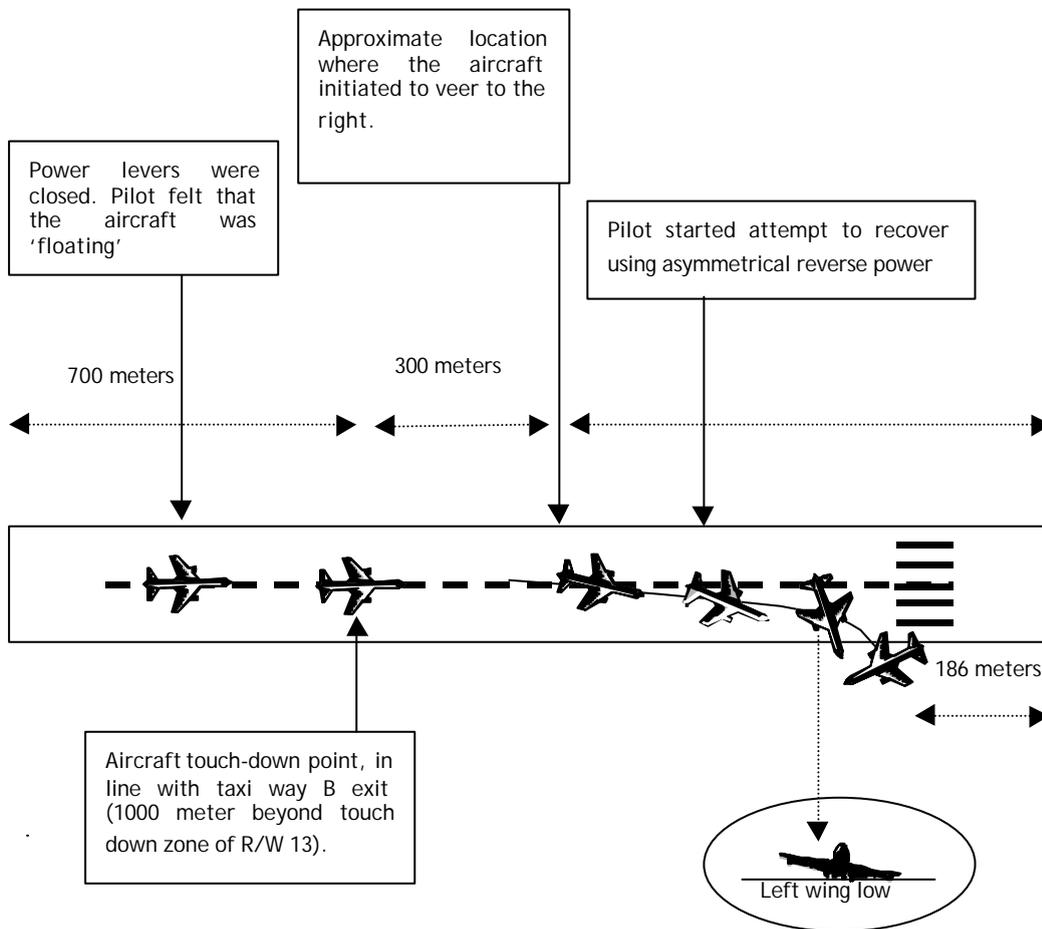
**Figure 2. Aircraft ground roll trajectory (sketch)**

The final position of the aircraft was at 186 meters from the R/W 13/31 threshold. No tire markings of first touch down were found on the runway, although it was reported that the approximate touch-down point was in line with the taxiway B exit, approximately 1000 meters beyond the R/W 13 touch down zone.

No tire brake markings were found along the approximate ground roll trajectory. Rubber deposits were found on R/W 13 at the point where the aircraft started veering to the right, which was at approximately 75 meters before the location where aircraft went off the runway. The significant facts and findings gathered were analyzed. The SHELL concept approach was used in the analysis. The analysis of the events and circumstances which may have contributed to the occurrence were weather conditions, wind measuring equipment, aircraft systems, flight and ground operations procedural deficiencies.

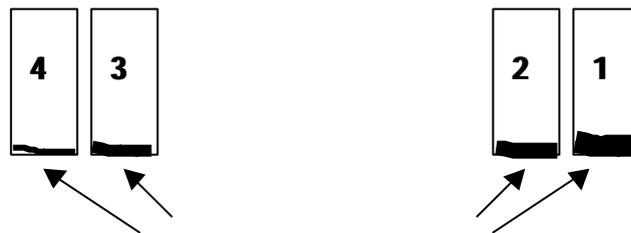
**Figure 3. The tire damage on the main wheel surfaces (worn spots on each main wheel) - front view**

One worn spot in line on all main tires were found and the #1 tire had the worst and followed linearly by #2 tire and #3 tire. The #4 tire was identified having a smaller worn spot mark than the others.

- 6) **Landing gear**. All landing gear tires showed worn out spots. The worst damage was found on the landing gear #1 tire, linearly diminishing in size, the worst or the largest worn out areas were found on landing gear tire #1 gradually diminishing in size on tires #2, #3 and #4. The worn out spot sizes were approximately 20x30 sq cm and less. The #1 landing gear damage is most likely due to high loading during the high speed right turn of the aircraft, which was also evidenced by the separation of the #1 engine.

- The damage to the tire surfaces indicates that the #1 tire experienced the highest loads during the landing maneuver, evidenced also by the separation of the #1 engine during the landing. The existing airport infrastructure was not sufficient to make instrument approaches on R/W 31. The only approach procedures published are ILS and VOR approaches for R/W 13 only. Note that at the time of the occurrence it was raining and the wind velocities and direction were northerly with gusts of up to 20 kts, while the aircraft operation manual procedures stated a tailwind limit of 20 kts during landings. It is noted that the weather monitoring system equipment is located near the tower at about 50 meters distance from the runway. During the landing maneuver, the approach control communicated with, and controlled the aircraft until touch-down.

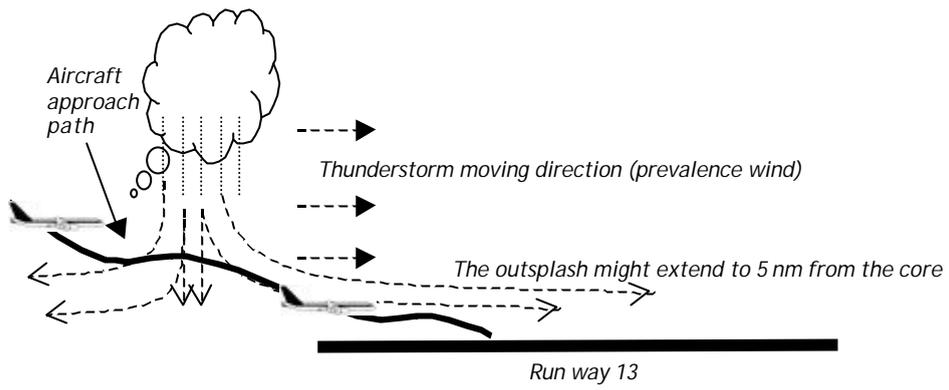
**Figure 4. The aircraft approach path illustration**

Note that these weather data may well point to wind changes that has the characteristics of wind bursts in the Hasanuddin Airport surrounding areas, resulting the aircraft touching down at approximately 3,000 ft beyond the target touchdown point.

- The aircraft was floating and the touch down was approximately 1000 meters beyond the target touch-down point. The cockpit crew apparently did not rely on the flight instrument readings, but seemed to trust visual observations of the environmental and weather conditions.
