Uncontained engine failure, Aircraft Accident Report, Garuda Indonesia Flight GA 880, Boeing B747-200 PK-GSD, In flight (21 minutes after takeoff from Denpasar, Bali), 23 November 2001

KNKT/01.27/03.01.009

AIRCRAFT ACCIDENT REPORT

Garuda Indonesia Flight GA 880

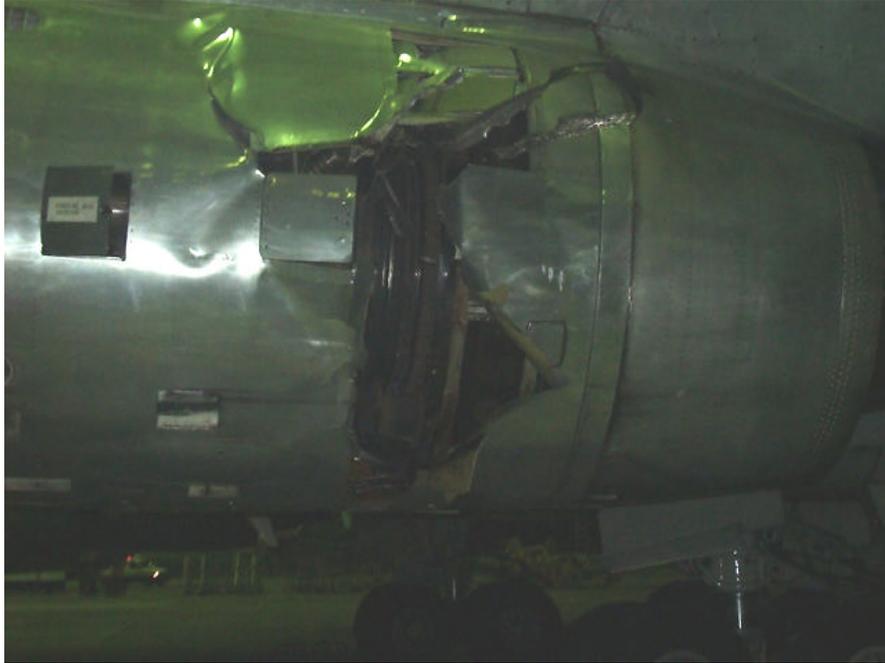
- Damages on outboard engine cowling and outer casing (see Figures A1, A2).
- Rupture on LPT casing, i.e. 5th and 6th stage outer airseal at 6 - 10 o'clock¹ position (see Figure B2).

Figure A1. Damage on Engine #2 casing (1)

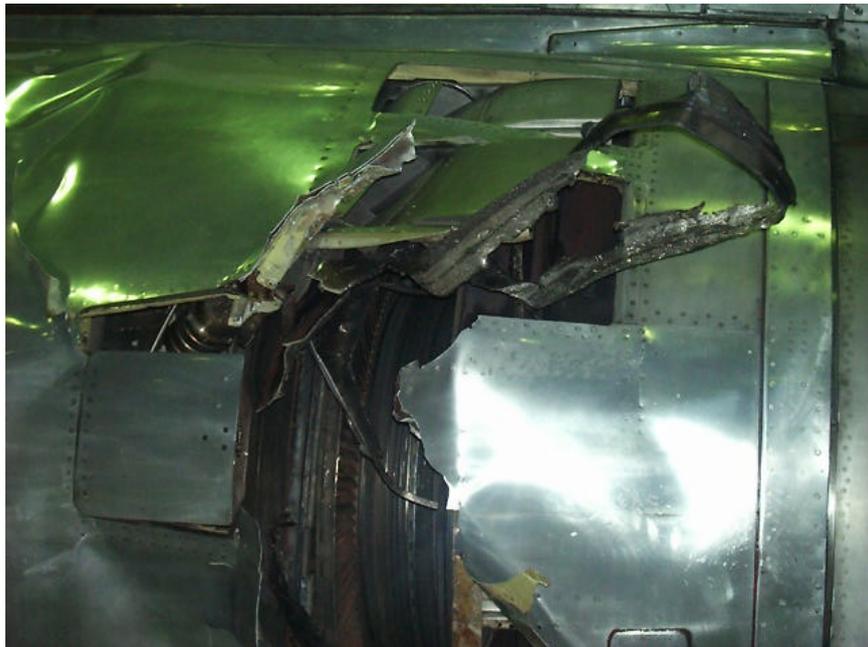
Figure A2. Damage on Engine #2 casing (2)

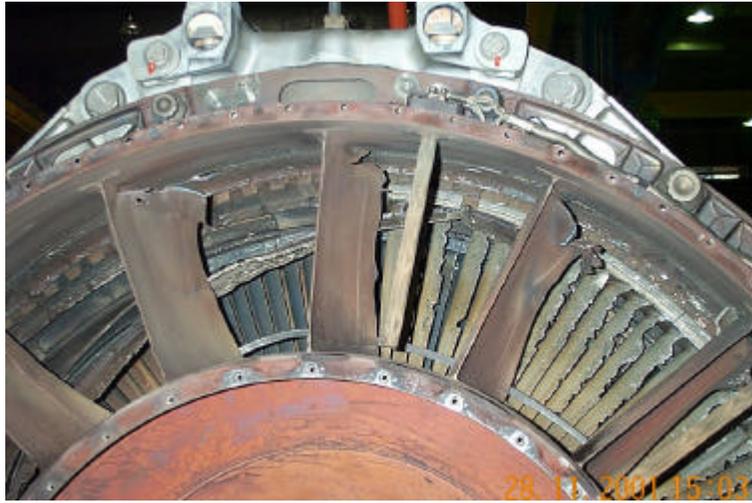
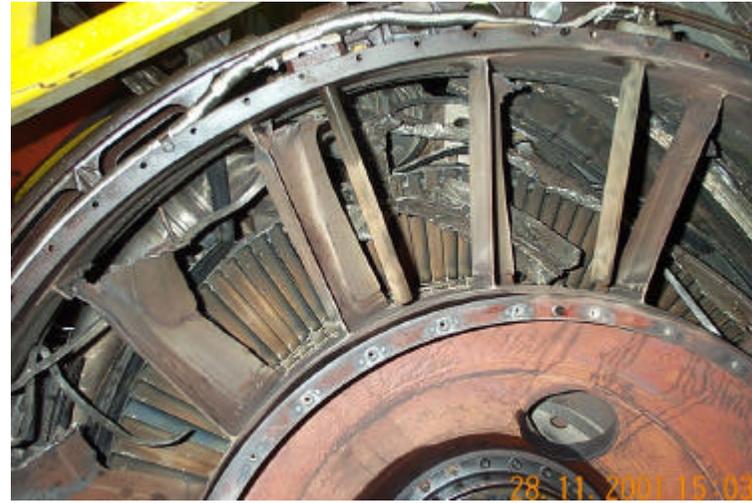
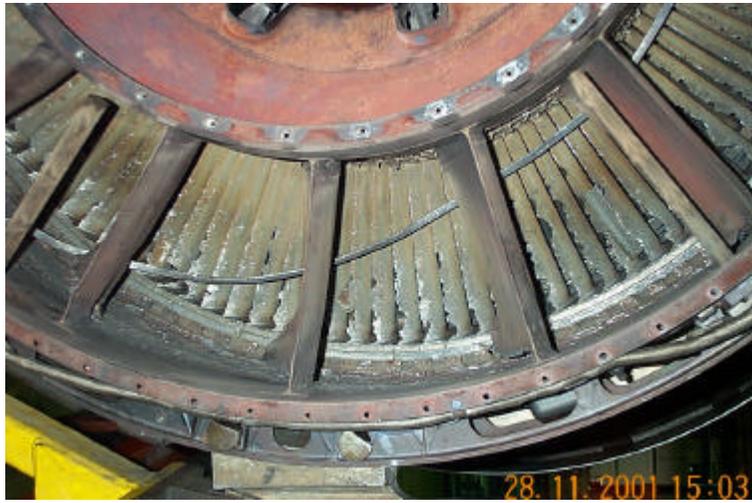
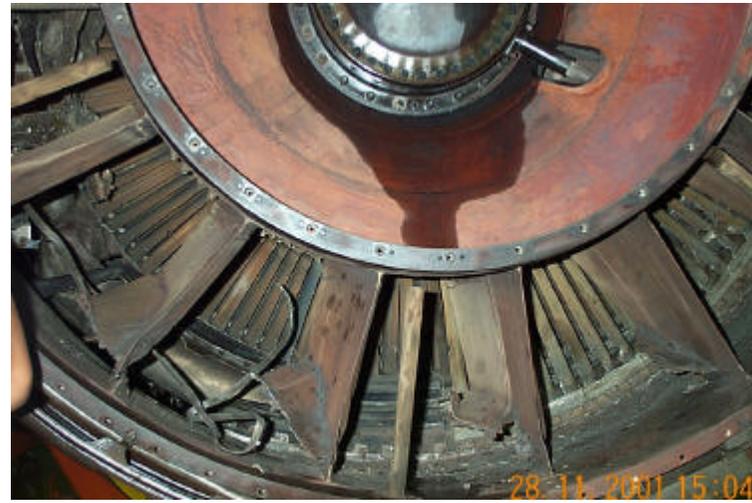
- Minor damages on the tailcone and flange bolt recess cavities.
- Severe impact damages on the turbine exhaust case and exhaust guide vanes (see Figures A3-A6).

Figure A3, A4, A5, A6. Engine #2 EGV

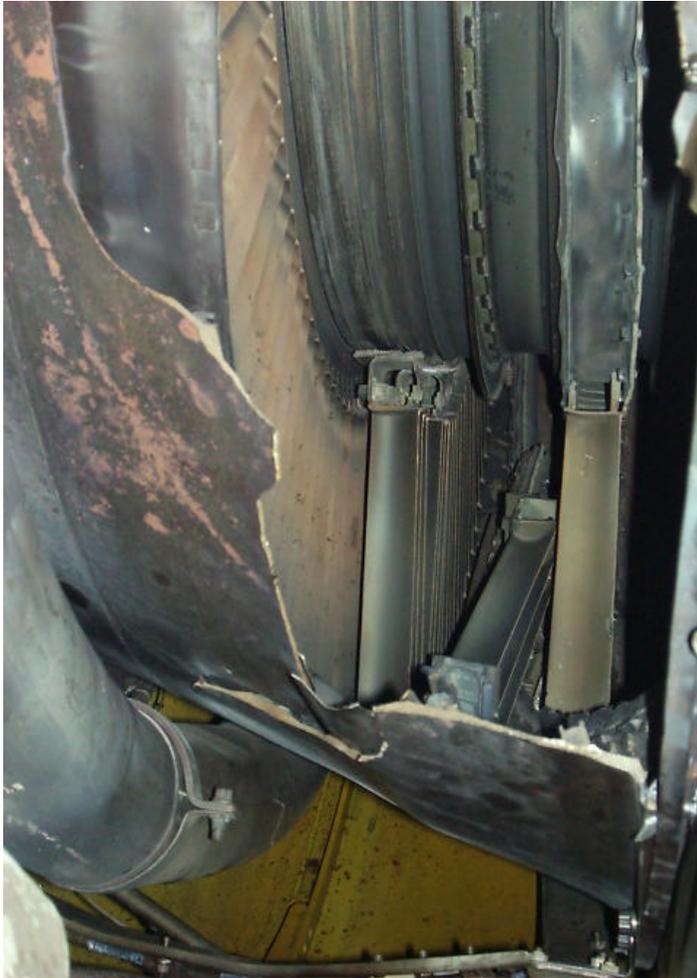
Figure A7. Engine #2 LPT Module, 5th and 6th stage (1)

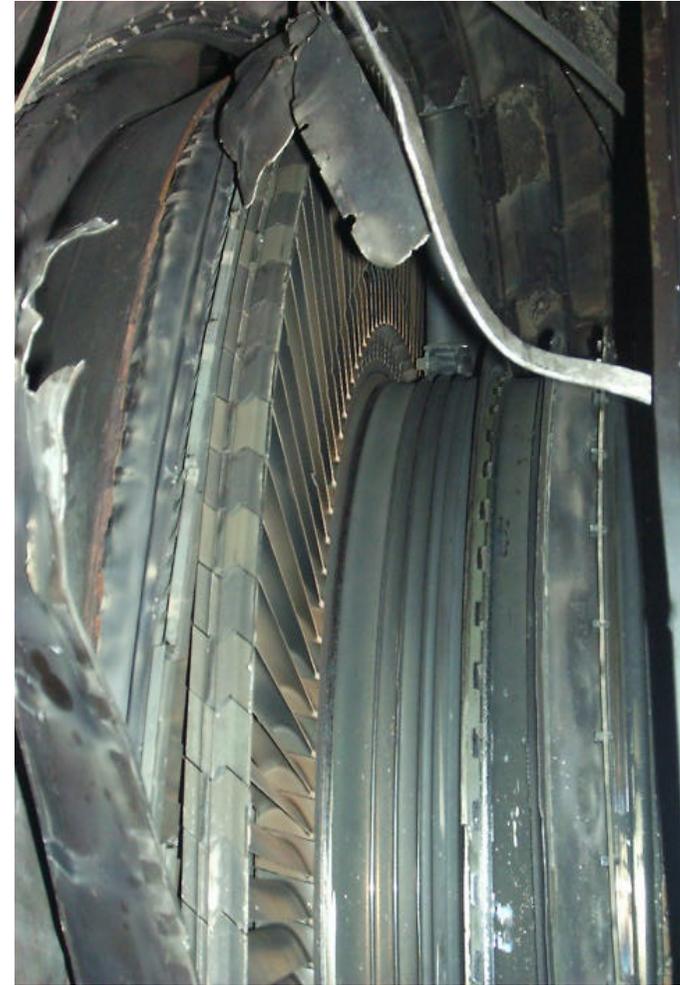
Figure A8. Engine #2 LPT Module, 5th and 6th stage (2)

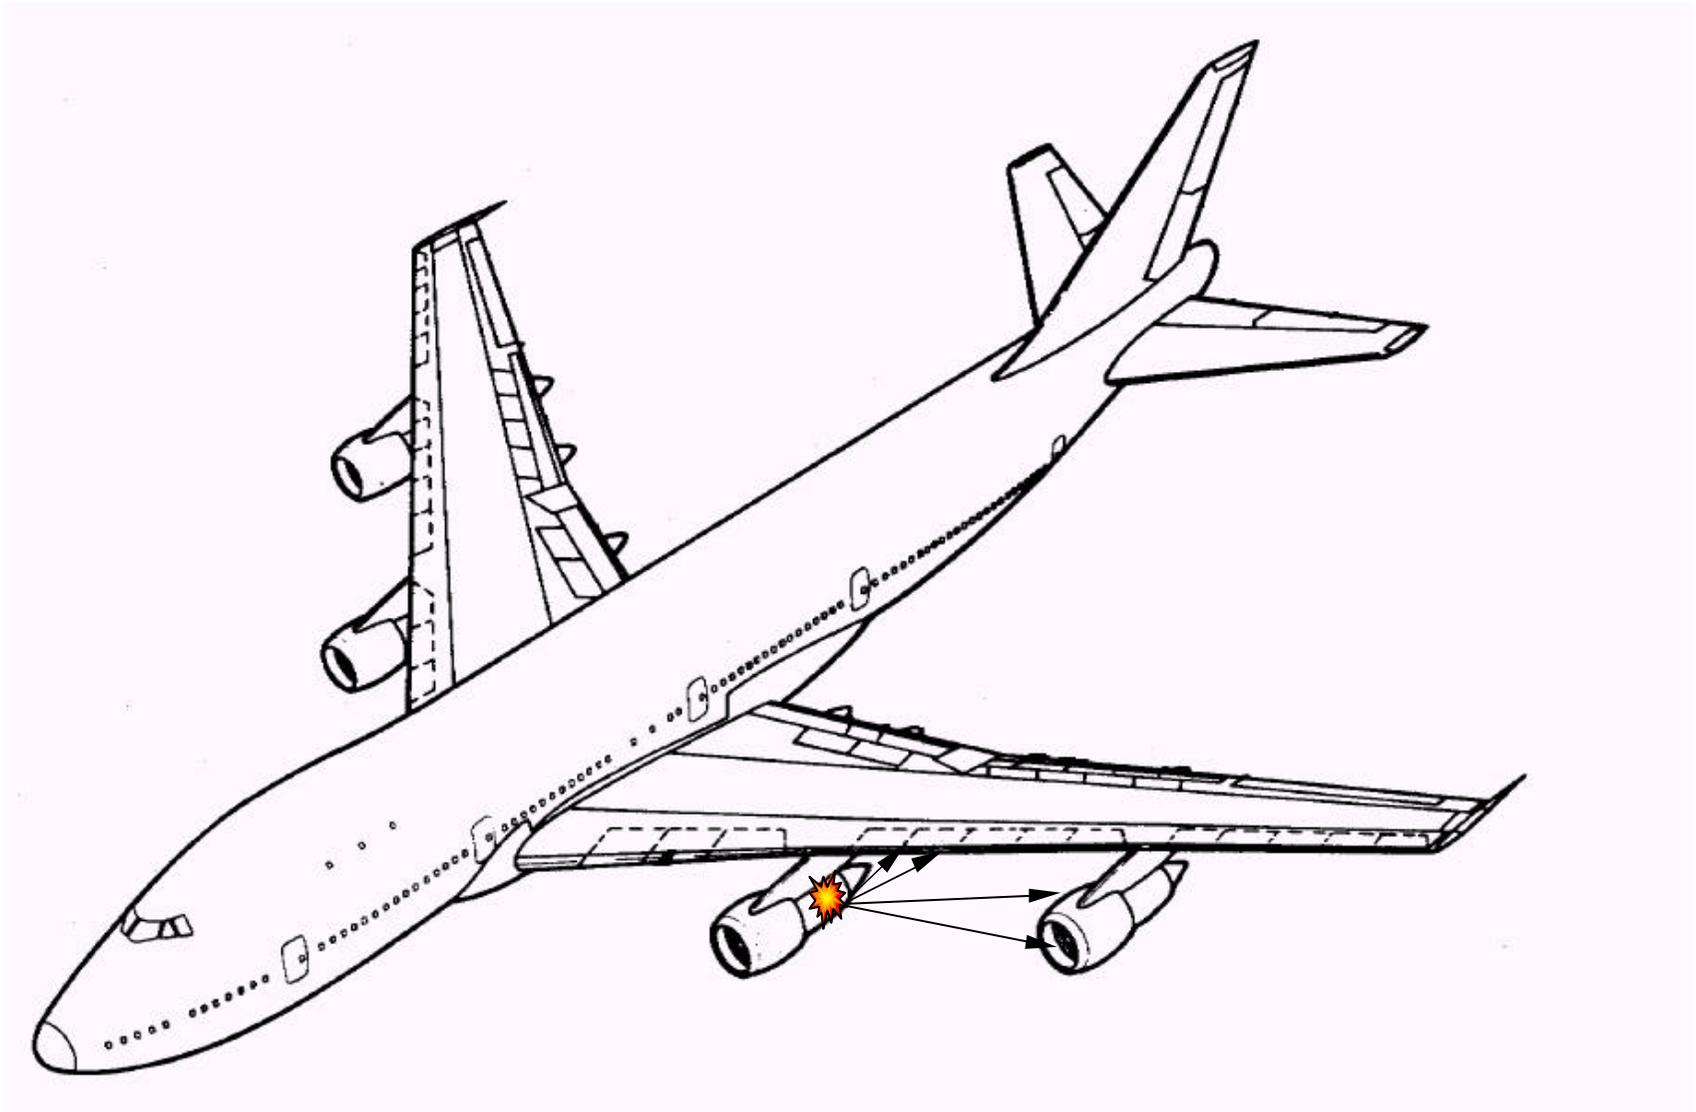
On-ground inspection revealed that an uncontained engine failure had occurred on the #2 engine low-pressure turbine, and the liberated debris had caused FOD on the #1 engine and airframe (see Figure A10).

Figure A10. Sketch of ejected debris path from engine #2

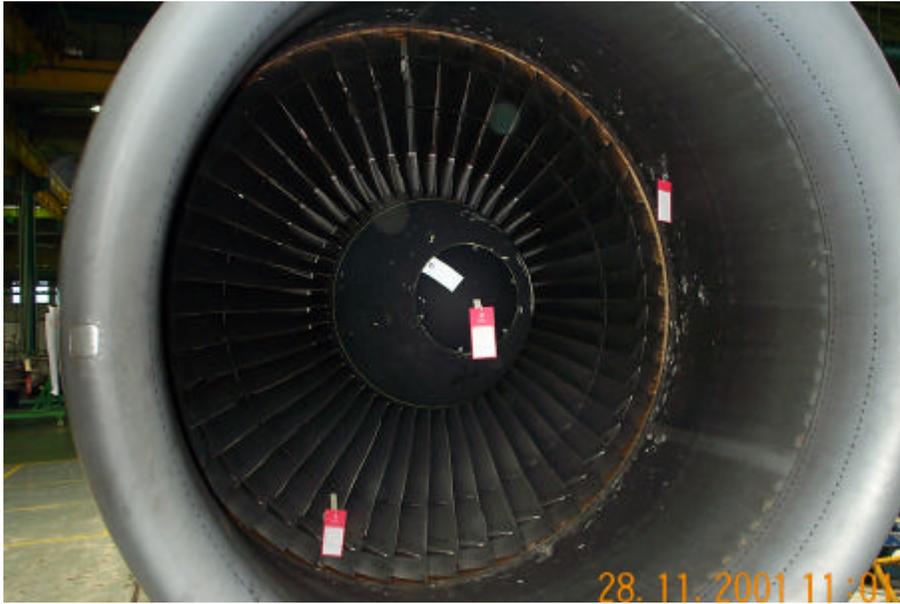
The #1 engine fan blades, spinner cone, side cowling and fan case had sustained damages (FOD) due to debris from the #2 engine (see Figures A11-A16).

Figure A11. FOD on Engine #1 fan (1) - tagged debris

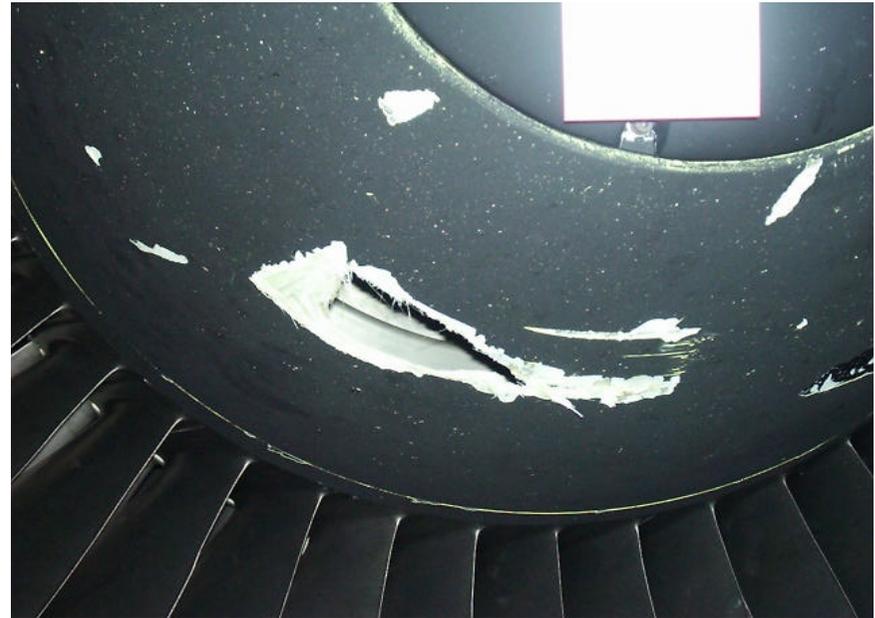
Figure A12. FOD on Engine #1 Fan (2)

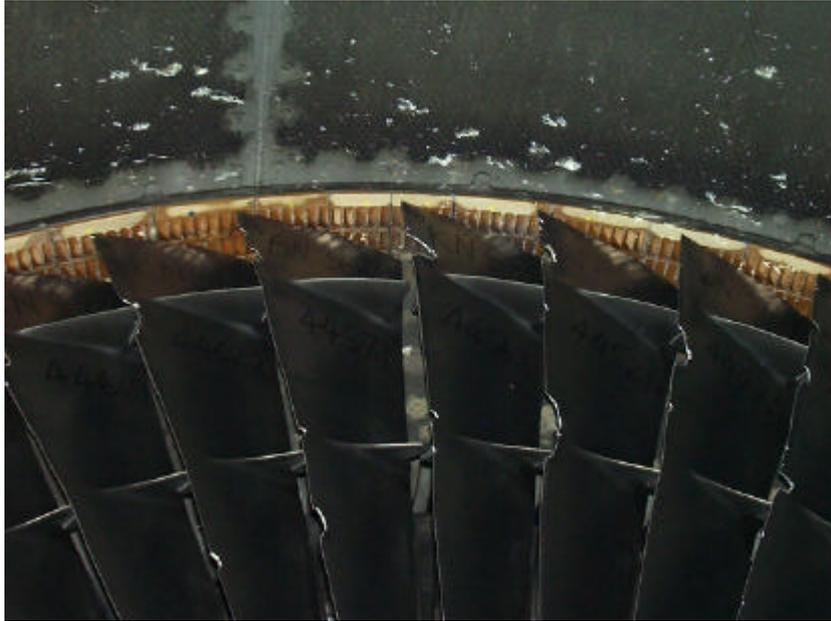
Figure A13. FOD on Engine #1 Fan/Fan Blades (2)

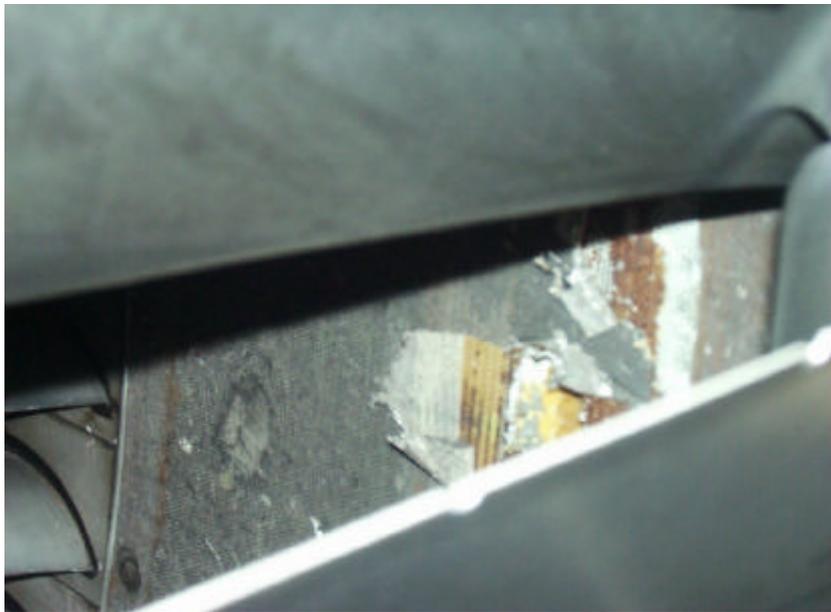
Figure A14. FOD on Engine #1 inner cowling

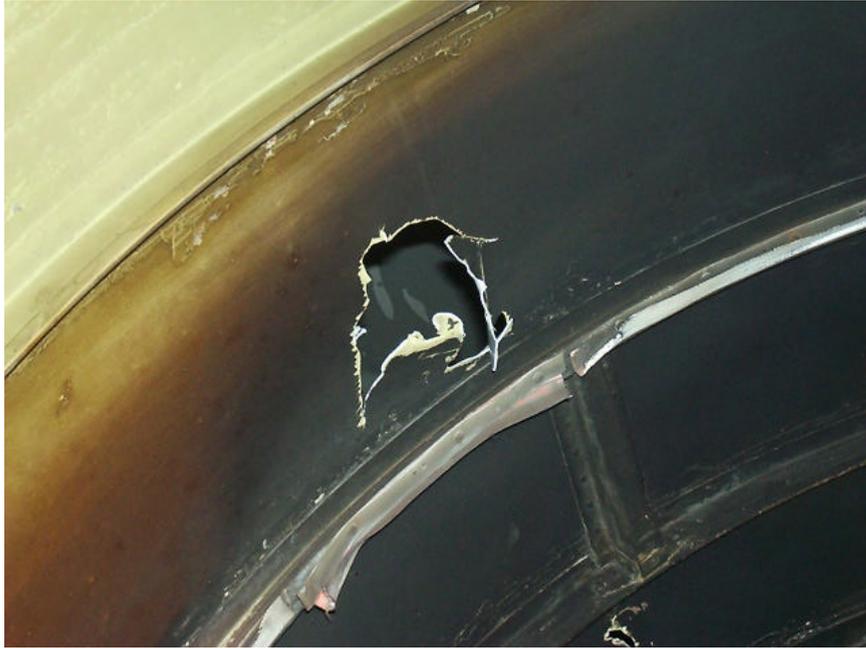
Figure A15. FOD on Engine #1 RH reverse cowl (1)

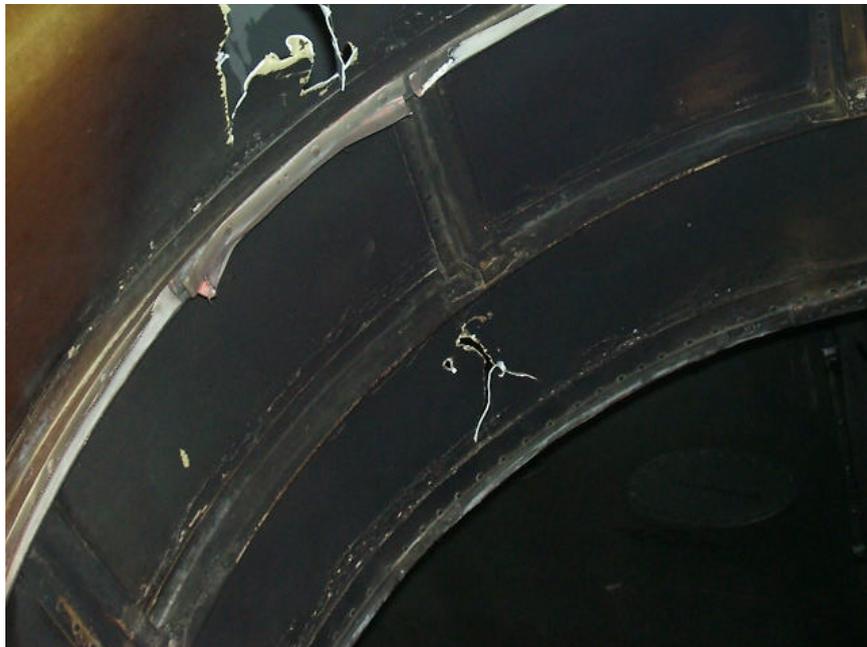
Figure A16. FOD on Engine #1 RH reverse cowl (2)

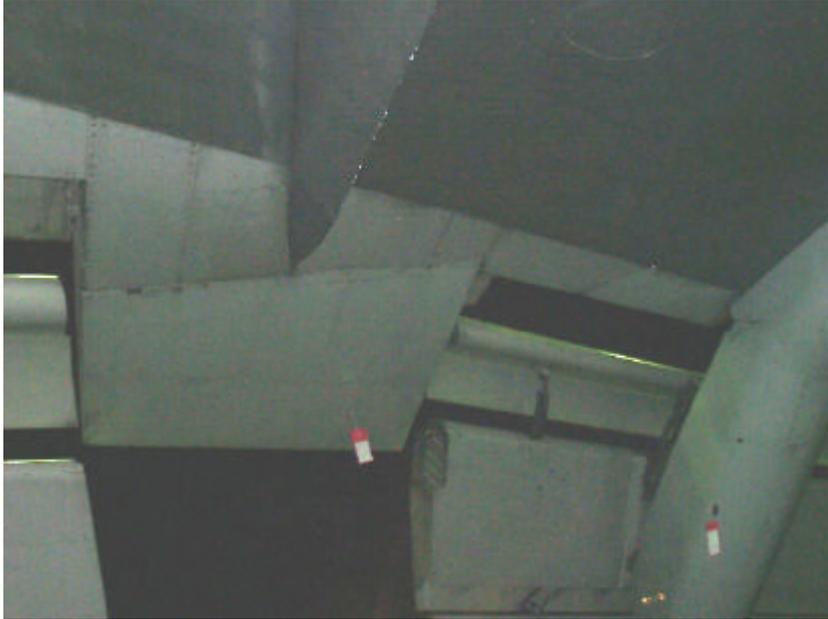
- Damages on lower surface of LH inboard aileron.
- Damages on LH inboard flap
- Damages on flap canoe #1 and #2.
- Damages on fix fairing near LH refueling panel.
- Damages on engine #1 pylon upper fairing.
- Skin scratches on engine #1 pylon RH side.
- Skin scratches on engine #1 hydraulic bay RH panel.

Figure A19. Damage on LH low speed aileron and flap track fairing - tagged debris

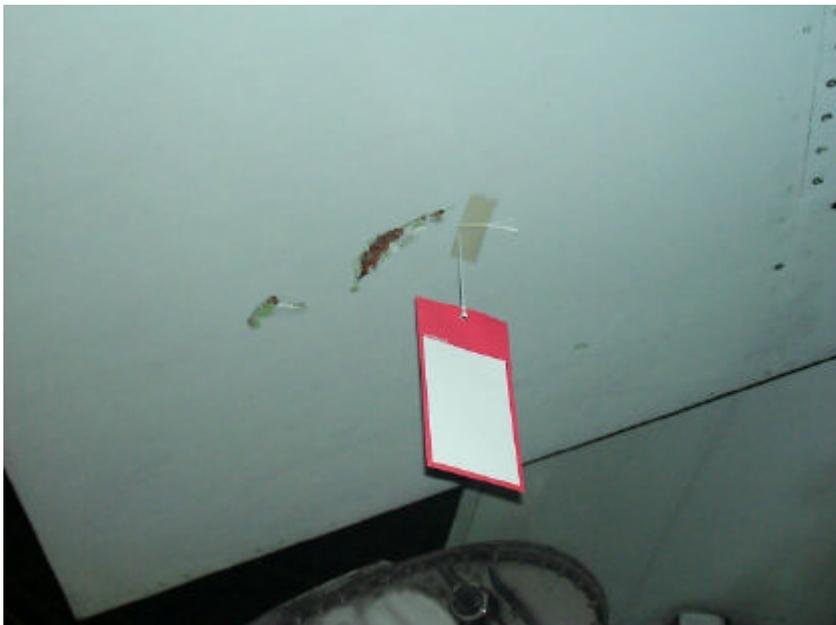
Figure A20. Damage on LH low speed aileron - tagged debris

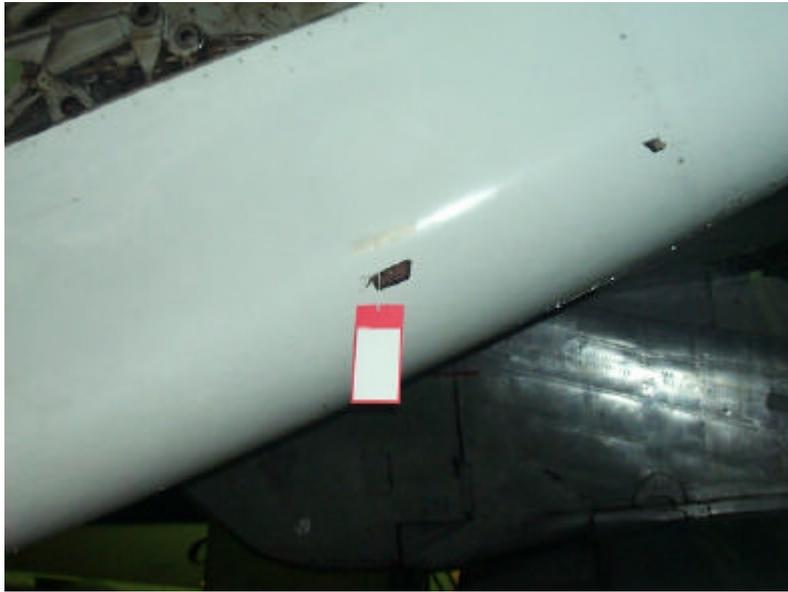
Figure A21. LH flap track fairing

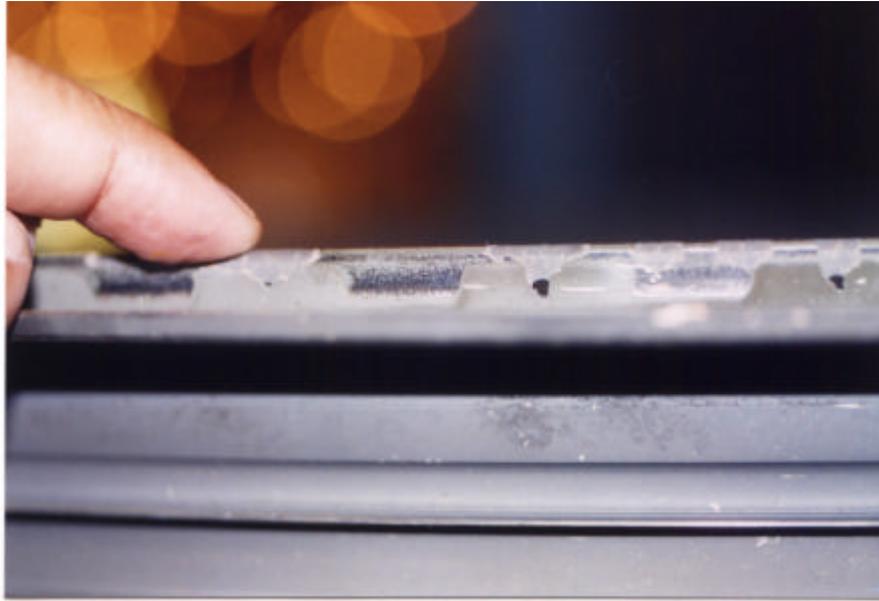
The 5th airseal has 60 holes for the cooling air passage. During the teardown, fifty-six of the 60 (>90%) cooling holes were found blocked by plasma coating material. The four that were found partially blocked were exposed because of chipped coating (Fig. B9 and B10).

Figure B9. 5th stage inner airseal cooling air holes - three holes partially opened

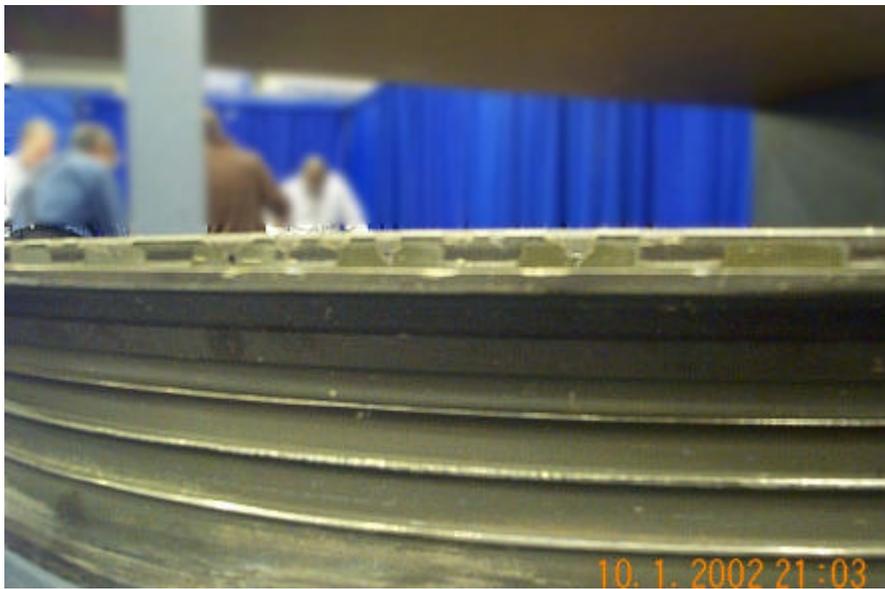
The engine tear down revealed the blockage of the cooling air holes of the 5th stage rotating airseal by plasma coating material. This blockage has a significant impact on the 5th stage disk lives and resulted in uncontained disk fracture.

Figure B10. 5th stage inner airseal cooling air holes - blocked holes

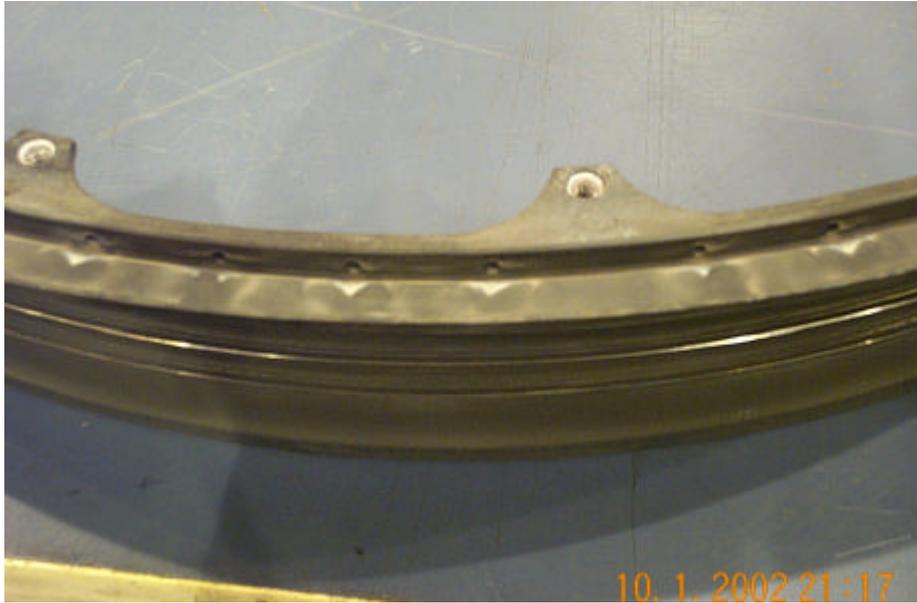
Figure B11. 4th stage inner airseal - discoloration due to cooling air passing through cooling air holes, not found on 5th stage inner airseal

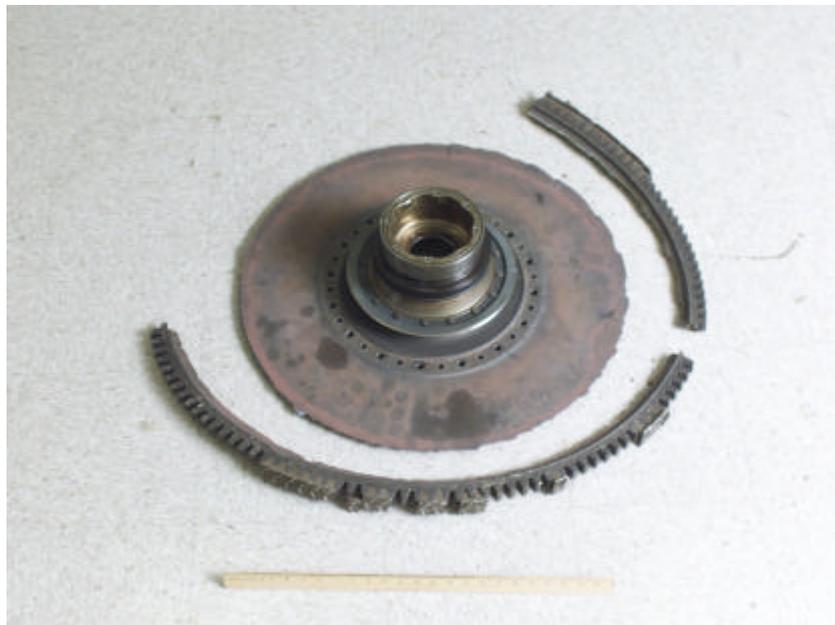
The rim of the disk was detached from the web (Fig. B12). The recovered rims consist of two broken pieces, which include 85 slots (out of 110 slots). These two pieces were recovered at Garuda Engine shop in Jakarta, and directly sent to NTSB Laboratory in Washington DC. The web of the disk shows different colors on both faces, the forward face has gray-blue color (Fig. C1), while the aft face has brown-red color (Fig. C2). The fracture surfaces of the disk show 90-degree plane on both faces connected by a 45-degree plane (Fig. C3, C4, C5 and C6).

Figure B12. 5th stage disc - web and two portions of recovered rims

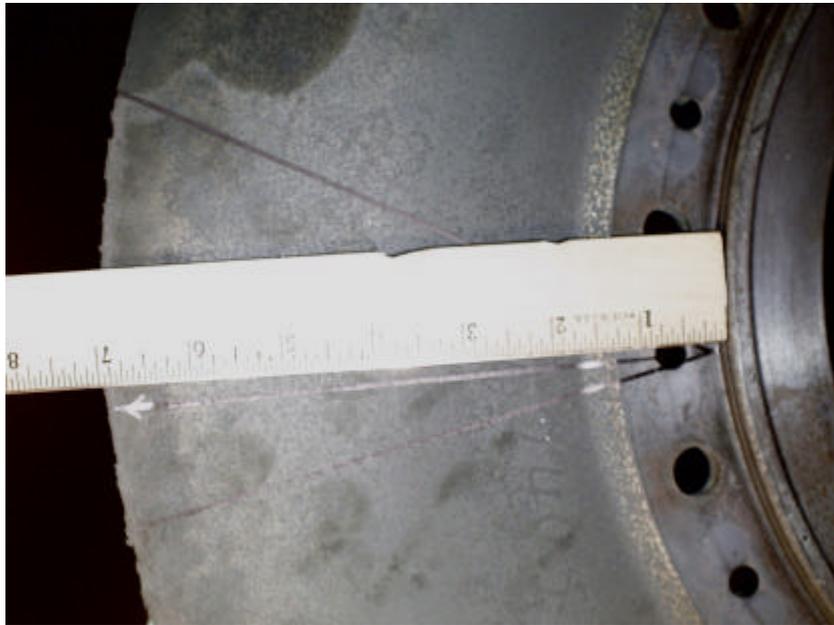
Figure C1. Location of fracture origin on 5th stage disc web, measured from bore - forward face

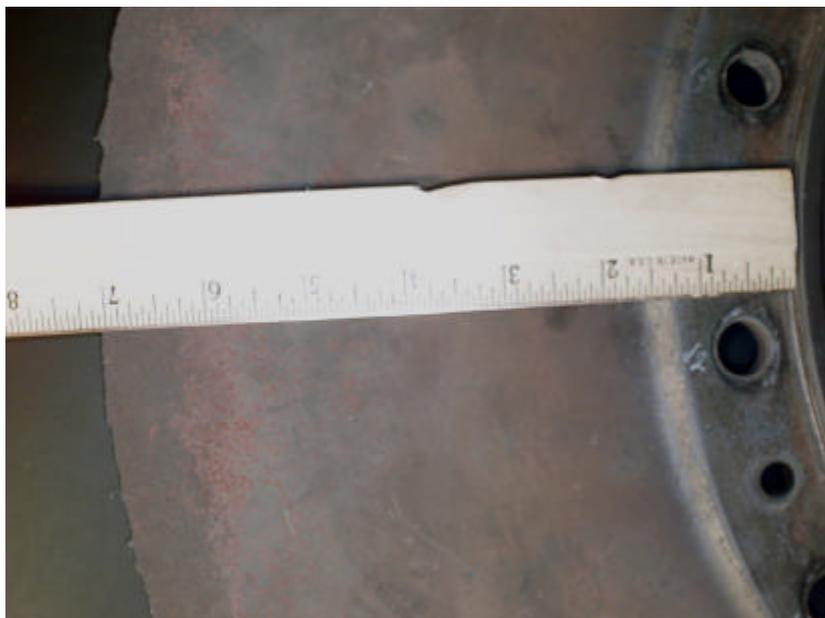
Figure C2. Location of fracture origin on 5th stage disc web, measured from bore - aft face

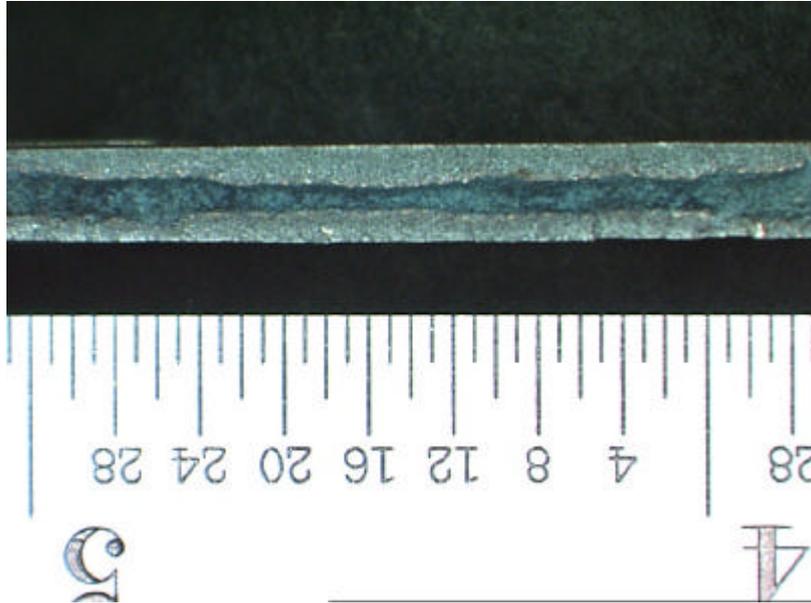
Figure C3. 5th stage disc web fracture origin surface (1)

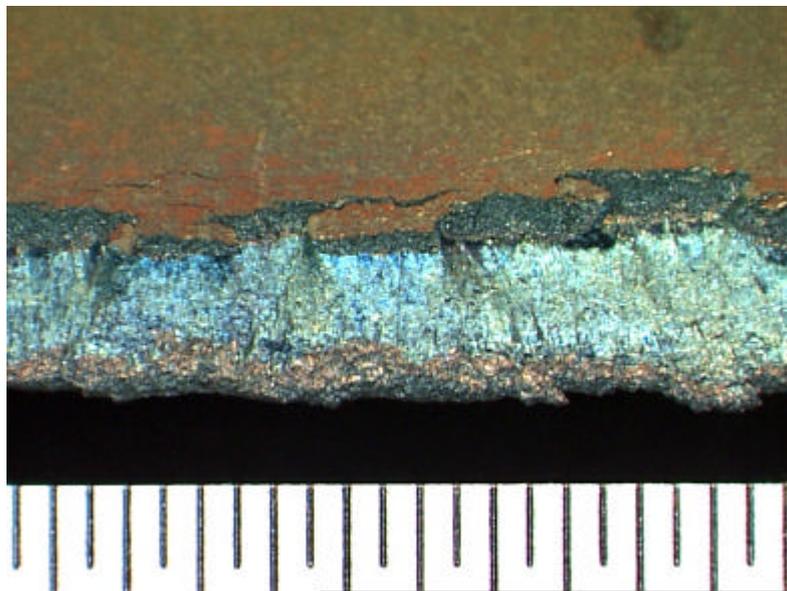
Figure C4. 5th stage disc web fracture origin surface (2)

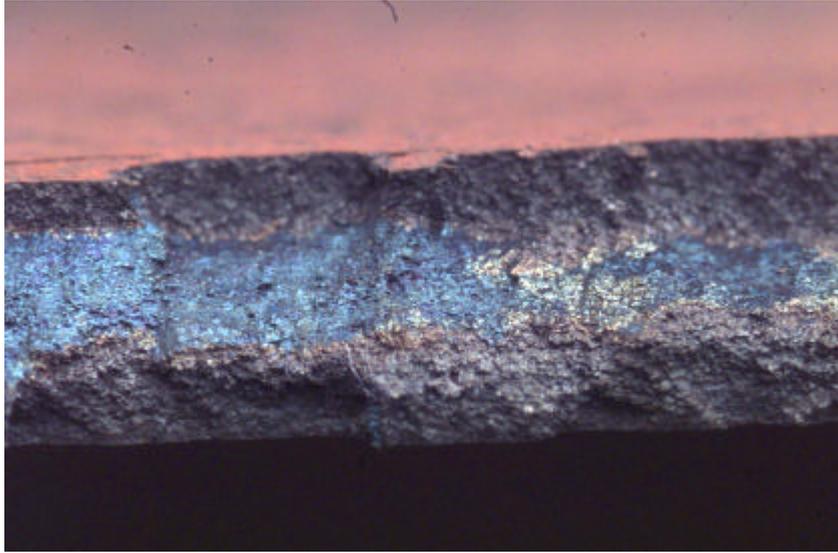
Figure C5. 5th stage disc web fracture origin surface (3)

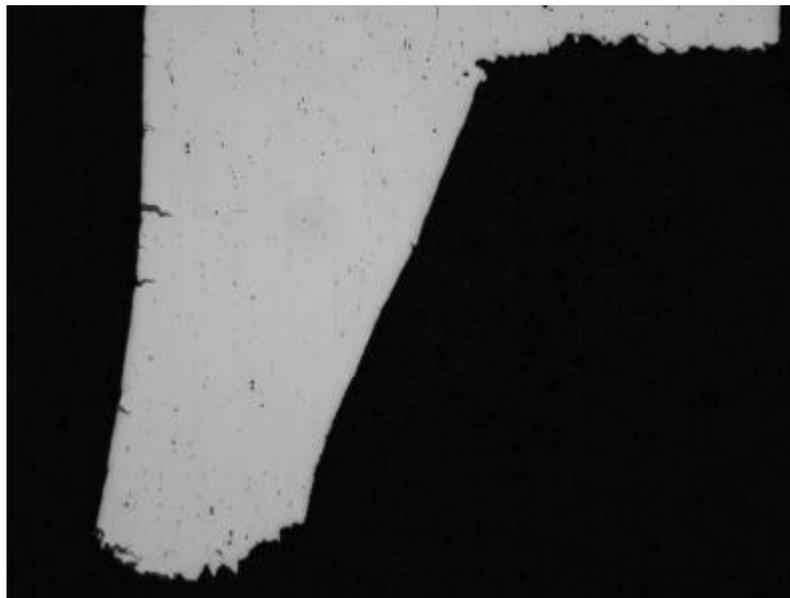
Figure C6. Radial metallographic section through fracture origin showing forward and aft face of web. Forward face is on left side.

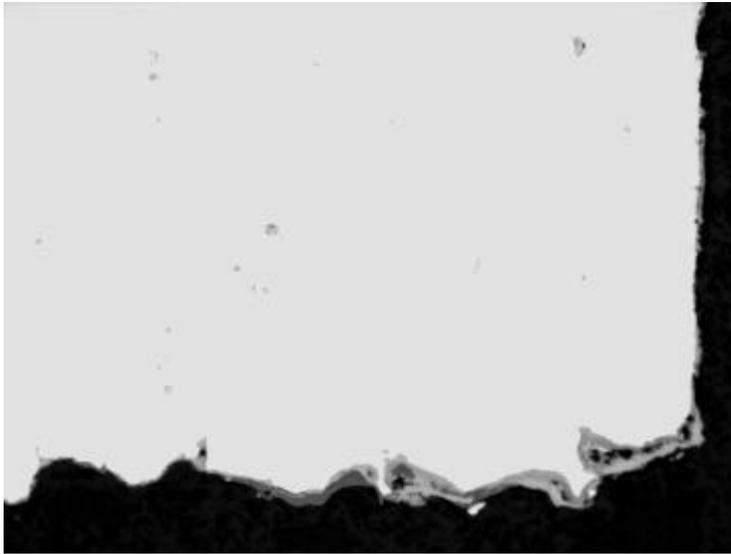
Figure C7. Fracture origin on aft face of web (aft face on right side)

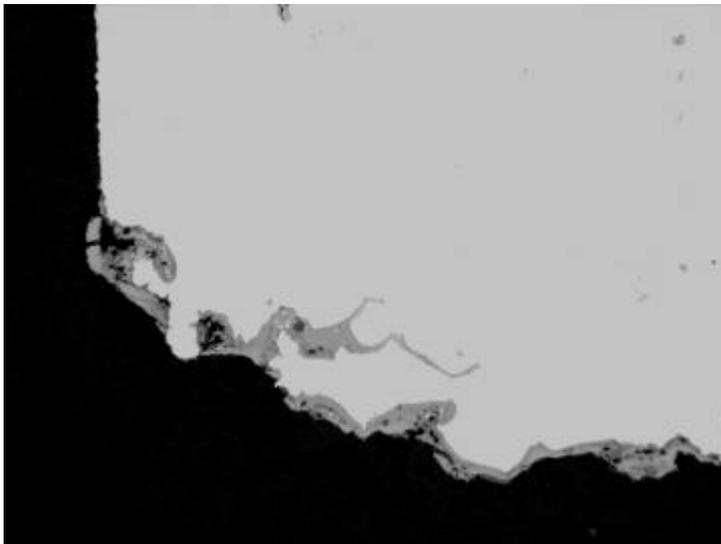
Figure C8. Fracture origin on forward face of web (forward face is on left side)

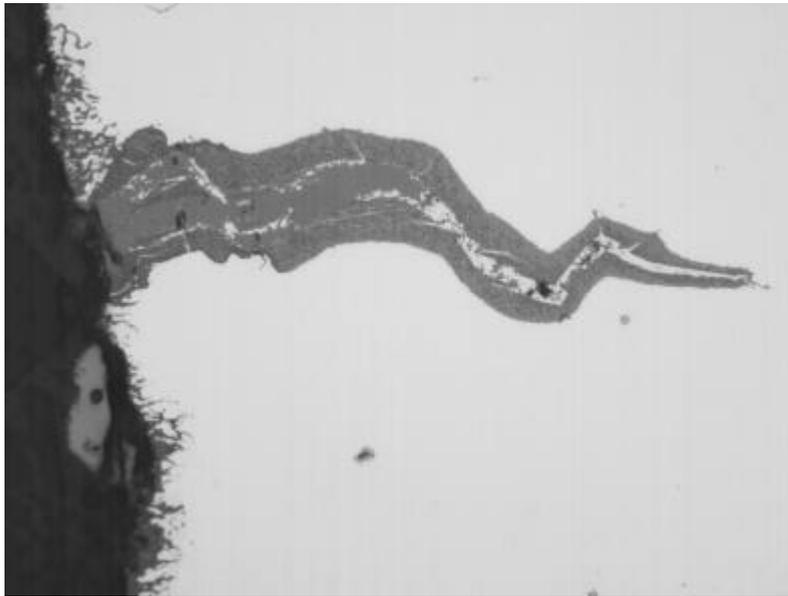
Figure C9. Secondary intergranular crack on forward face (left side)

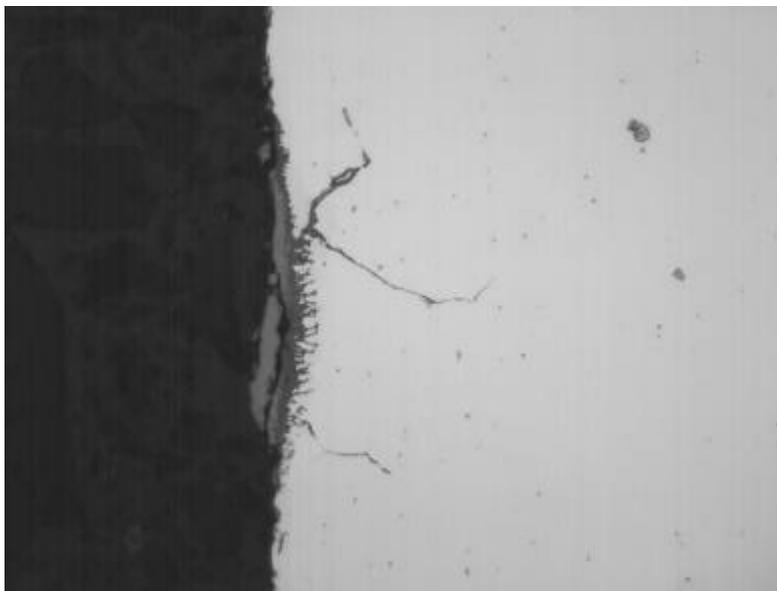
Figure C10. Secondary crack on forward face (left side)

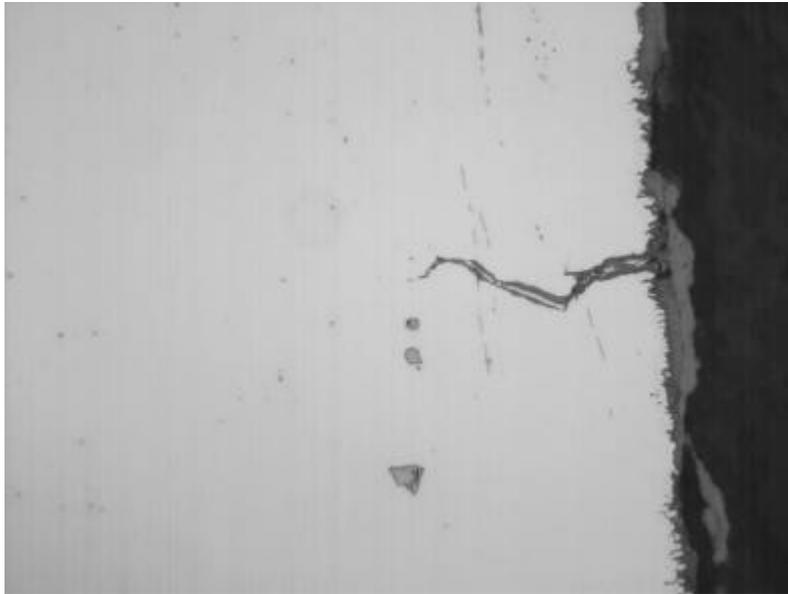
Figure C11. Secondary intergranular crack on aft face (right side)

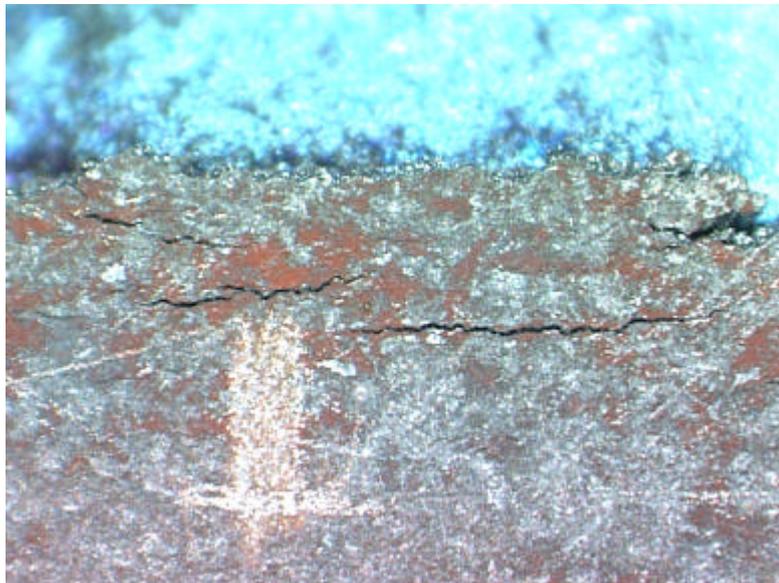
Figure C12. Secondary crack on aft face of web

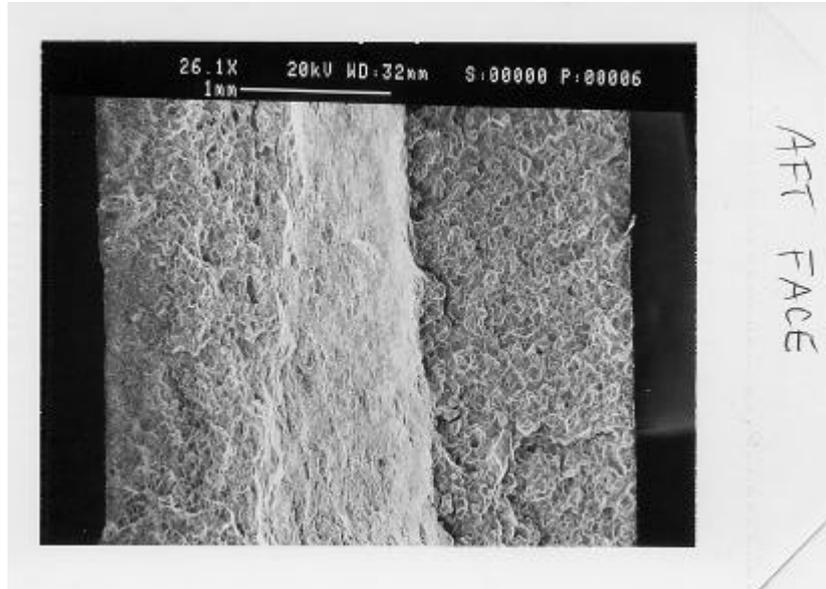
SEM examination was done on the fracture surface revealed the intergranular nature of the 90° fracture surface and smooth sheared surface of the 45° fracture surface (Fig. C13). On the 90° fracture surfaces the intergranular nature is more distinct at locations away from the disk face. Intergranular cracks were also observable at these locations. The less prominent intergranularity near the disk face is due to oxide formation (Fig. C16).

Figure C13. SEM Photo of fracture origin area

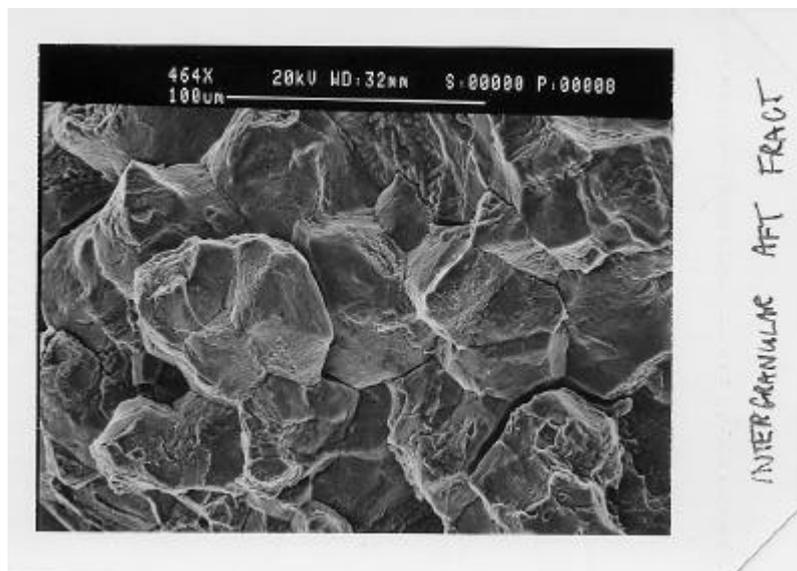
Figure C14. Intergranular fracture - aft face

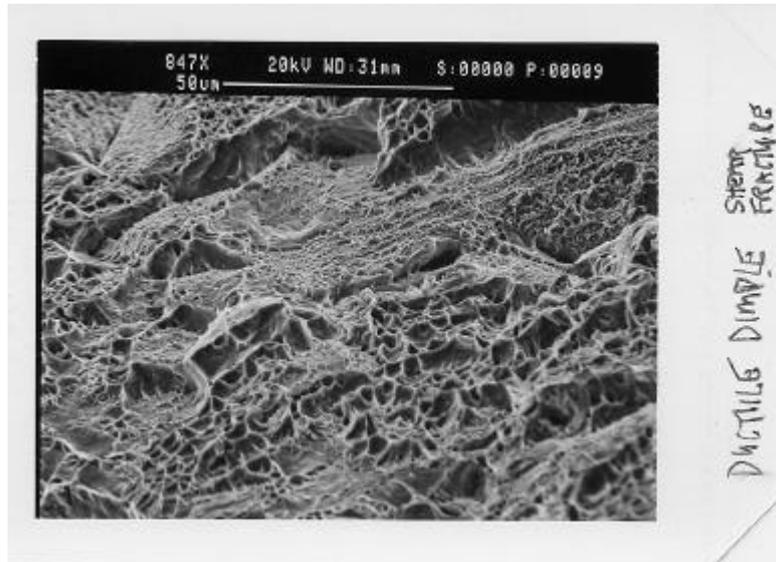
Dimples showing shear movement were observed on the 45° fracture surface (Fig. C15).

Figure C15. Ductile dimples indicating shear fracture in the middle section of the fracture origin surface

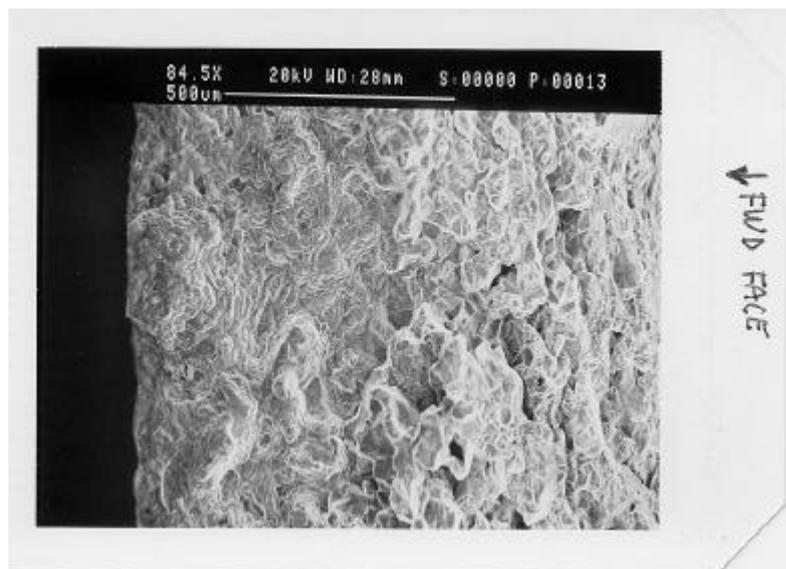
SEM observation on the face showed a circumferential intergranular crack (Fig. C16). Similar feature of fracture surface was observed in the secondary crack, due to oxide formation indicating longer exposure to gases.

Figure C16. Severely oxidized intergranular fracture on left side (forward face)

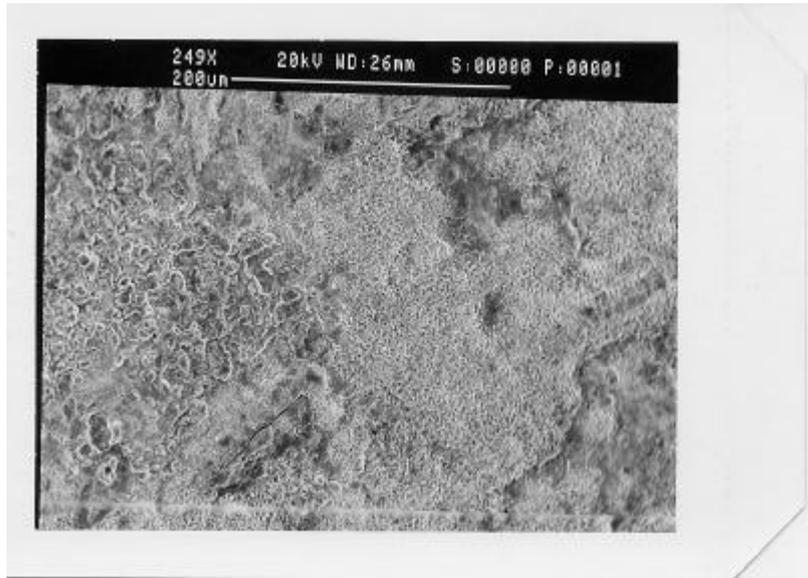
Figure C17. Close up of aft face showing oxidized surface (red oxide appears as fine feature)

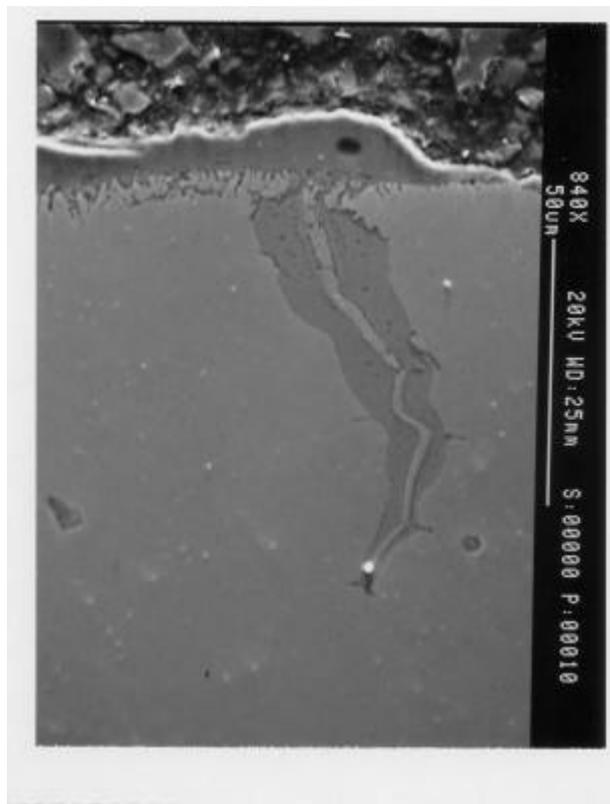
Figure C18. SEM photo of secondary intergranular crack (forward face)

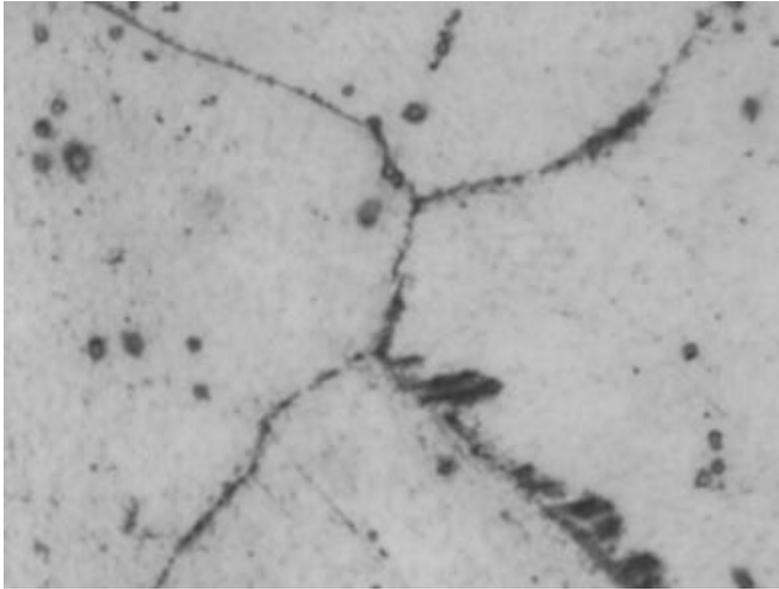
Figure C19. Microstructure next to fracture origin area
