Uncontained engine failure, Aircraft Accident Report, Garuda Indonesia Flight GA 880, Boeing B747-200 PK-GSD, In flight (21 minutes after takeoff from Denpasar, Bali), 23 November 2001

KNKT/01.27/03.01.009

AIRCRAFT ACCIDENT REPORT

Garuda Indonesia Flight GA 880

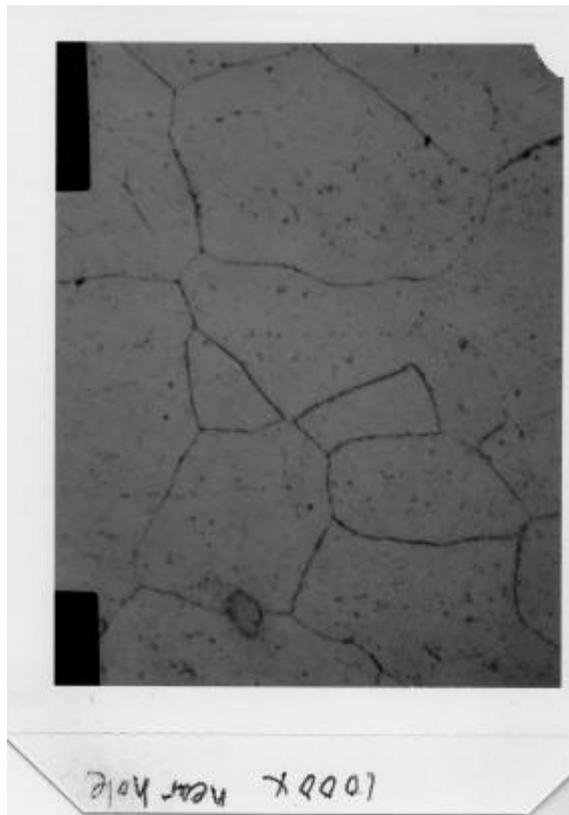
Figure C20. Microstructure next to hole area

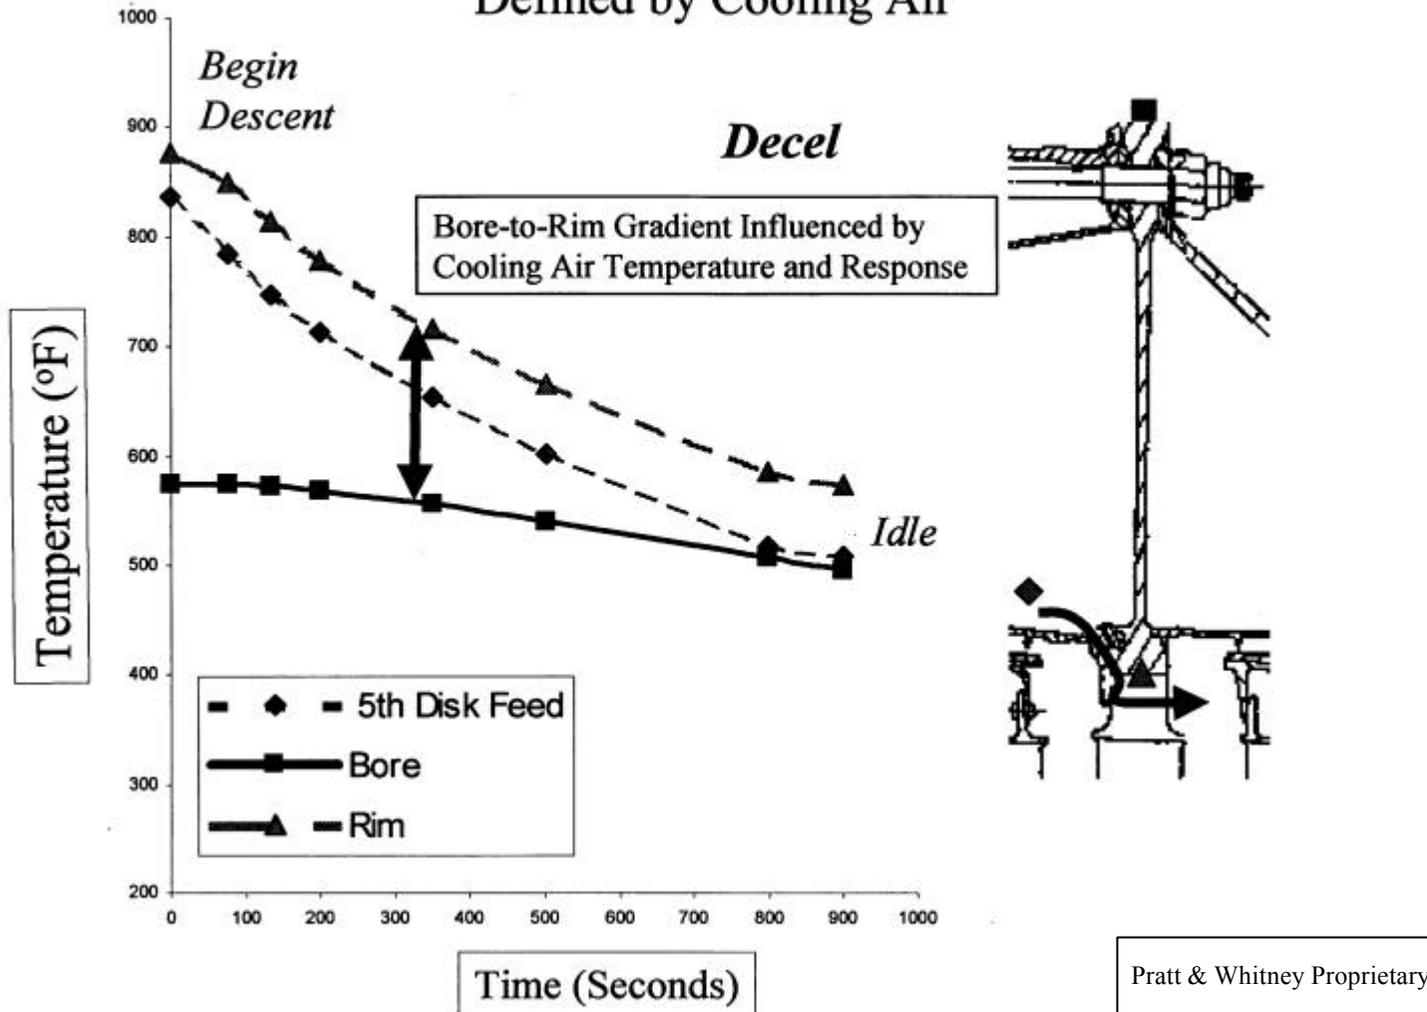
When the Live Rim Cooling Air is Blocked, Live Rim Temperatures Will Start Approaching Gas Path Temperatures

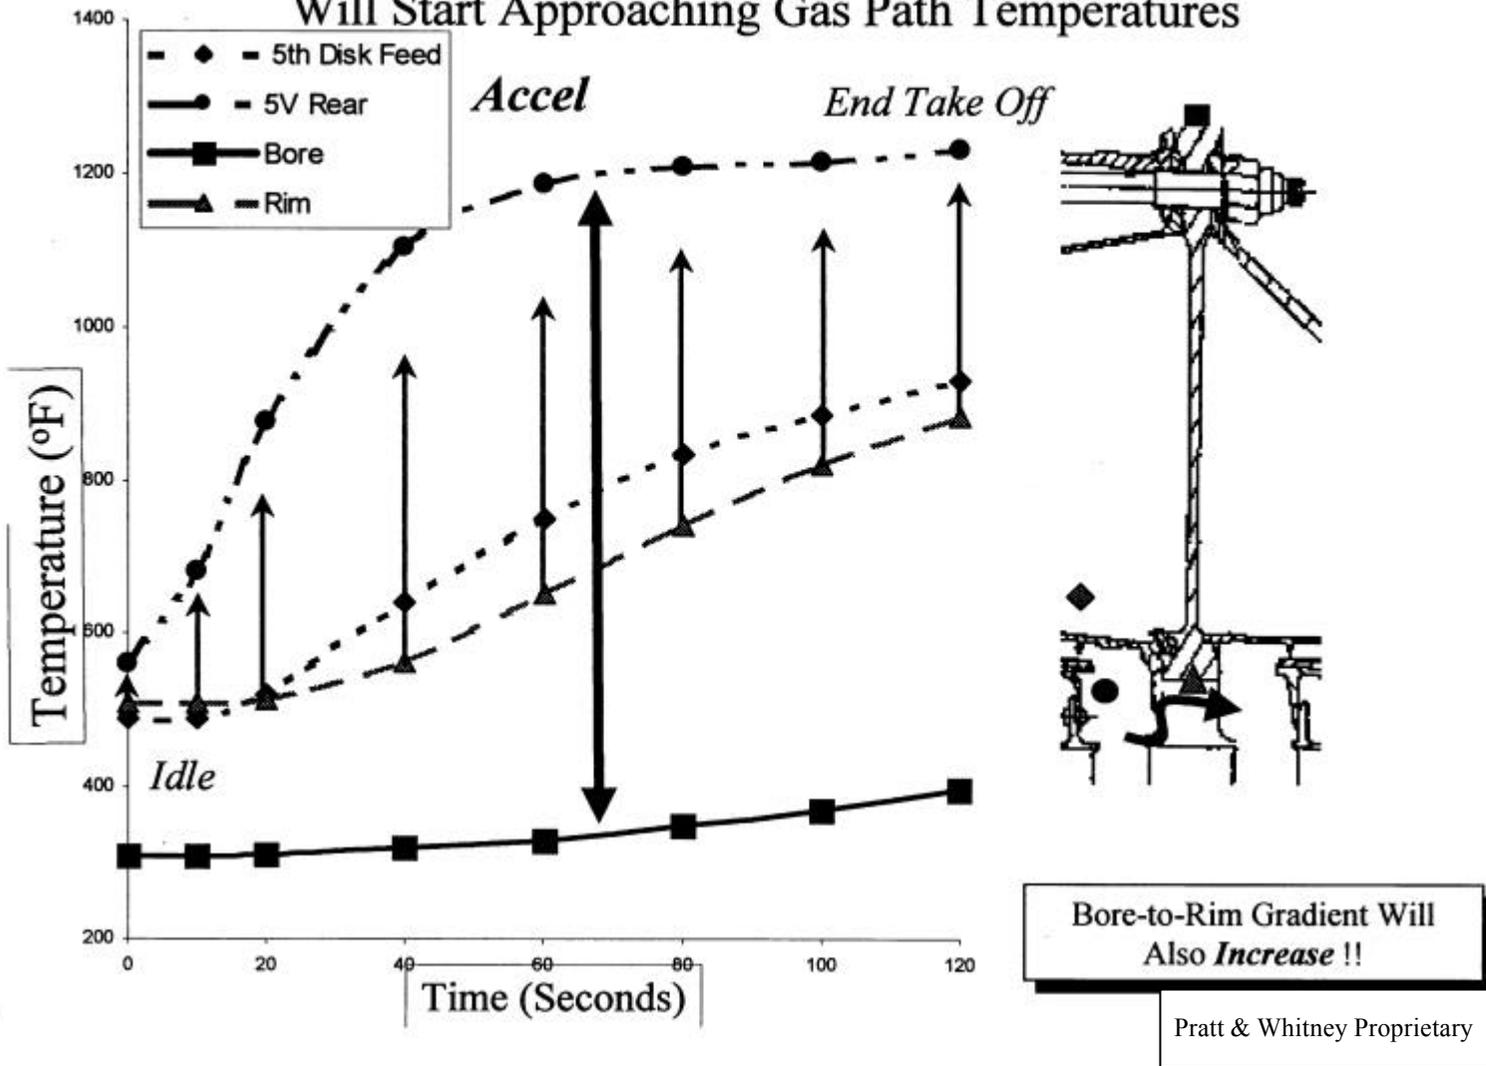
When the Live Rim Cooling Air is Blocked, Live Rim Temperatures will Increase Due to Increase in Cooling Air Temp – Not as Severe as Accel

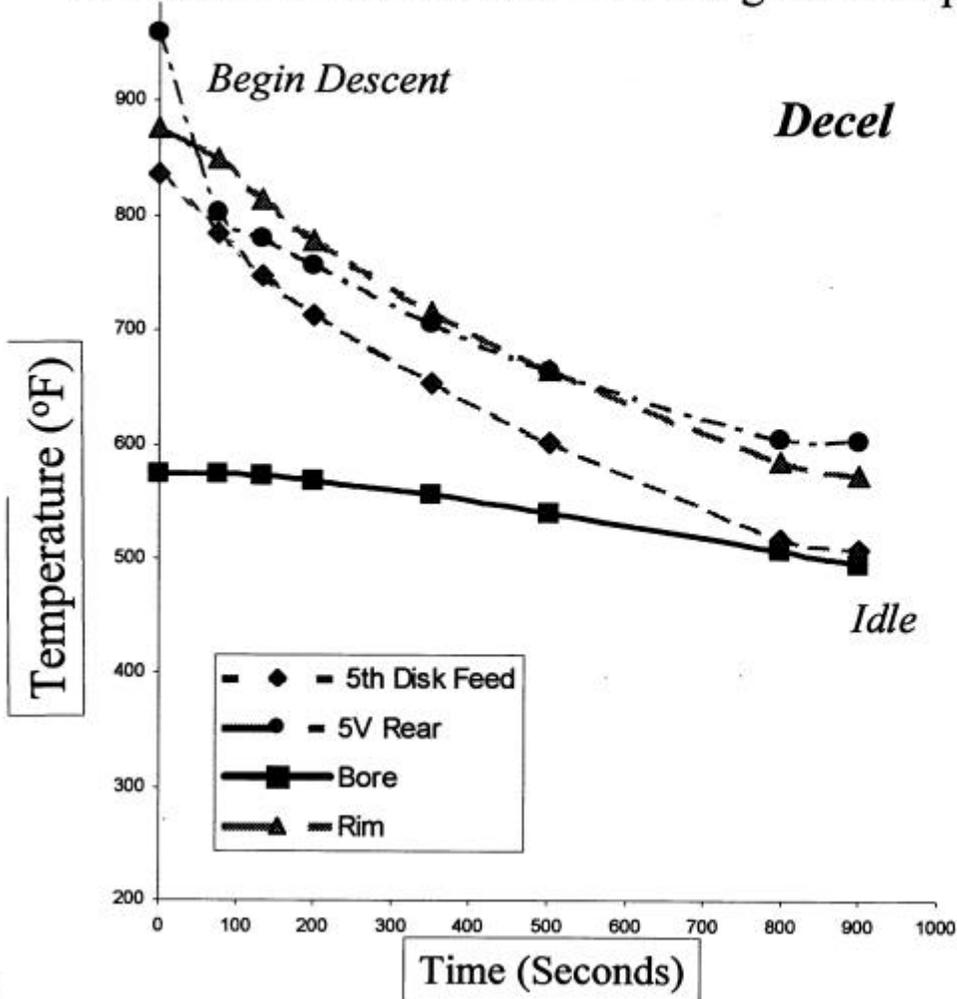
Bore-to-Rim Gradient Will Also *Increase* !!

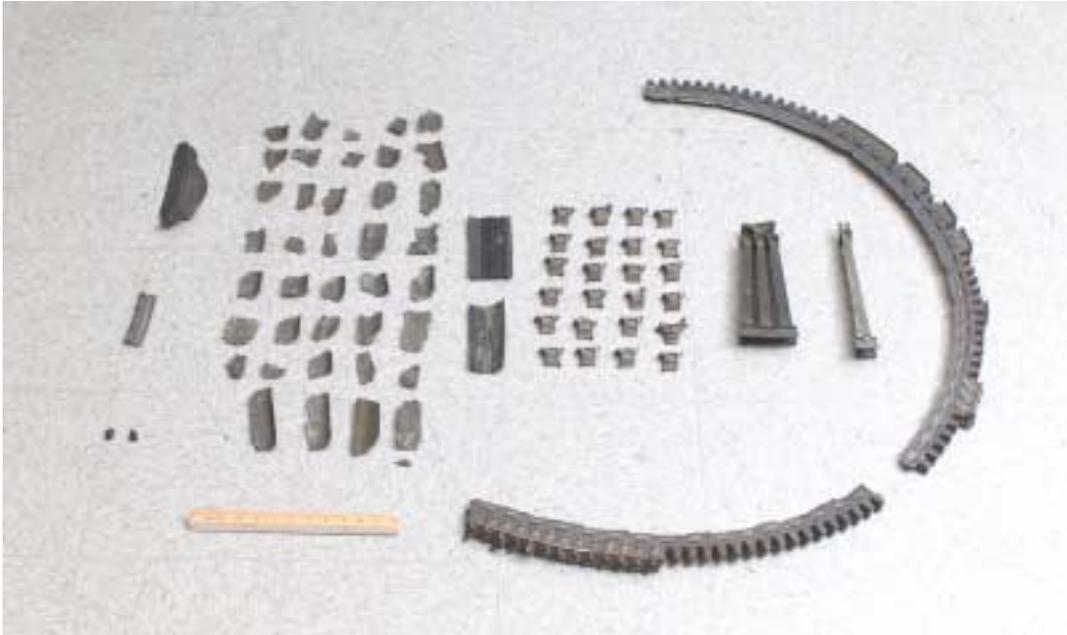
Figure 1. As-received portions of the 5th stage LPT disk showing two pieces of the rim (right side of photograph), and several pieces of vane and blades.

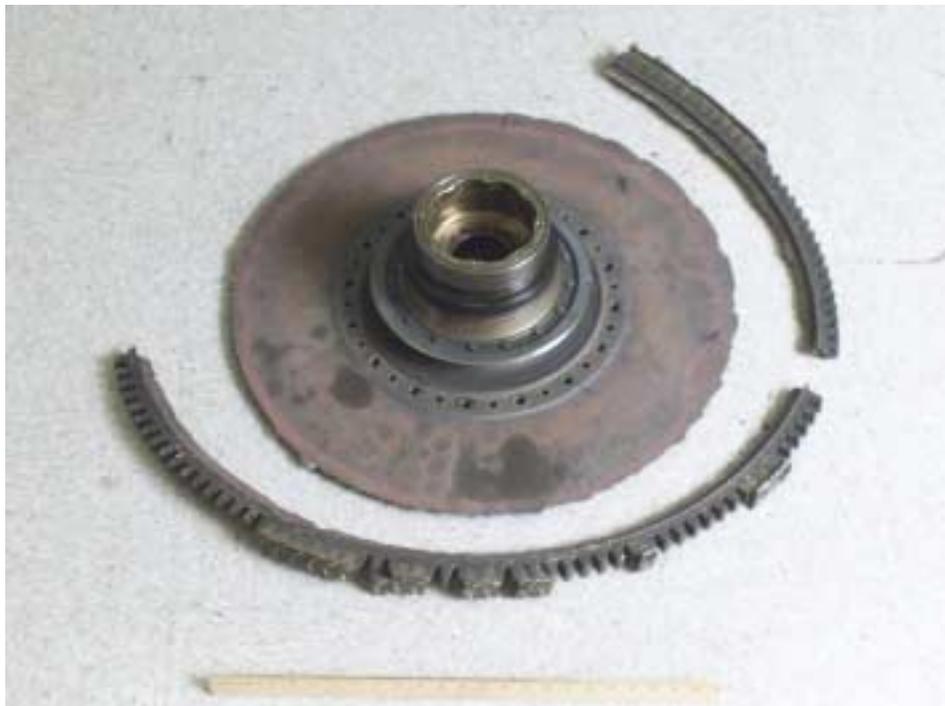
Figure 2. As-received disk that fractured all around the web. The two rim pieces were positioned next to the web portion as if intact.

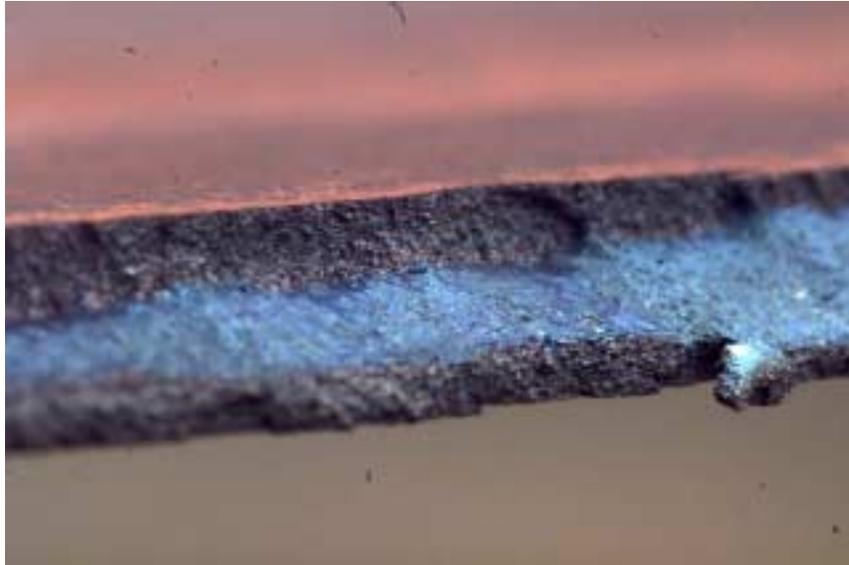
Figure 3. Optical photograph of a portion of the web fracture face. The flat fracture regions adjacent to each face of the web (appear gray-dark blue) are connected by a slant fracture (blue). The aft face of the web appears red-brown and is located on the upper side of the photograph. Photograph taken by P&W after disassembly of the disk.

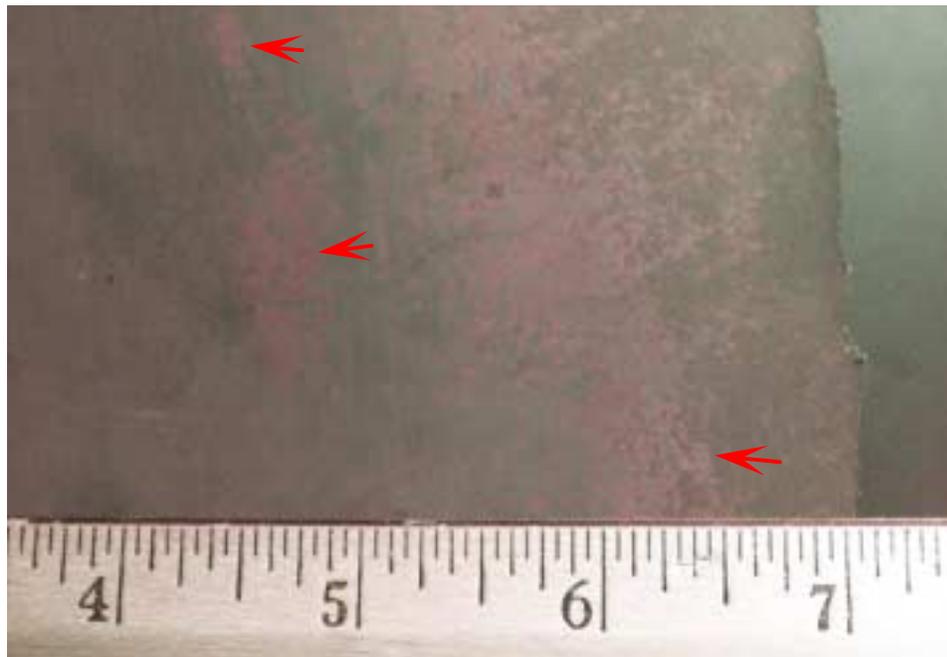
Figure 4. Area of the aft face of the web with some of the red-brown deposits indicated by unmarked arrows.

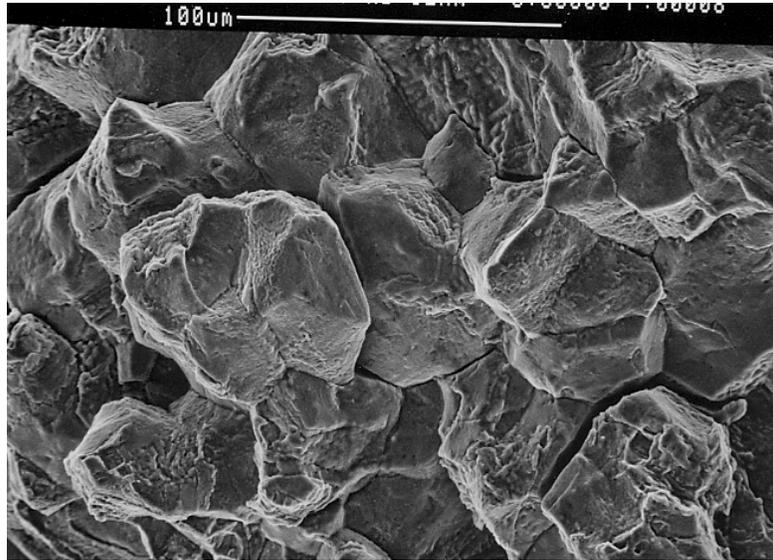
Figure 5. Scanning electron microscope photograph of typical intergranular fracture features that were found on the web portion of the disk. This photograph was taken on the flat fracture region that was located adjacent to the aft face of the web.

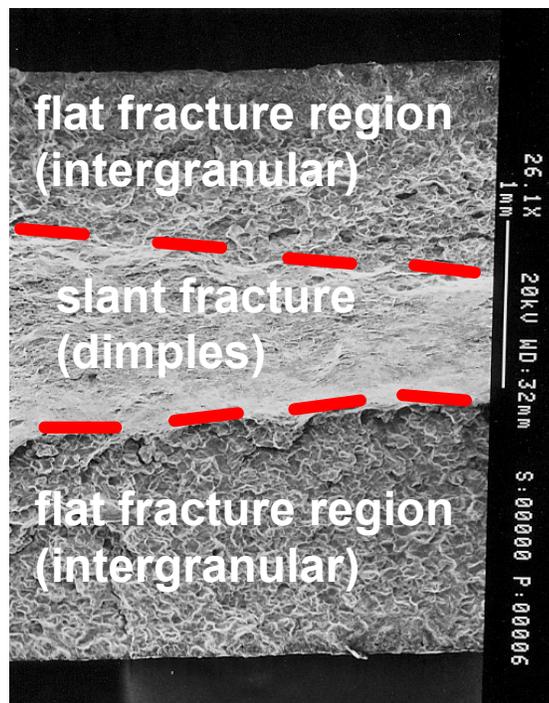
Figure 6. Scanning electron microscope (SEM) photograph of the fracture face located on the web portion of the disk. Flat fracture regions were situated adjacent to the forward and aft faces of the web. Aft face of the web is on the bottom side of photograph.

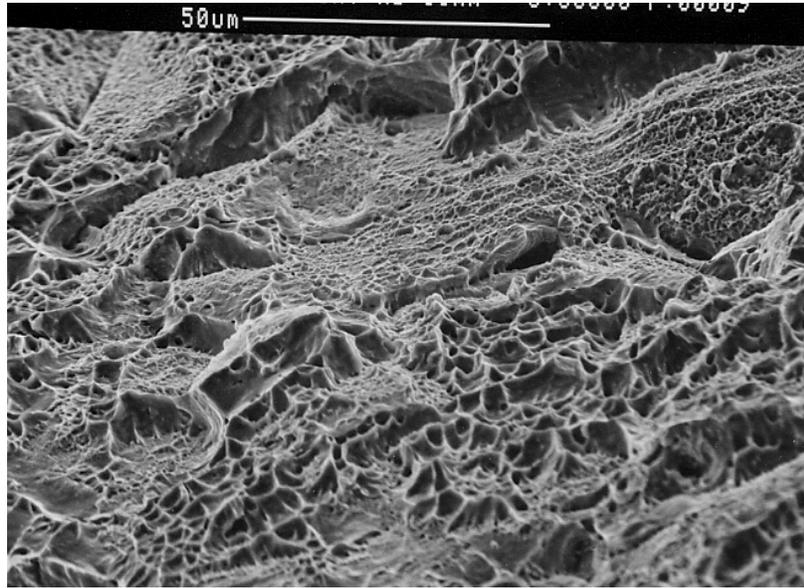
Figure 7. SEM photograph of typical ductile dimple features on the slant fracture.

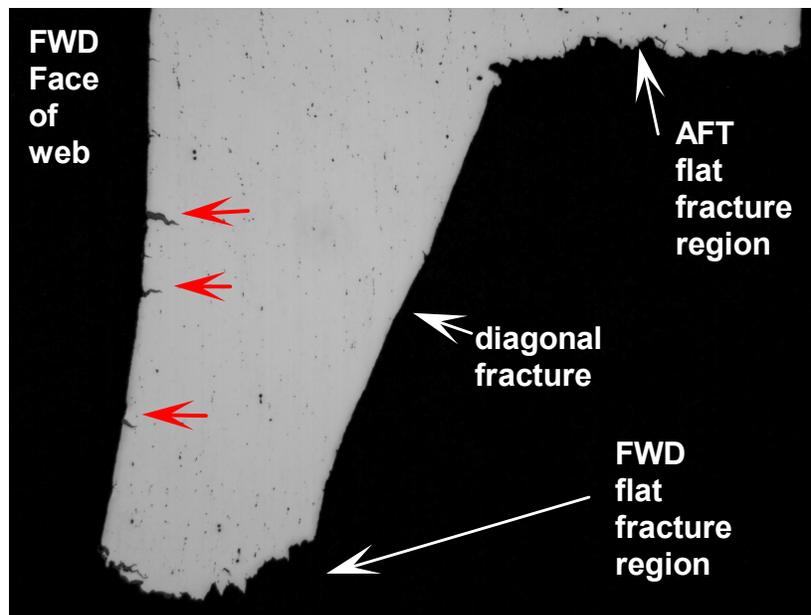
Figure 8. Metallurgical section radially through the fracture. The flat fracture regions on the forward and aft face of the web are connected by a diagonal (shear) fracture. Arrows indicate location of secondary cracks on the forward face of the web.

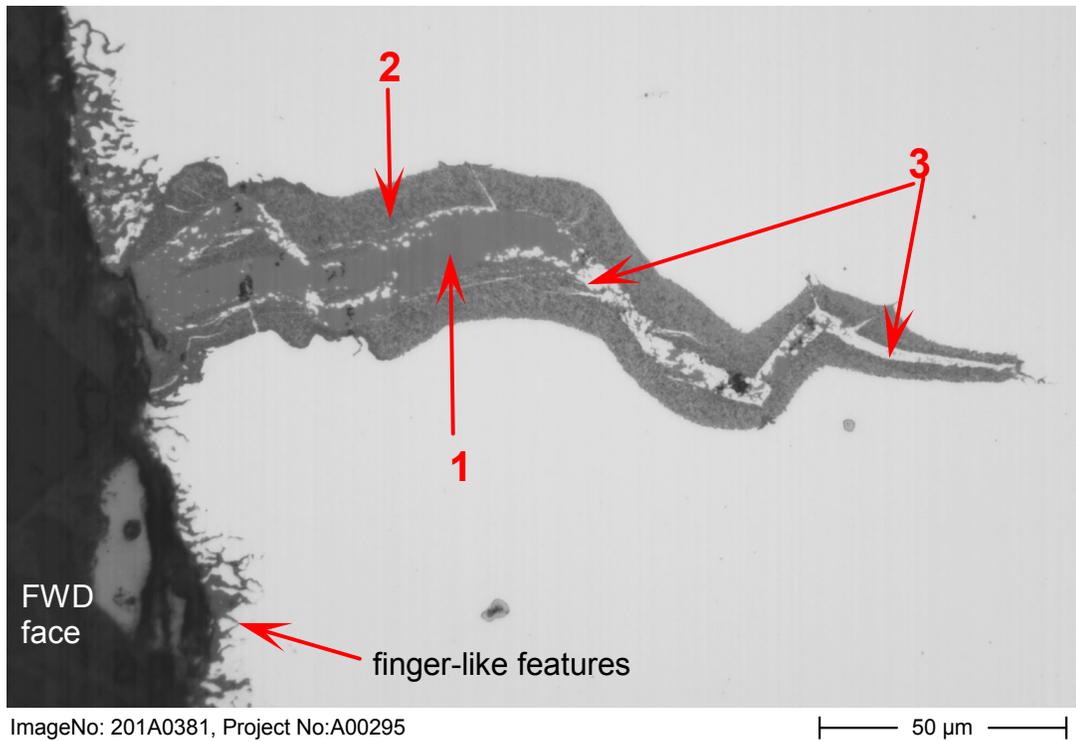
Figure 9. Polished section showing a crack that emanated from the forward face of the web. The crack is filled with three types of oxides, labelled "1" through "3".

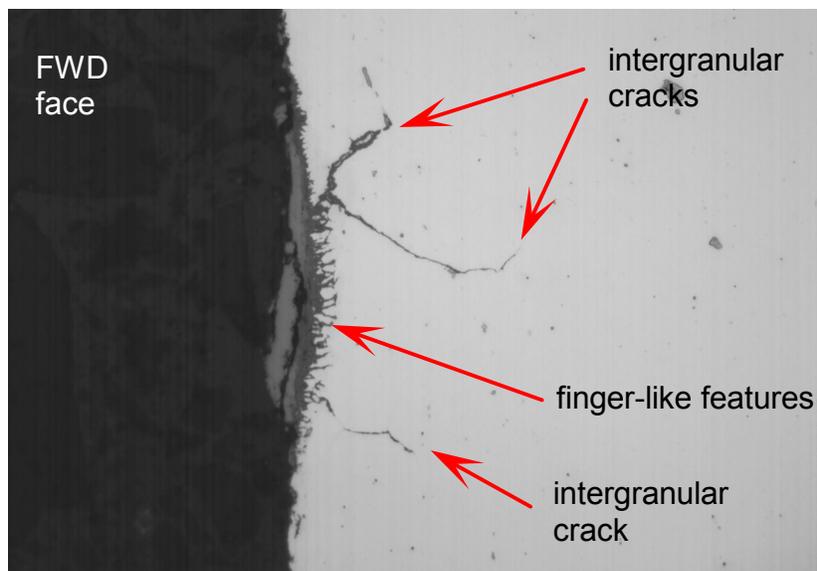
Figure 10. Portion of a polished section showing another crack that emanated from the forward face of the web. The crack is filled with oxides and it propagating along the grain boundaries.
