## **Failure to attain flight, Airport Accident Report, PT. Lion Air, Boeing 737-200 PK-LID, Sultan Syarif Kasim II Airport, Pekanbaru, Riau, 14 January 2002**

**KNKT/02.01/03.03.011**

## **AIRCRAFT ACCIDENT REPORT**

**Boeing 737-200 PK-LID**

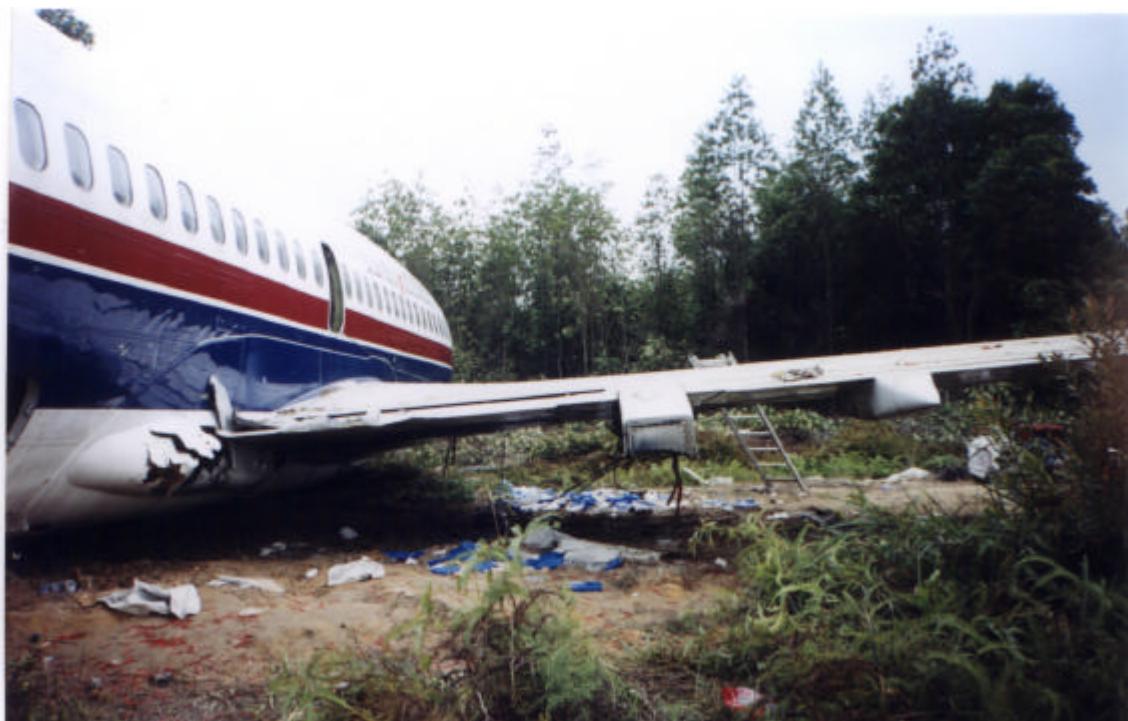
The LH and RH flap were found stowed. Inspection of the flap ball nut number 4 and 5 confirmed that the flap is at zero position (touching the up position). Left wing leading edge # 1 slat measured 3/8-inch gap between leading edge and fixed wing. Right wing leading edge were damage extensively. The leading edge actuator number 8 hydraulics tubes severed. Actuator was visible and was in a retracted position.

**Flap position of the RH wing**
