Loss of directional control on landing, McDonnell Douglas MD-82, PK-LMM, Hassamuddin Airport, Indonesia, 31 October 2003

Investigative Body: National Transportation Safety Committee (NTSC), Indonesia

Occurrence Brief

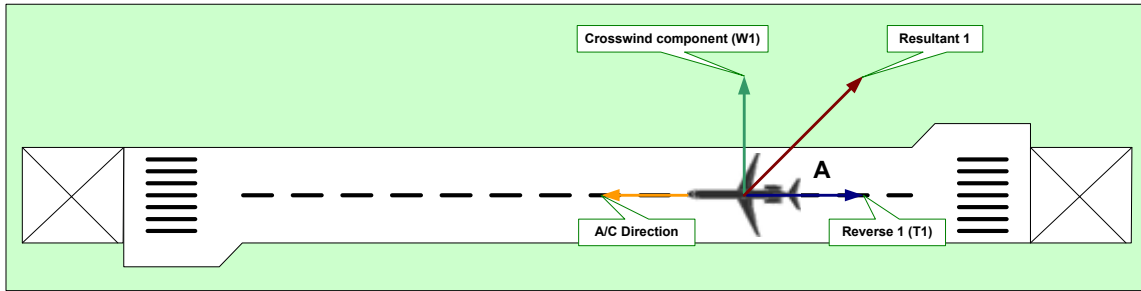
Figure 1. Thrust Reverse 1.4 EPR

- Wind speed and direction were variable (direction, speed 7-8 knots according to PF navigation displayed, aircraft landed normal positively at touch down zone of runway 13 followed by automatic deployment of spoiler and engine thrust reversers (L/R) \pm 1.4 EPR (Fig.1)
- The deceleration process of the aircraft was normal from the beginning until the aircraft speed reached 60-80 knots. After passing intersection with taxiway Charlie (C) then the aircraft slowly drifted to the right hand side of centerline runway 13 and then the pilot flying (PF) tried to recycle the reverser and increase it to maximum value about 2.0 EPR followed by stepping left hand rudder to counteract.(Fig.2)

Angle B is bigger than A and bigger than C. Concluded that the bigger opposite forces of thrust applied (reverse and brake) the bigger resultant angle. The bigger resultant angle would make the correction to the centerline more difficult.

In the AOM (Aircraft Operation Manual volume II page 46B), the landing technique for wet runway states that: “Do not use more than reverse idle thrust at speeds below 60 knots.....If difficulty in maintaining directional control is experienced during reverse thrust operation, reduce thrust as required and select forward idle, if necessary, to maintain or regain directional control. Do not attempt to maintain directional control by using asymmetric reverse thrust”.

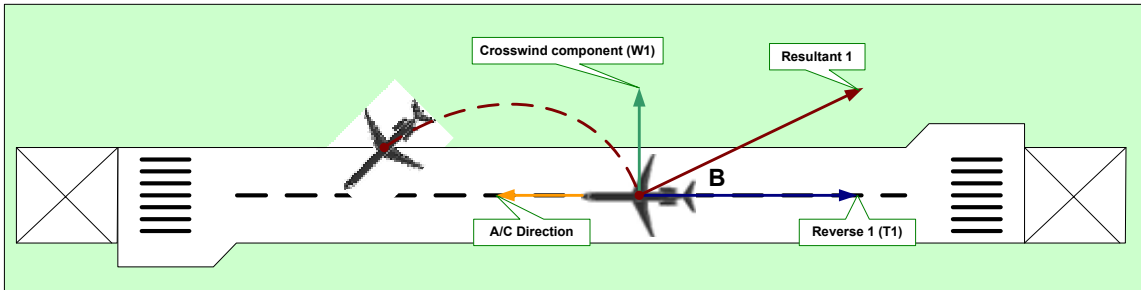
Figure 2. Thrust Reverse 2.0 EPR

Angle **a** is bigger than **b**, this proved with equation:

Landing incidents, especially overruns on wet runway which has repeatedly occurred in Hassanuddin airport shown similar characteristics. These incident indicate a serious deficiency in the pilots airmanship during landings under adverse weather condition. Referring to the analysis, NTSC recommendation are addressed to the airline operator to provide the flight crews with additional training for landings on slippery runway and use of engines reverses on such condition.
