Risk of collision involving an Air Luxor Lockheed L-1011 and a USAF Learjet 35.

Investigative Body: Air Accident Investigation Unit (AAIU), Ireland

AAIU Report No. 1999/016
AAIU File No. 19980061
Published 11/06/1999

Aircraft Type and Registration: (i) Lockheed L 1011, CS-TEB
(Civil)
(ii) Learjet LJ35, 40085 (Military)

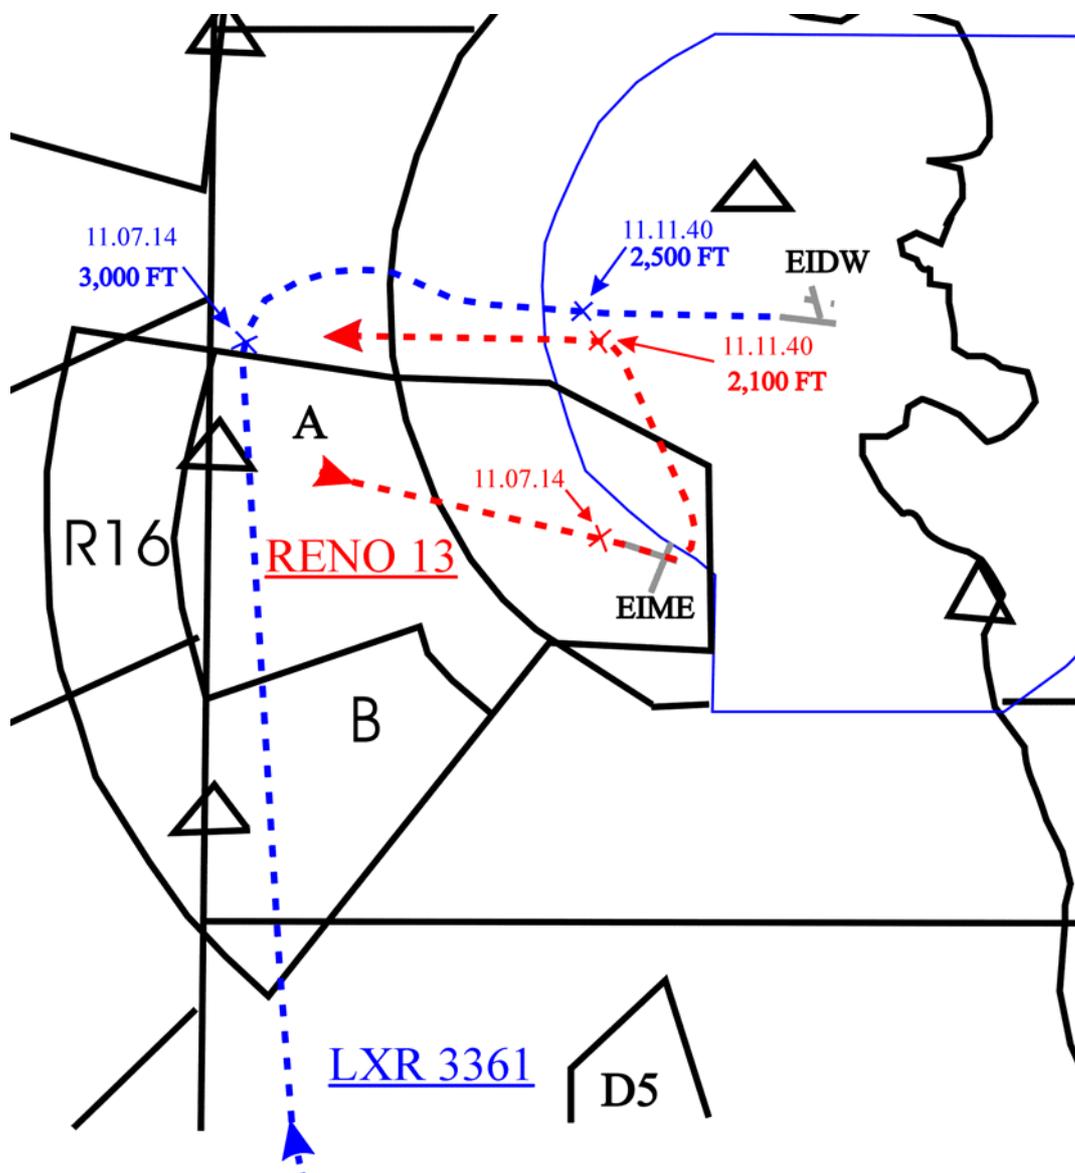
ANNEX A

The military aircraft, having passed the missed approach point, turned left as appropriate and climbed to 2,000 ft. The radar trace of the aircraft's track (see Annex A), indicates that the aircraft did not continue the turn on to a heading of 270° as required, but stopped turning on a heading of 345° with the mistaken intention of intercepting the 292° Radial to Baldonnel VOR. He continued on this heading of 345° and passed through the Dublin Control Zone boundary at about four miles from the Baldonnel VOR. The Dublin Approach controller then contacted military ATC who instructed the military aircraft to turn on to a westerly heading. By the time the military aircraft turned it was within 1.5 nm of the Luxor 3361 flight and approximately 400 ft below that aircraft.

Considering the closing speed of 360kts between the military aircraft whilst on a heading of 345° and the civilian aircraft on the ILS approach, with its vertical profile set, the risk must be considered to be in the "Risk of Collision" category.

SKETCH SHOWING FLIGHT PATHS OF
RENO 13 AND LXR 3361
