## Truck hits BAe-146 at Dublin Airport on March 12, 1999

*AAIU Report No.2001-008*  
*AAIU File No. 1999 0011*  
*Published.: 17/07/2001*

<b>Aircraft Type and Registration:</b>	BAe 146, EI-CLI
<b>No. and Type of Engines:</b>	Four, Allied Signal ALF502 R-5
<b>Aircraft Serial Number:</b>	3159
<b>Year of Manufacture:</b>	1990
<b>Date and Time (UTC):</b>	12th March 1999, 10.20 hrs
<b>Location:</b>	Stand 24 Dublin Airport
<b>Type of Flight:</b>	Public Transport
<b>Persons on Board:</b>	49 Transit Passengers and cabin crew.
<b>Injuries:</b>	None
<b>Nature of Damage:</b>	Port Aileron damaged
<b>Commanders Licence:</b>	Air Transport Pilots Licence
<b>Commanders Age:</b>	40 years
<b>Commanders Flying Experience:</b>	5000 hours, 2300 on Type
<b>Information Source:</b>	Airline Safety Officer

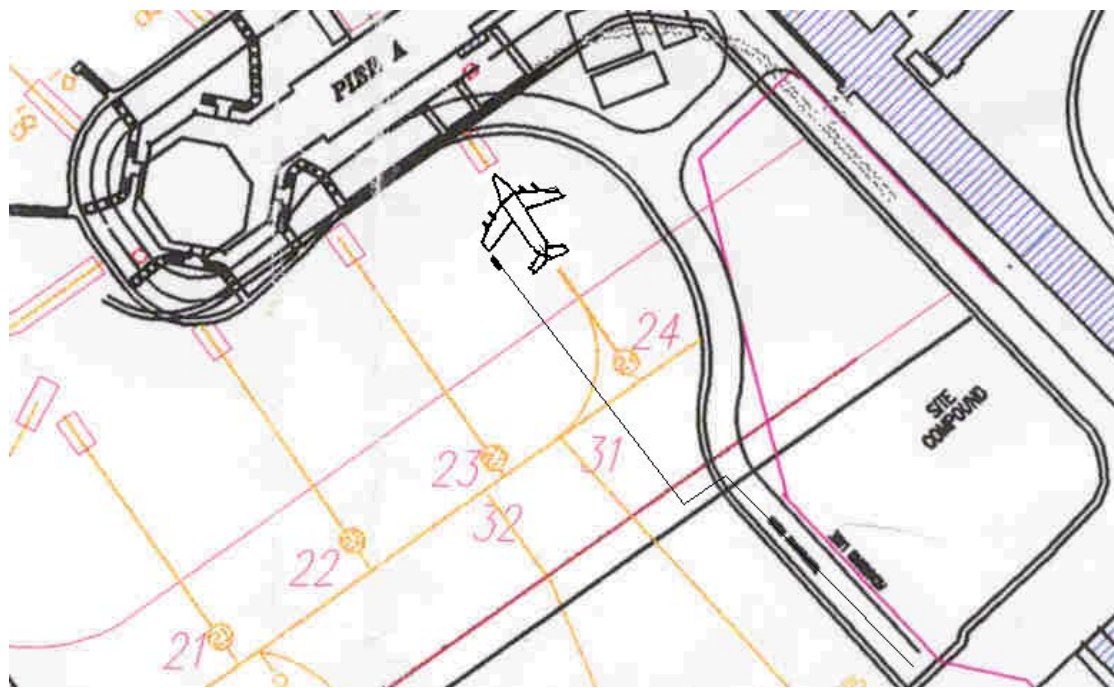
EI-CLI on Stand 24, showing the direction from which the vehicle came.
