Collision with air bridge, Boeing 737-500, Dublin, Ireland, May 12, 1999

AAIU Report No. 2001/003
AAIU File No. 19990024
Published: 29/01/2001

Aircraft Type and Registration:	B737-500 EI-CDH
No. and Type of Engines:	CFM 56 – 3B1
Aircraft Serial Number:	25739
Year of Manufacture:	1992
Date and Time (UTC):	12 May 1999, 05.20 hrs.
Location:	Stand 38, Dublin Airport
Type of Flight:	Public Transport
Persons on Board:	Pax 25 Crew 5
Injuries:	Pax Nil Crew Nil
Nature of Damage:	Damage to upper surface area port wing tip for a distance of approx. 3 ft in from the wing tip. Extensive damage to the underside of airbridge mechanism.
Commanders Licence:	ATPL
Commanders Age:	54 years
Commanders Flying Experience:	12000 hours, 4500 hours on type.
Information Source:	Duty Officer, Aer Rianta Dublin Airport. AAIU Field Investigation.

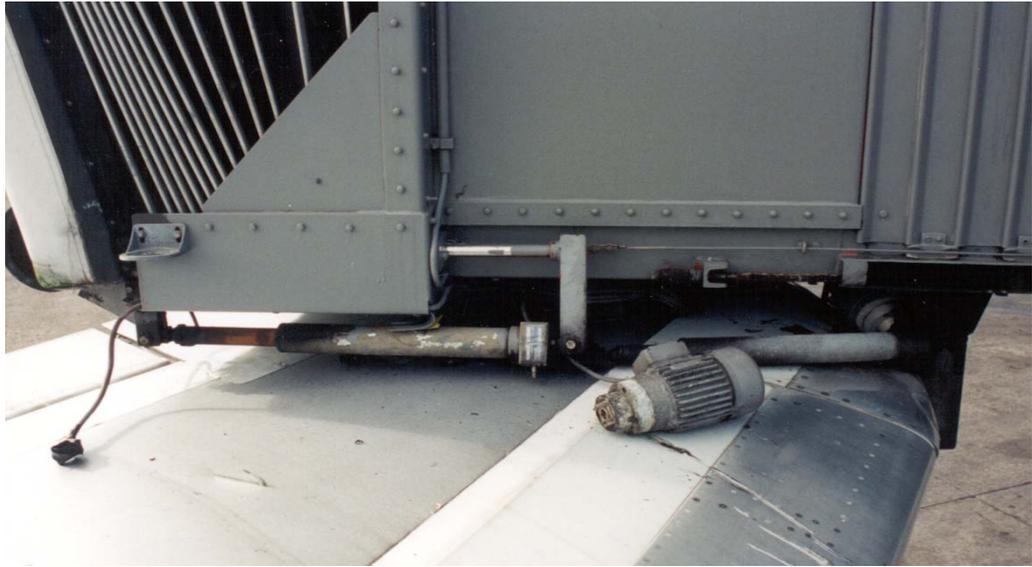
The port wing of the aircraft slipped under the airbridge platform (see Photo1). The top surface of the wing outboard of the ailerons was scored and damaged by the underhanging electrical mechanism of the airbridge. Considerable crushing of the top wing tip sheet metal was evident which would require repair/replacement. The nose wheel was offset about 15cm from the yellow taxiline centre as a result of the impact.

Photo.1 The port wing of EI-CDH following the aircraft's impact with the airbridge on Stand 38.

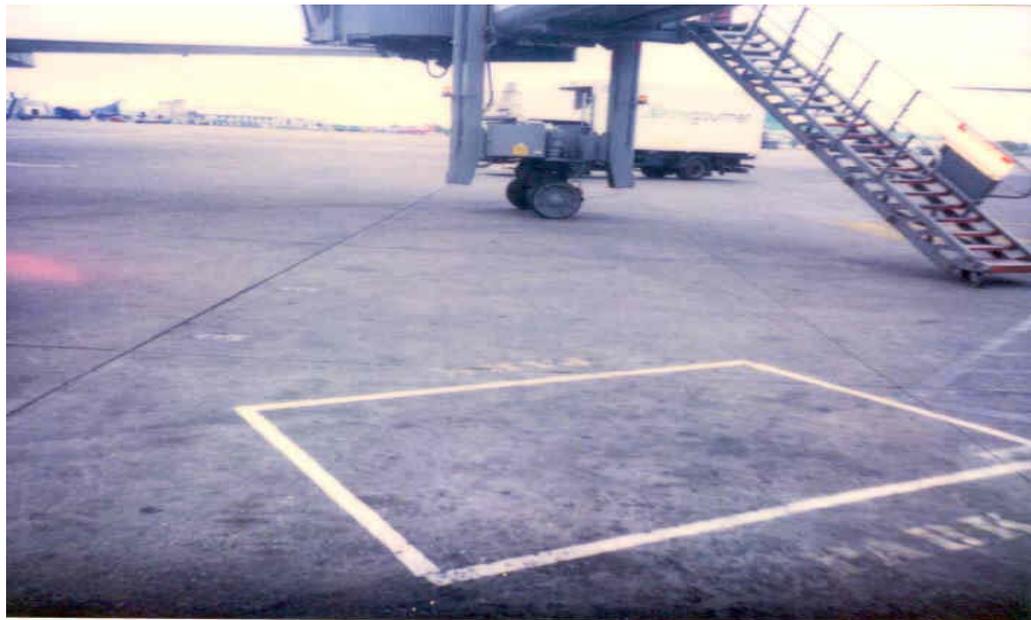
Just as the aircraft was being brought to a halt at the hammerhead, the upper surface area of the port wing, outboard of the aileron, collided with the underneath electrical mechanism of the airbridge. There were no injuries to passengers or crew and the aircraft's airstairs was used to allow the passengers to disembark. The Investigator-in-Charge noted on his arrival that the airbridge was 12.3 metres from its normal parked position.(see Photo 2)

On inspection the investigators found the airbridge bogey extended 12.3 metres from the "Park" position.

Photo.2 Position of airbridge relative to the PARK area.

- 4.1 The Airport Authority should give adequate and timely warning to Aircraft Operators when stand equipment is out of order due to maintenance. **(SR 3 of 2001)**
- 4.2 The Aircraft Operator should ensure that a qualified and experienced marshaller accompany newly trained marshalls during their first few duty assignments. **(SR 4 of 2001)**
- 4.3 On arrival at a stand airbridge operators should confirm that the airbridge is in the correct parked position. **(SR 5 of 2001)**
